Mercedes-Benz

Campaign No. 2014040002, April 2014

SUBJECT: **Models X166 (GL), Model Year 2014**
Replace Second Row 60% Seat Pan

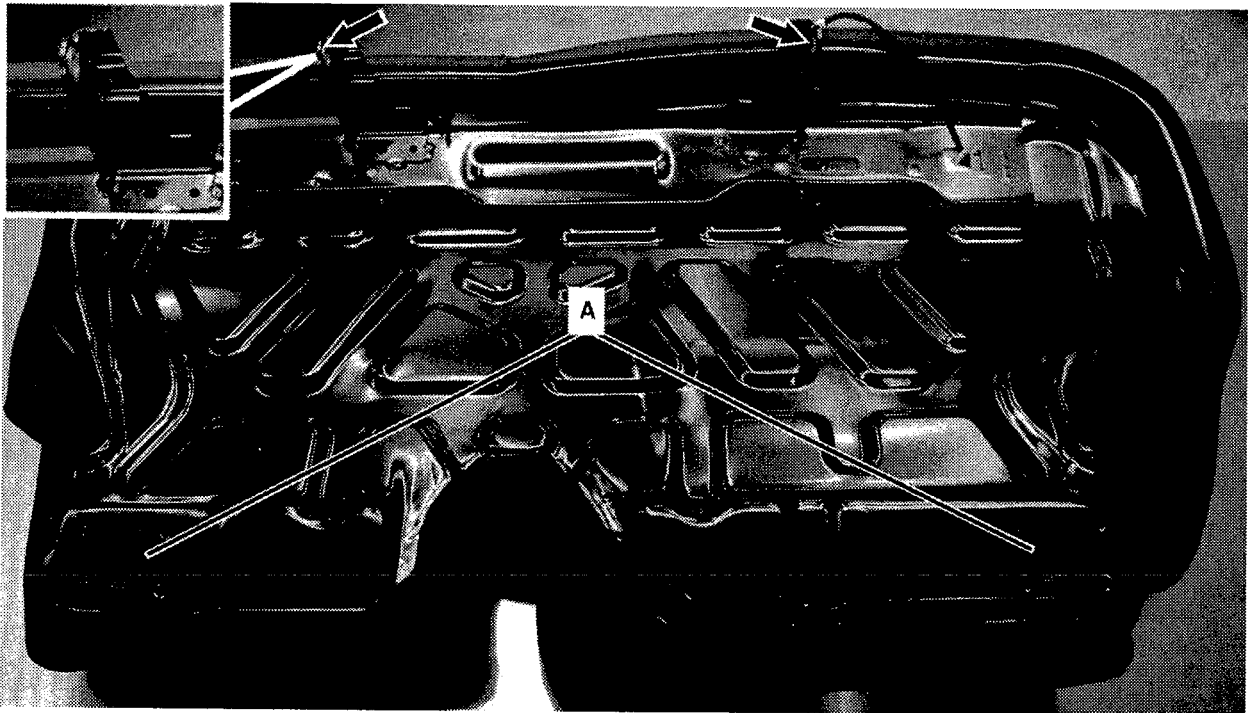
Figure 1

Daimler AG (DAG), the manufacturer of Mercedes-Benz vehicles, has determined that due to a deviation in the production process at the seat supplier, the mount for the second row 60% seat pan may have been welded to the seat structure at an incorrect angle. Consequently, the second row 60% seat base might not reach its lowest position which could prevent access to the ISOFIX child seat anchors as required in FMVSS 225 (Child Restraint Anchorage Systems). MBUSA therefore has initiated a voluntary recall of all potentially affected vehicles described above. The recall will be conducted to replace the second row 60% seat pan in the subject vehicles.

Replace seat cushion frame (pan).

- Be sure to transfer grommets (A, Figure 1) and plastic sleeves with washers (arrows) from "old" seat cushion frame (pan) to "new" seat cushion frame (pan).
- Reinstall cable tie mounting clip (attached to seat wiring harness) to new seat cushion frame (pan).
- Secure seat wiring harness to new seat cushion frame (pan) with cable tie.
