PRODUCT SAFETY RECALL

SUBJECT: Driver's Airbag Module

MODELS: 2009-2010 Pontiac Vibe

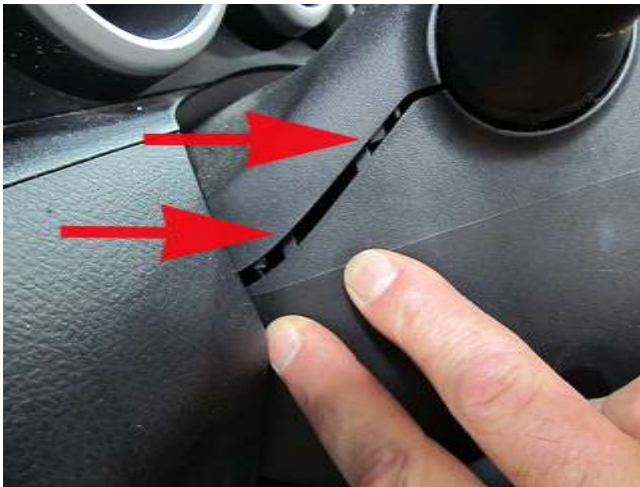
3946765

Note: when removing the upper and lower steering column trim covers, use care to fully release all of the attachments. Do not force the clips, they will break off of the trim.

1. Remove the steering wheel air bag coil. Refer to Steering Wheel Airbag Coil Replacement in SI. Discard the coil, it is not re-usable.
