# Recall Bulletin

## PRODUCT SAFETY RECALL

**SUBJECT:** Replace Ignition Key

**MODELS:** 2005-2010 Chevrolet Cobalt  
2006-2011 Chevrolet HHR  
2006-2010 Pontiac Solstice  
2005-2006 Pontiac Pursuit (Canada Only)  
2007-2010 Pontiac G5  
2003-2007 Saturn Ion  
2007-2010 Saturn Sky

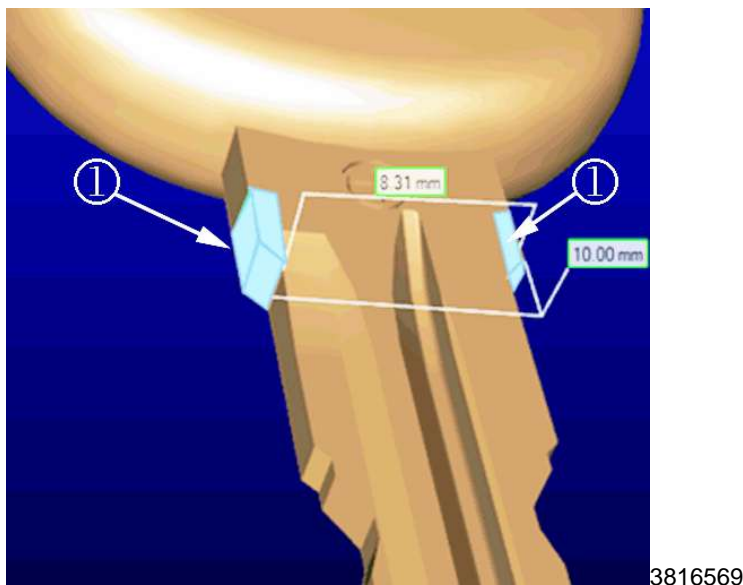
For the Saturn Ion only, if the replacement key profile is wider near the key head than the original equipment manufacturer (OEM) key, it may only work in the ignition lock cylinder and not in the doors or trunk. The replacement key may require modification BEFORE it can be used to open a vehicle door or trunk. Perform the Key Modification procedure in this bulletin if the replacement key will not open the doors or trunk of the vehicle.

1. Using a file, remove the extra width of key near the over molded head as shown in blue (1) in the photograph above. Removing this material makes the width of the key 8.3mm (same as the OEM key) rather than 10mm. This will allow the key to enter fully into the door and trunk lock cylinders.

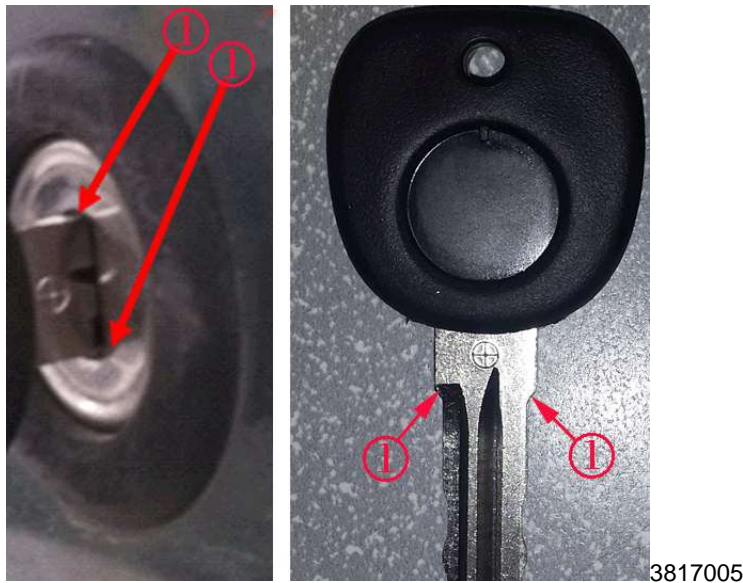
**Note:** Without the modification, the key stops on the shoulder and will not fully enter the key lock cylinder. Refer to the photograph.

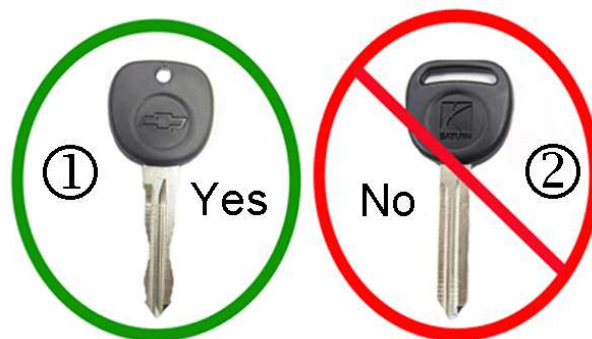
- Only use keys with a small round hole (1) and not a slot (2)
- Use only a 1/2" diameter key ring (provided by your GM dealer)
- Only include 1 or 2 keys plus your key fob
- Don't attach extra items to your key ring
- Contact your dealer if you need new keys
- Do not attempt to reprogram any old slotted keys you may still have in your possession. These keys must be turned into your GM dealer or destroyed.
