Recall Bulletin

PRODUCT SAFETY RECALL

SUBJECT: Replace Ignition Lock Cylinder and Ignition Key

MODELS: 2005-2010 Chevrolet Cobalt
2006-2011 Chevrolet HHR
2006-2010 Pontiac Solstice
2005-2006 Pontiac Pursuit (Canada Only)
2007-2010 Pontiac G5
2003-2007 Saturn Ion
2007-2010 Saturn Sky

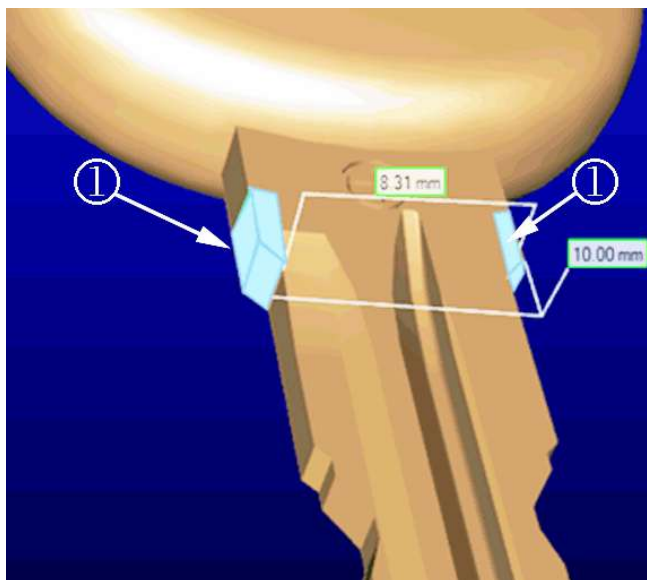
For the Saturn Ion only, if the replacement key profile is wider near the key head than the original equipment manufacturer (OEM) key, and it may only work in the ignition lock cylinder and not in the doors or trunk. The replacement key may require modification BEFORE it can be used to open a vehicle door or trunk. Perform the *Key Modification* procedure in this bulletin if the replacement key will not open the doors or trunk of the vehicle.

1. Using a file, remove the extra width of key near the over molded head as shown in blue (1) in the photograph above. Removing this material makes the width of the key 8.3mm (same as the OEM key) rather than 10mm. This will allow the key to enter fully into the door and trunk lock cylinders.

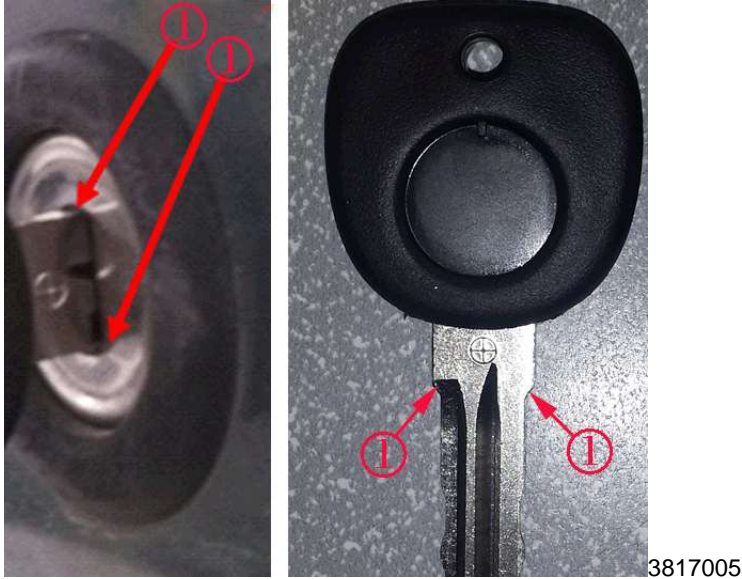
Note: Without the modification, the key stops on the shoulder and will not fully enter the key lock cylinder. Refer to the photograph.

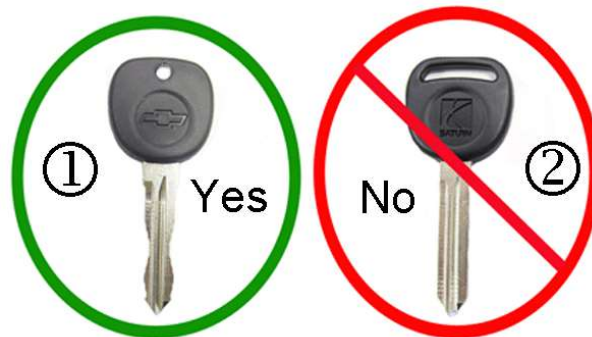
- Only use keys with a small round hole (1) and not a slot (2)
- Use only a 1/2" diameter key ring (provided by your GM dealer)
- Only include 1 or 2 keys plus your key fob
- Don't attach extra items to your key ring
- Contact your dealer if you need new keys
- Do not attempt to reprogram any old slotted keys you may still have in your possession. These keys must be turned into your GM dealer or destroyed.
