Recall Bulletin

PRODUCT SAFETY RECALL

SUBJECT: Replace Ignition Key

MODELS: 2005-2010 Chevrolet Cobalt
2006-2011 Chevrolet HHR
2006-2010 Pontiac Solstice
2005-2006 Pontiac Pursuit (Canada Only)
2007-2010 Pontiac G5
2003-2007 Saturn Ion
2007-2010 Saturn Sky

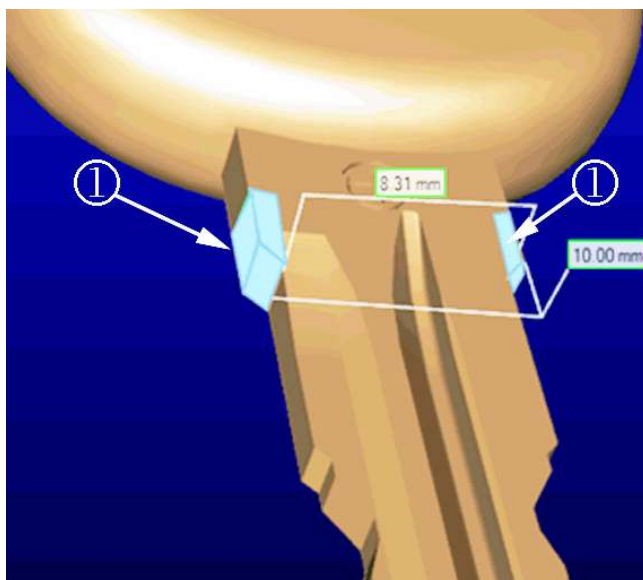
3816569

For the Saturn Ion only, if the replacement key profile is wider near the key head than the original equipment manufacturer (OEM) key, it may only work in the ignition lock cylinder and not in the doors or trunk. The replacement key may require modification BEFORE it can be used to open a vehicle door or trunk. Perform the Key Modification procedure in this bulletin if the replacement key will not open the doors or trunk of the vehicle.

1. Using a file, remove the extra width of key near the over molded head as shown in blue (1) in the photograph above. Removing this material makes the width of the key 8.3mm (same as the OEM key) rather than 10mm. This will allow the key to enter fully into the door and trunk lock cylinders.

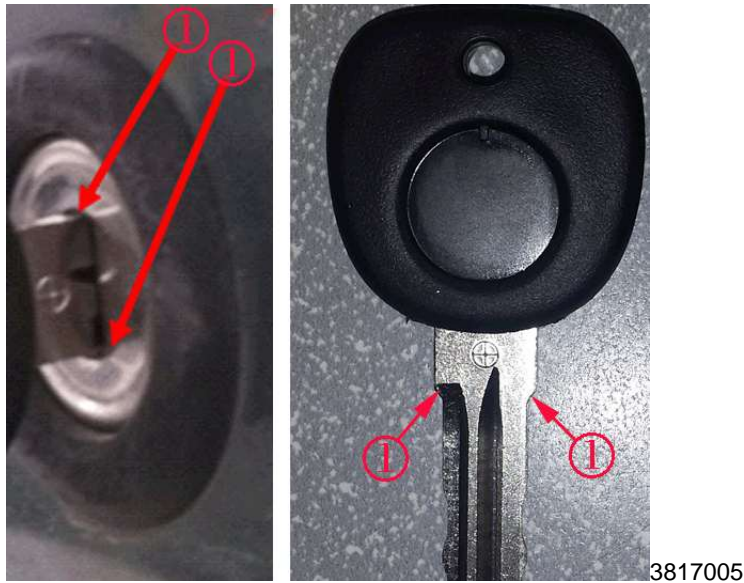
Note: Without the modification, the key stops on the shoulder and will not fully enter the key lock cylinder. Refer to the photograph.

2. Verify key function in the ignition cylinder as well as all door and trunk lock cylinders prior to delivery to the customer.
3. Assemble the new key(s), the key fob(s) and the 1/2" key ring together.
