This Service Information bulletin supersedes SI B11 07 14 **dated September 2014.**

Recall Campaign 14V-176: N51, N52K and N52T Engine – Replace VANOS Gear Bolts

REPAIR PROCEDURE

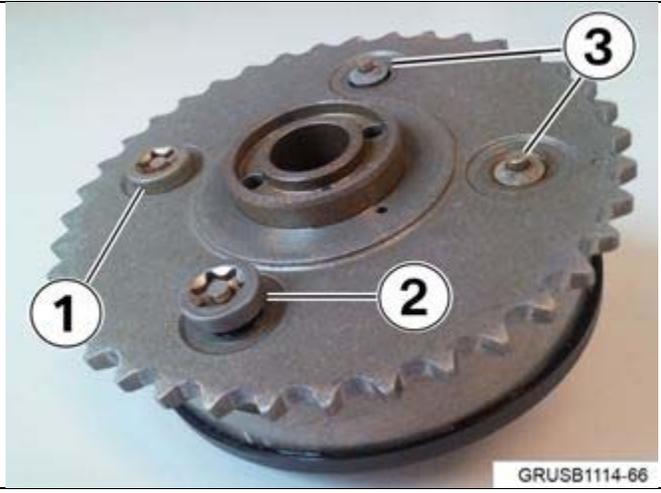
<p>3. Evaluation of bolt:</p> <p>If any of the bolts were loose or broken during this procedure, the VANOS assembly will need to be replaced. Refer to step 14.</p> <p>VANOS bolt is tight (1)</p> <p>VANOS bolt is loose (2)</p> <p>VANOS bolt heads have sheared off (3)</p> <p>Note: VANOS gear assembly removed from engine for clarity. Do not remove VANOS Gear Assembly</p>
<p>Intake VANOS Adjustment Unit:</p>

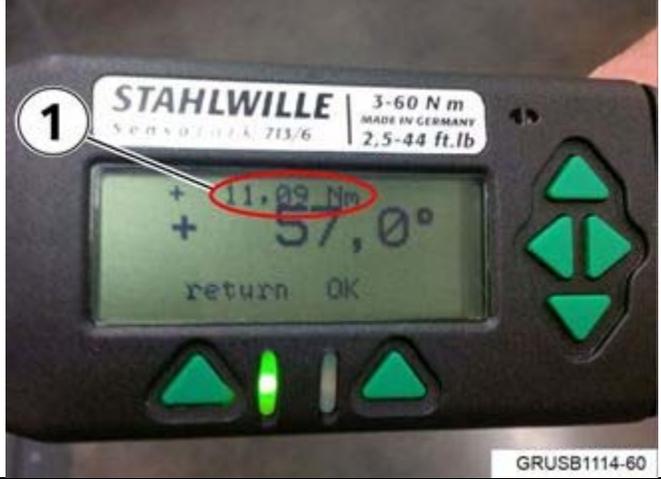
<p>8. While performing the angle torque, the digital screen on the torque wrench will display the current Nm meter value. This value should be between 8 Nm-14 Nm.</p> <p>If the displayed value is not within the specification, the bolt will need to be removed and replaced with a new bolt again. Repeat as necessary.</p> <p>To reset the torque wrench and clear the screen to Nm again, just press the “MR” button to continue replacing additional bolts.</p>
<p>9. If any of the bolts were loose or broken during this procedure, the VANOS assembly will need to be replaced. Refer to step 16.</p> <p>If no bolts were found loose, repeat steps 4-8 for the remaining 3 bolts on the VANOS gear assembly. It is good practice to mark each bolt head with a felt marker as it is replaced, so one is not mistaken and removed again.</p> <p>When all of the intake VANOS assembly bolts have been replaced successfully, proceed to step 10.</p>

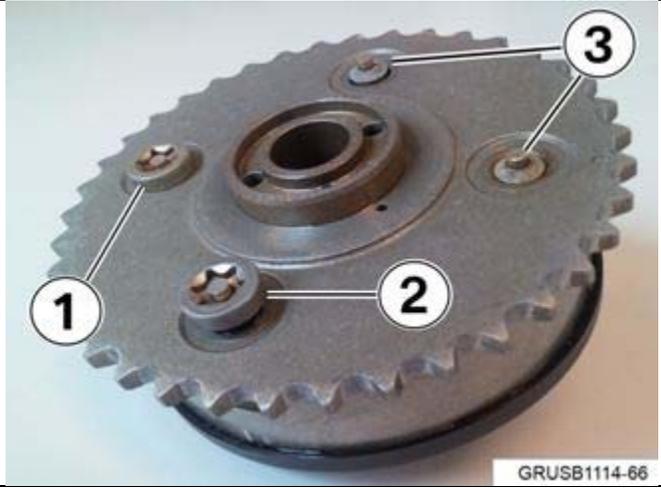
<p>10. Evaluation of bolt:</p> <p>If any of the bolts were loose or broken during this procedure, the VANOS assembly will need to be replaced. Refer to step 16.</p> <p>VANOS bolt is tight (1)</p> <p>VANOS bolt is loose (2)</p> <p>VANOS bolt heads have sheared off (3)</p> <p>Note: VANOS gear assembly removed from engine for clarity. Do not remove VANOS Gear Assembly</p>

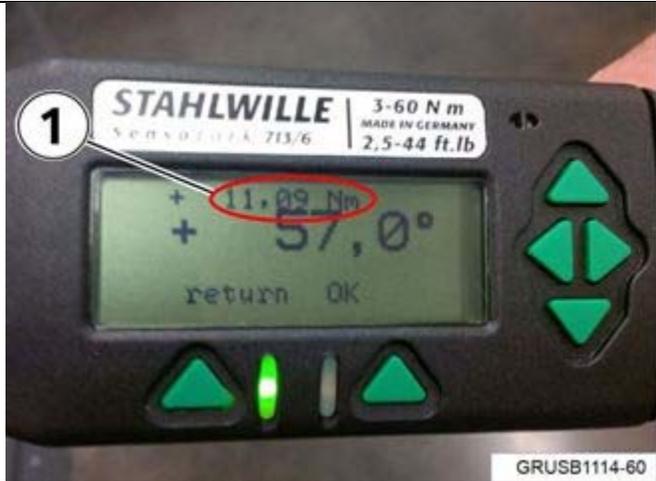
<p>15. While performing the angle torque, the digital screen on the torque wrench will display the current Nm meter value. This value should be between 8 Nm-14 Nm.</p> <p>If the displayed value is not within the specification, the bolt will need to be removed and replaced with a new bolt again. Repeat as necessary.</p> <p>To reset the torque wrench and clear the screen to Nm again, just press the “MR” button to continue replacing additional bolts.</p>
<p>16. If any of the bolts were found loose or broken during this procedure, the affected VANOS assembly will need to be replaced. Refer to step 17.</p> <p>If no bolts were found loose, repeat steps 10-15 for the remaining 3 bolts on the applicable VANOS gear assembly. It is good practice to mark each bolt head with a felt marker as it is replaced, so one is not mistaken and removed again. Refer to step 18 when complete.</p>	
<p>17. If any of the VANOS bolts were found loose or broken, that VANOS unit will need to be replaced. Refer to Repair Instruction 11 36 046, “Removing and installing or replacing intake and exhaust camshaft adjusters.”</p>
