This Service Information bulletin supersedes SI B11 08 14 **dated September 2014.**

Recall Campaign 14V-176: N55 Engine – Replace VANOS Gear Bolts

The VANOS adjustment units may develop an internal oil leakage that will no longer allow the VANOS to adjust quickly enough. Due to this leakage, the vehicle's engine emergency mode and engine malfunction is permanently active.

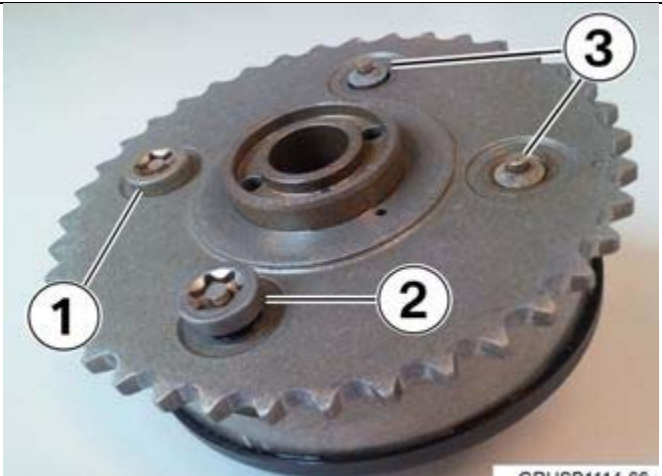
<p>GRUSB1114-66</p>	<p>3. Evaluation of bolt:</p> <p>If any of the bolts were loose or broken during this procedure, the VANOS assembly will need to be replaced. Refer to step 14.</p> <p>VANOS bolt is tight (1)</p> <p>VANOS bolt is loose (2)</p> <p>VANOS bolt heads have sheared off (3)</p> <p>Note: VANOS gear assembly removed from engine for clarity. Do not remove VANOS Gear Assembly</p>
<p>Intake VANOS Adjustment Unit:</p>

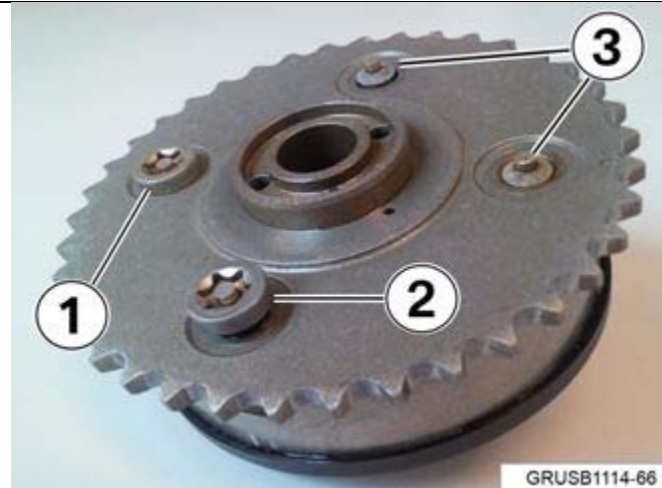
10. Evaluation of bolt:

If any of the bolts were loose or broken during this procedure, the VANOS assembly will need to be replaced. Refer to step 16.

VANOS bolt is loose (2)

VANOS bolt heads have sheared off (3)

17. If any of the VANOS bolts were found loose or broken, that VANOS unit will need to be replaced. Refer to Repair Instruction 11 36 046, “Removing and installing or replacing intake and exhaust camshaft adjusters.”
