star bulletin

Date: June
Order No.: P-B-82.10/704
Group: 82

**SUBJECT: Model 204, Model Years 2008 - 2011
Check Right and Left Tail Lamp Bulb Carrier, Replace if Necessary**

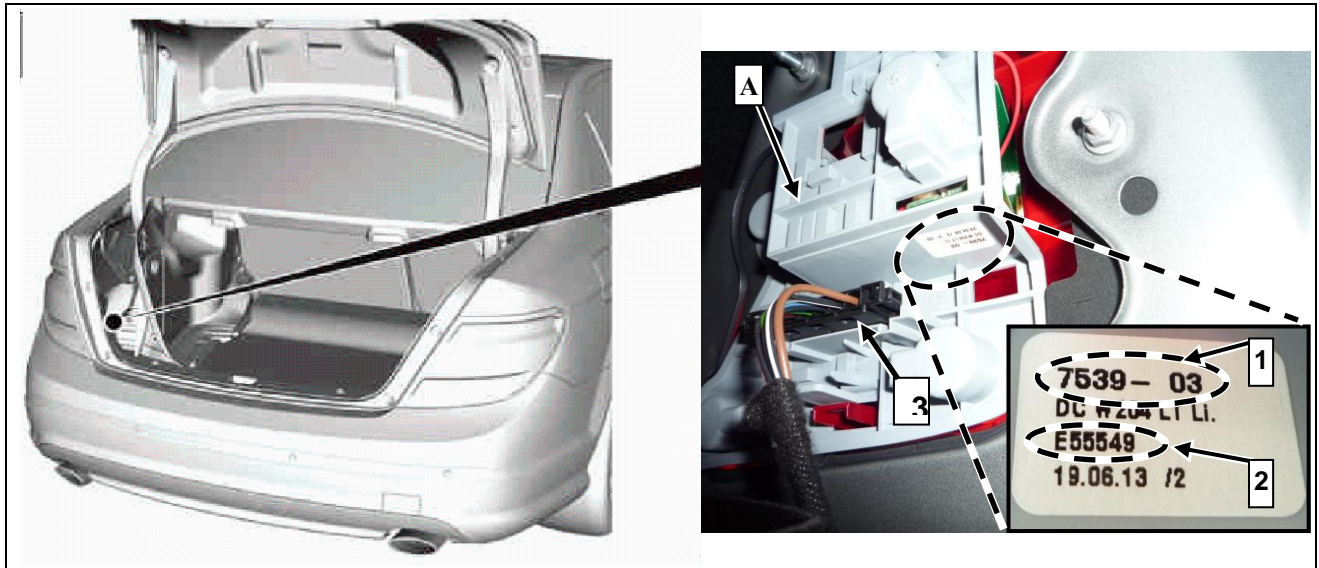
Figure 1

1. Check object number (1, Figure 1) and index (2) on sticker affixed to lamp carrier (A) on left and right tail lamp:

It is relevant for the test whether **both**, the object number (1) and the index (2), are present as a combination as specified in the table below.

Example: Object number 7539-03 belongs with index E55549 (OK).

- If there is no sticker affixed (**NOT OK**): Proceed to Subject B.
 - If object number (1, Figure 1) and the index (2, Figure 1) are **not** present (on sticker) as specified in the table below (**NOT OK**): Proceed to Subject B.
- Note:**
Refer also to Figure 2
- If object number (1, Figure 1) and the index (2, Figure 1) **are** present on sticker as found in the table below (OK): Procedure is complete.

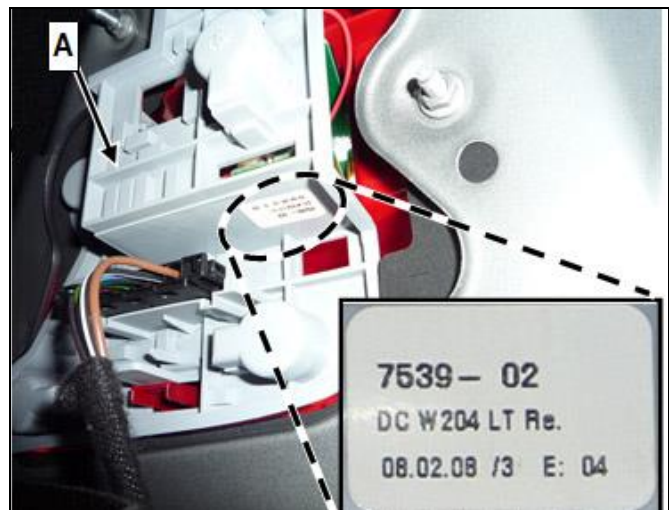
Figure 2 Example of bulb carrier that is: **NOT OK**
(index information not present on sticker)

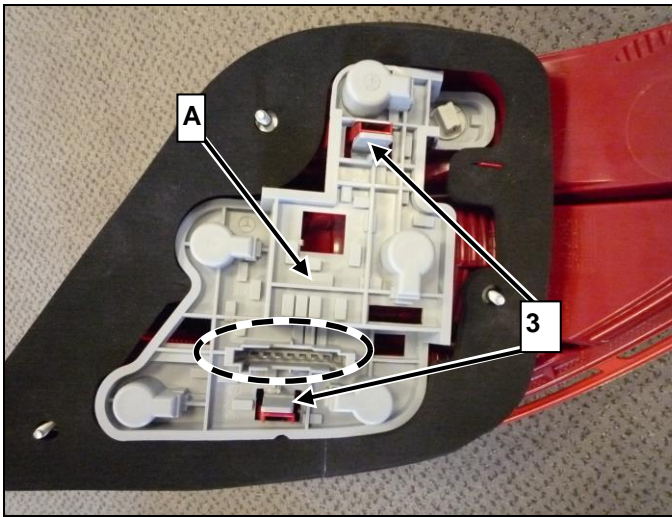
Figure 4

Check (female) wire contact in position 1 (B, Figure 5) on brown ground wire (1, Figure 4) with associated harness connector (2, Figure 4) for damage: Replace defective components refer to WIS:
 - AR00.19-P-0120-07A - Remove contacts from Junior Power Timer coupling.
 - AR00.19-P-0100-03A - Repair wiring harness by crimping.

Unplug harness connector (2, Figure 4) from tail lamp bulb carrier (A).
2.
