Campaign No. 2014050001, November 2014

SUBJECT: Model 204, Model Years 2008 - 2011 Check Tail Lamp Carrier, Replace as Necessary

<u>Recall Campaign Bulletin</u>

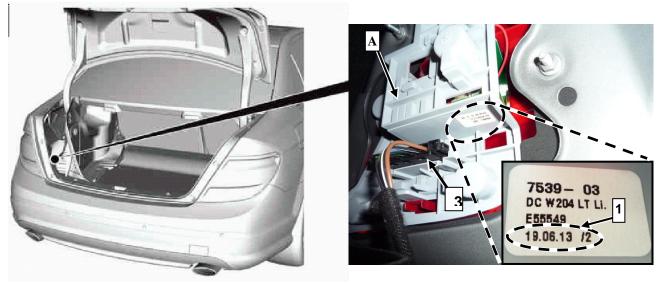
Figure 1

- A. Inspect Tail Lamp Bulb Carriers
- 1. Check production date (1, Figure 1) on sticker affixed to lamp carrier (A) on left and right tail lamp: **i** Note:

- Production date *as of* 13.04.2012 (*OK*): Procedure is complete.
- Production date *up to* and including 12.04.2012 (*NOT* OK): Proceed to Subject B
- If there is no sticker or no production date: (NOT OK): Proceed to Subject B
