star bulletin

Date: June
Order No.: P-B-82.10/704
Group: 82

**SUBJECT: Model 204, Model Years 2008 - 2011
Check Right and Left Tail Lamp Bulb Carrier, Replace if Necessary**

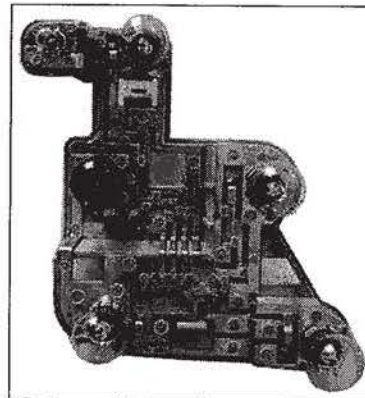
Object number and index

The object number and index on each bulb carrier will be verified and the carrier(s) will be replaced if necessary. Both tail lamp connectors and wire contacts will be inspected for evidence of oxidation and the connector(s) and affected wire contact(s) will be replaced if necessary. Customers who previously paid for this repair can request reimbursement with appropriate documentation.

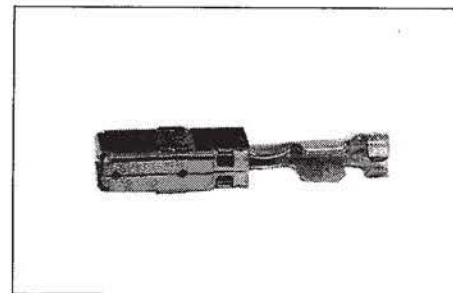
Harness connector

Female wire contact connected to wire on wiring harness
