Campaign No. 2014050001, August 2014

SUBJECT: **Model 204, Model Years 2008 - 2011**  
**Check Tail Lamp Carrier, Replace as Necessary**

**IMPORTANT SAFETY RECALL 2014050001**

**This notice applies to your vehicle, Insert VIN here  
Rear Tail Lamp Bulb Carrier  
NHTSA Recall # 14V-177**

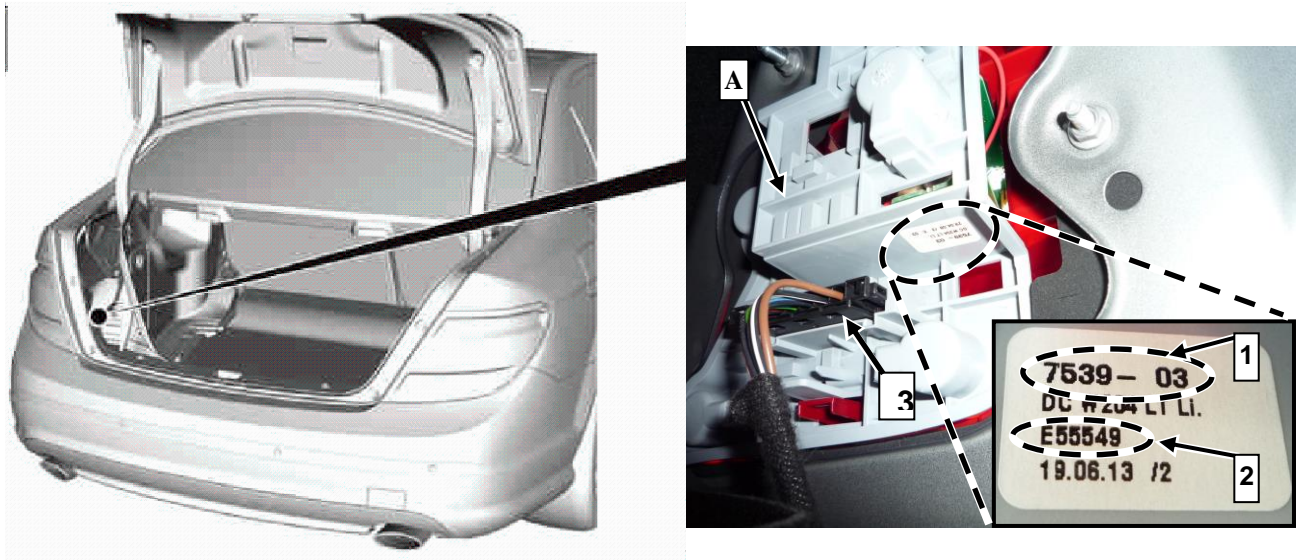
Figure 1

Check object number (1, Figure 1) and index (2) on sticker affixed to lamp carrier (A) on left and right tail lamp:

It is relevant for the test whether **both**, the object number (1) and the index (2), are present as a combination as specified in the table below.

Example: Object number 7539-03 belongs with index E55549 (**OK**).

- If there is no sticker affixed (**NOT OK**): Proceed to Subject B.
- If object number (1, Figure 1) and the index (2, Figure 1) are **not** present (on sticker) as specified in the table below (**NOT OK**): Proceed to Subject B.

- If object number (1, Figure 1) and the index (2, Figure 1) **are** present on sticker as found in the table below (**OK**): Procedure is complete.

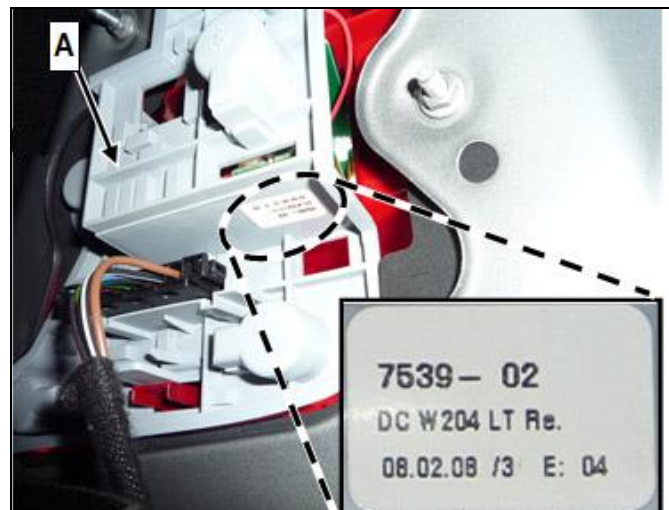
Figure 2 Example of bulb carrier that is: **NOT OK**  
(index information not present on sticker)
