Mercedes-Benz

Campaign No. 2014050001, August 2014

SUBJECT: **Model 204, Model Years 2008 - 2011**
Check Tail Lamp Carrier, Replace as Necessary

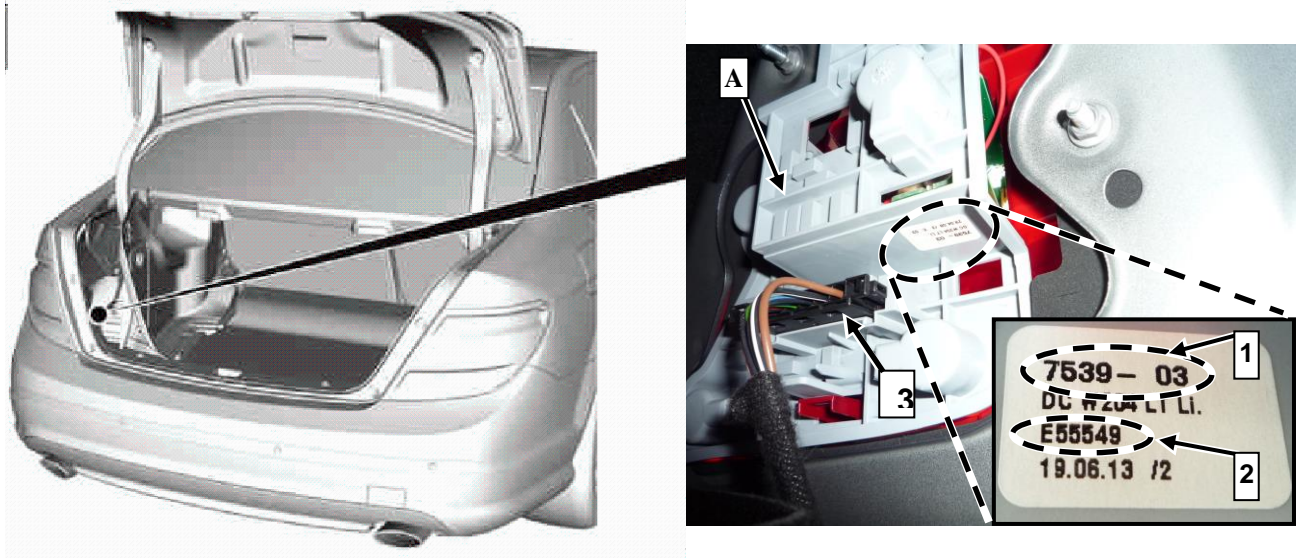
Figure 1

Check object number (1, Figure 1) and index (2) on sticker affixed to lamp carrier (A) on left and right tail lamp:

It is relevant for the test whether **both**, the object number (1) and the index (2), are present as a combination as specified in the table below.

- If there is no sticker affixed (**NOT OK**): Proceed to Subject B.
- If object number (1, Figure 1) and the index (2, Figure 1) are **not** present (on sticker) as specified in the table below (**NOT OK**): Proceed to Subject B.

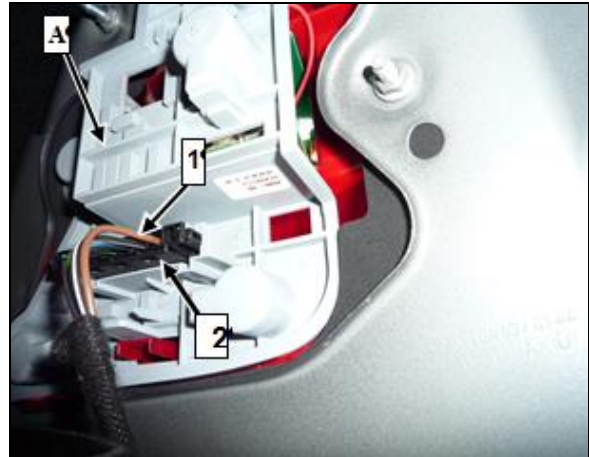
Figure 4

Check (female) wire contact in position 1 (B, Figure 5) on brown ground wire (1, Figure 4) with associated harness connector (2, Figure 4) for damage: Replace defective components refer to WIS:
 - AR00.19-P-0120-07A - Remove contacts from Junior Power Timer coupling.
 - AR00.19-P-0100-03A - Repair wiring harness by crimping.

Unplug harness connector (2, Figure 4) from tail lamp bulb carrier (A).
2.
