# Safety Recall

Code: 38B9

**Subject: 2014 MY Jetta, Beetle, Beetle Convertible and Passat Vehicles with 1.8T Engine and Torque-Converter Automatic Transmission Transmission Oil Cooler**

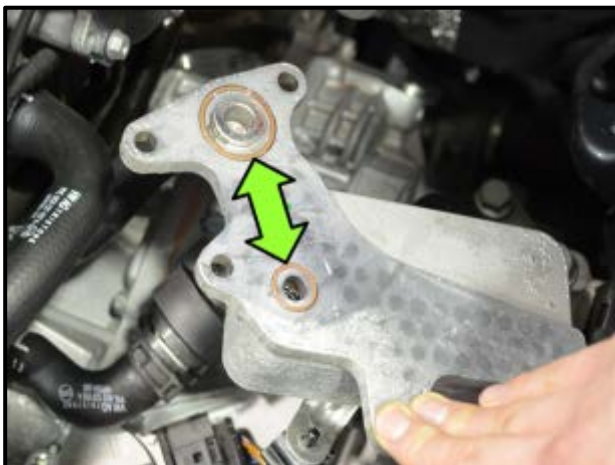
⇐ Gently lift the ATF cooler from the transmission and rotate the cooler toward the front of the vehicle to expose the O-rings <arrow>.

**!** Note: Be careful while lifting and handling the ATF cooler in order to prevent scratching or damaging the mating surfaces of the cooler and transmission.
