Campaign Service BULLETIN

BULLETIN NUMBER:
CB14-N-001

INOPERATIVE HORN – 14V-203

(Transport Canada #2014-143)

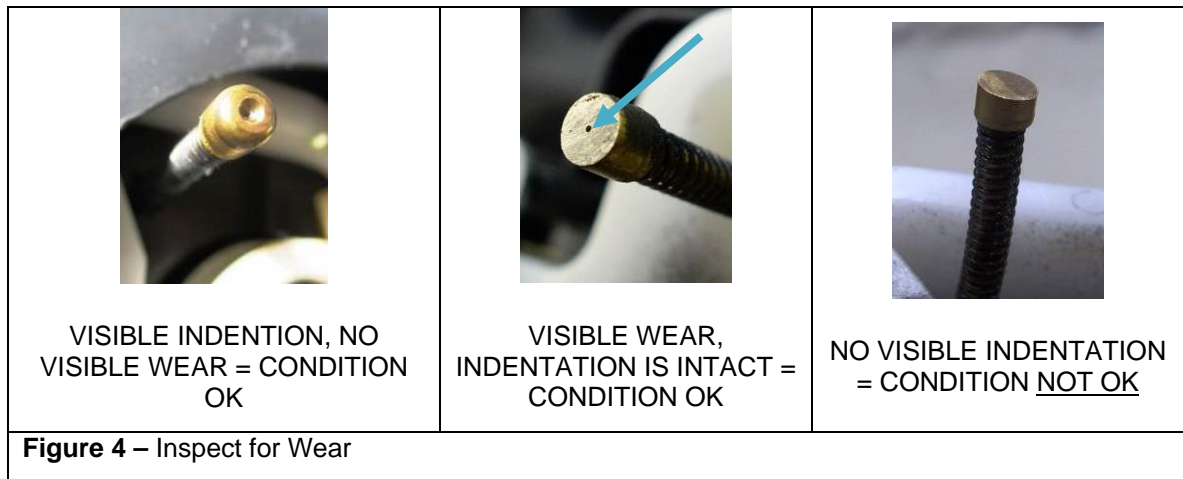
10. Inspect the horn contact shaft for premature wear and/or bending.

a. Inspect for Wear

i. Inspect the horn contact shaft for a visible indentation = CONDITION OK.

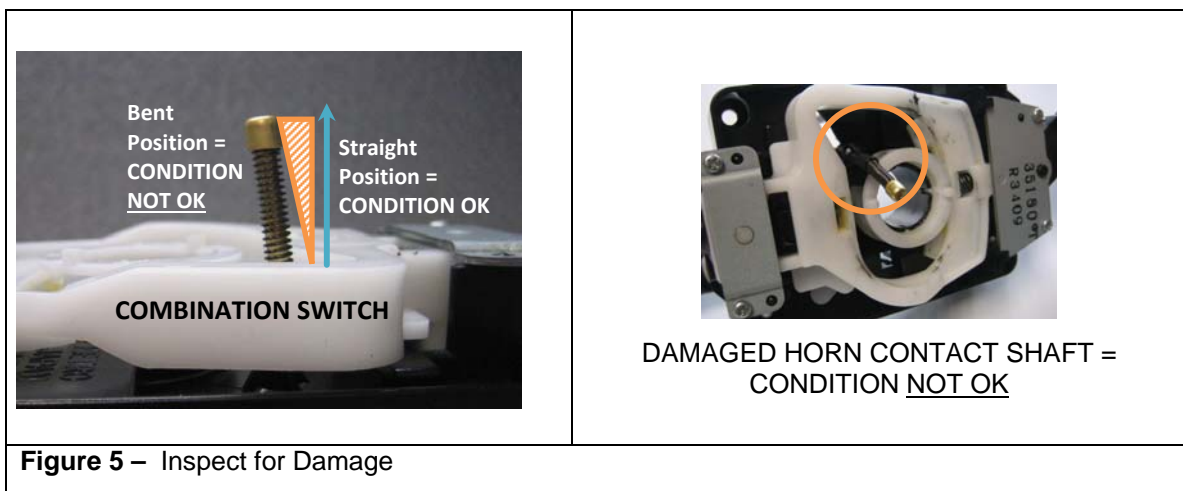
b. Inspect for Damage

i. Depress the horn contact shaft several times.

1. If the shaft springs back easily = CONDITION OK.

2. If the shaft does not spring back easily = CONDITION NOT OK.

12. If the horn contact shaft has been determined NOT OK as noted above in Step 10 (that is, if it is worn or damaged), follow the combination switch assembly replacement procedure in this bulletin.
