BMW Motorrad USA Service Information Bulletin

****Notice of Recall 14V-211****

Subject: Retainer for Radial Shaft Seal

Model: R 1200 GS (K50, 0A01/0A11)

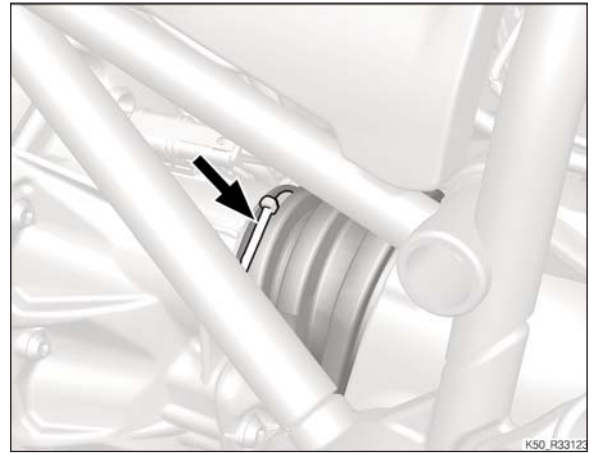
Remove cable tie (arrow).

Work flexible gaiter (1) to the rear.

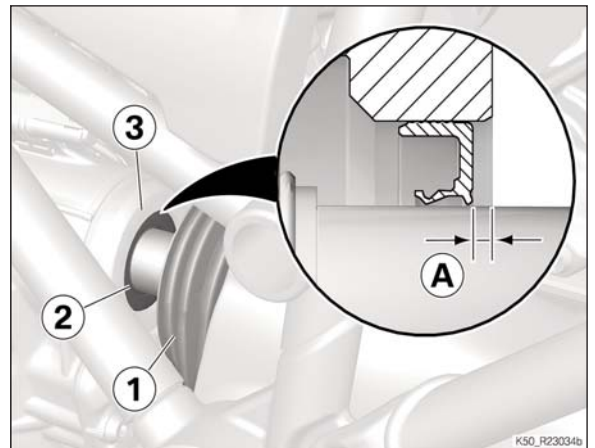
Lay a precision straight-edge across shaft sealing ring (2), resting at both ends on gearbox cover mating faces (3).

Check recess (A), shaft sealing ring (2) must be recessed or at most flush.

Shaft sealing ring projects past gearbox cover shows signs of rubbing or leaks.

Replacing radial shaft seal of output shaft (description in work item: 23 12 620, to be billed as a separate item).
