# Recall Bulletin

## PRODUCT SAFETY RECALL

**SUBJECT:** Transmission Shift Cable Fracture

**MODELS:** 2004-2007 Chevrolet Malibu Maxx  
2004-2008 Chevrolet Malibu  
2005-2008 Pontiac G6  
2007-2008 Saturn AURA  
Equipped with 4-Speed Automatic Transmission (ME7/MN5)

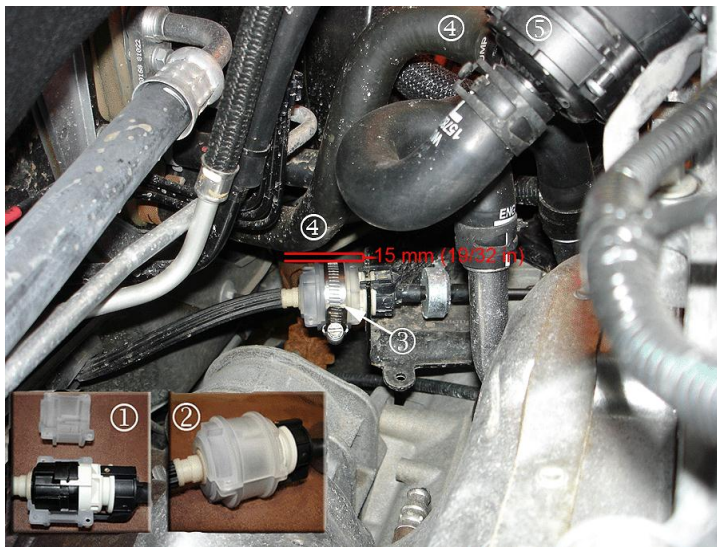
2269484

Hybrid vehicle shown. Combustion engine vehicle is similar.

- (1) Clam Shell in Two Pieces
- (2) Clam Shell Around Shifter Cable Locking Tabs
- (3) Clamp on Clam Shell
- (4) Inlet Coolant Hose and
- (5) Heater Cooler Pump.

4. Install the clam shell (1) (2) over the shifter cable locking tabs.
5. Install the service clamp over the clam shell (3). Position the clamp fastener head away from the inlet coolant hose (4). **Tighten the clamp to 4 N·m (35 lb-in).**
6. Ensure that there is 15 mm (19/32 in) of clearance between the inlet coolant hose (4) and the clam shell (3). On hybrid equipped vehicles, it may be necessary to reposition the inlet coolant hose (4) to achieve the required 15 mm (19/32 in) of clearance. **To reposition the inlet coolant hose (4) on hybrid equipped vehicles, locate the heater cooler pump (5) and perform Steps 6.1-6.5.**

**Caution: Do not kink or damage the inlet coolant hose (4) when repositioning the hose to obtain the 15 mm (19/32 in) clearance. To avoid damaging the hose clamp, use J-38185 or equivalent hose clamp pliers to loosen the hose clamp.**
