Recall Bulletin

PRODUCT SAFETY RECALL

SUBJECT: Transmission Shift Cable Fracture

MODELS: 2004-2007 Chevrolet Malibu Maxx
2004-2008 Chevrolet Malibu
2005-2008 Pontiac G6
2007-2008 Saturn AURA
Equipped with 4-Speed Automatic Transmission (ME7/MN5)

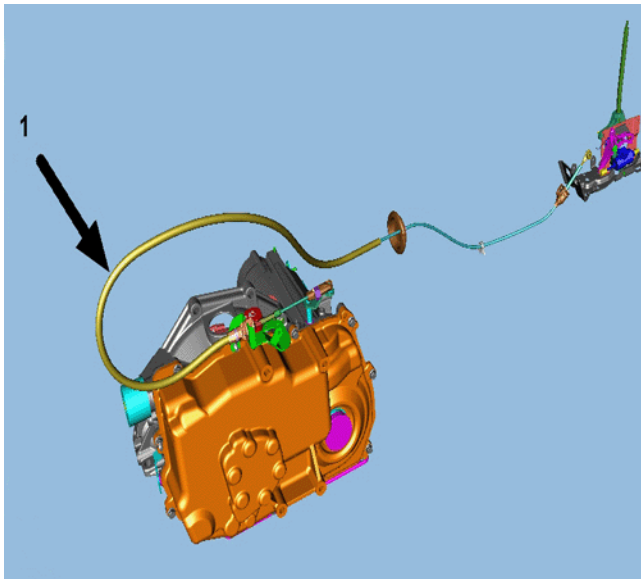
4056223

- If the shift cable makes a loop (1) before it attaches to the transmission shift lever, no further action is required.

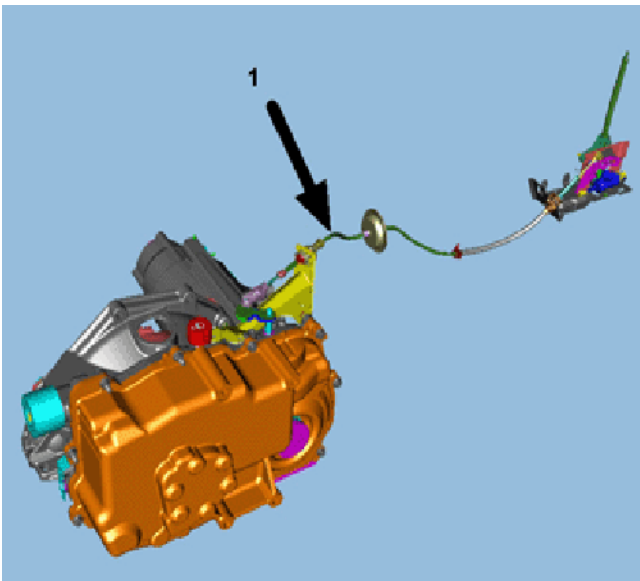
4056216

- If the shift cable routing is directly from the bulkhead to the transmission shift lever (1), proceed to the next step.
2. Remove and discard the floor shift control cable. Refer to *Floor Shift Control Cable Replacement* or *Range Selector Lever Cable Replacement* in SI.
