December 2014

# **Safety Recall P25 / NHTSA 14V-234**

## **Rear Quarter Vent Window Switch**

**2010 - 2014 (RT) Dodge Grand Caravan and Chrysler Town & Country**

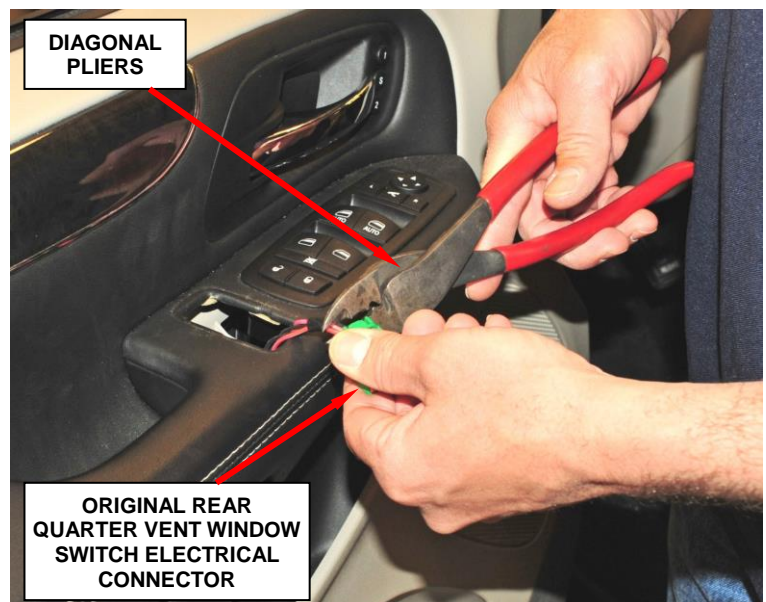
**Figure 3 – Cut Off Damaged Connector**

4. Inspect the rear quarter vent window switch wiring connector:
  - If the rear quarter vent window switch electrical connector **is not melted or damaged**, continue with Step 6 of this procedure.
  - If the rear quarter vent window switch electrical connector **is melted or damaged**, continue with Step 5 of this procedure.

- a. Cut each wire at the original connector (Figure 3).
