NUMBER: 08-046-14 REV. A

Power Window-Vent Switch - Recall P25 Interim Repair

2010-2014 (RT) Town and Country/Grand Caravan
(Left Hand Drive only)

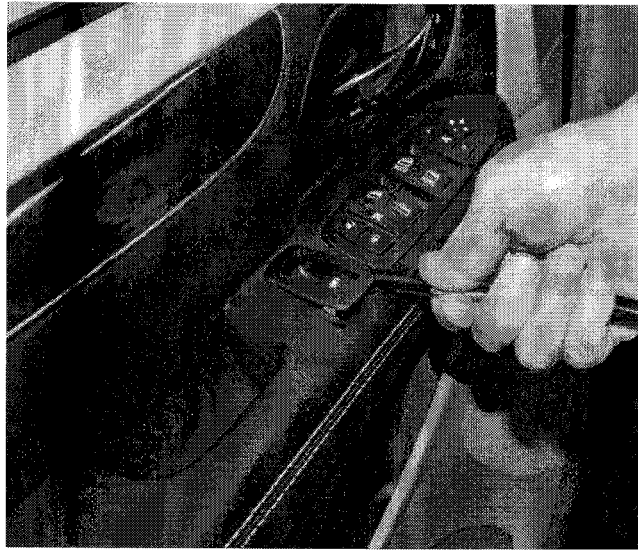
Fig. 1 Removing Window Vent Switch

A customer may inquire about Safety Recall P25 and request to have their Power Quarter Vented Window Switch disconnected or a customer may have noticed a burning odor or have seen smoke coming from the power vented window switch on the drivers door. Once the proper amount of parts are available, all of the customer will be notified. In the meantime, the switch can be disconnected, to satisfy the customer.

1. Remove the switch from the drivers door arm rest, using a proper trim stick.

Use the proper trim tool to remove the switch.
