# Recall Bulletin

## PRODUCT SAFETY RECALL

**SUBJECT:** Incorrect Front Brake Rotor

**MODELS:** 2014 Buick LaCrosse  
2014 Chevrolet Malibu

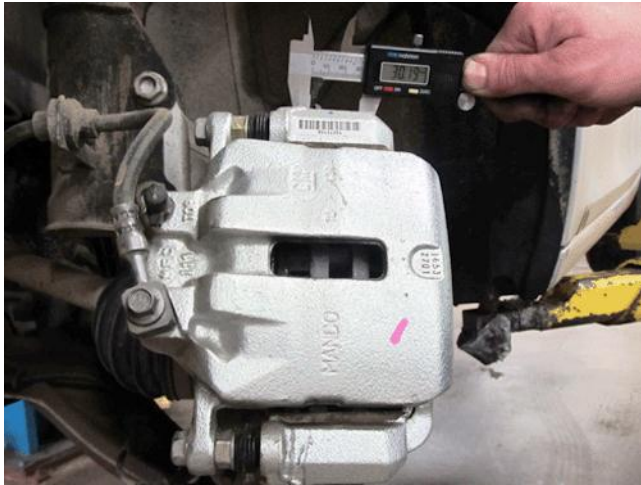
3822952

3. Using calipers, or a ruler, measure the thickness of both front rotors.
  - If the rotor measures 30.1 mm thick, the vehicle has the correct rotor and no further action is required. Reinstall the front tire and wheel assemblies. Refer to *Tire and Wheel Removal and Installation* in SI.
  - If either rotor measures 23.1 mm thick, the rotor is the incorrect size and will need replacement. Proceed to the *Replacement Procedure* below.

1. Remove the front brake rotor(s) from either/both affected sides. Refer to *Front Brake Rotor Replacement* in SI.
2. Remove the front brake pads from both sides.
3. Install new front brake pads to both sides.
4. Install a new front brake rotor to either/both affected sides. Refer to *Front Brake Rotor Replacement* in SI.
