Technical Service Bulletin

14-01-020

TUCSON (LM)

SUBJECT: DRIVER FRONT AIRBAG MODULE BOLT INSPECTION
(RECALL CAMPAIGN 118)

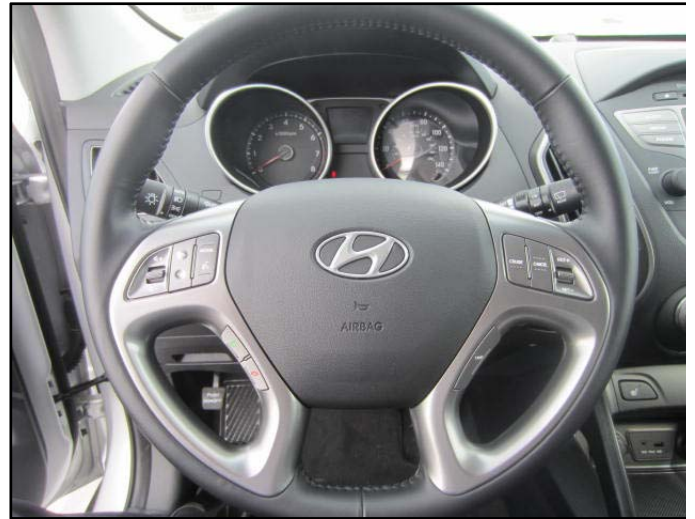
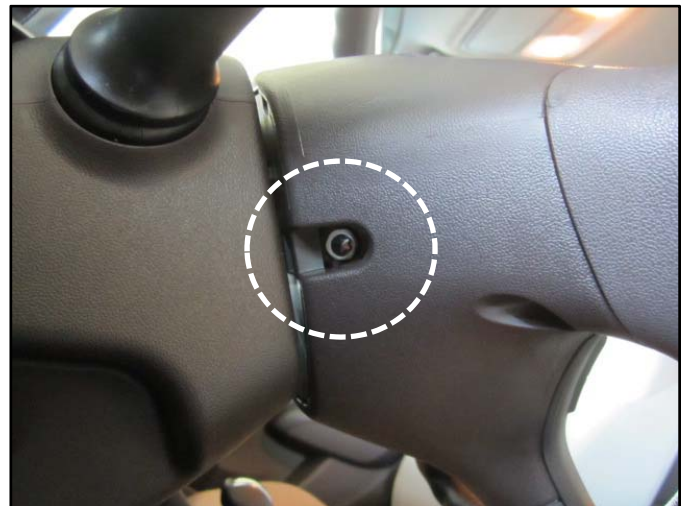
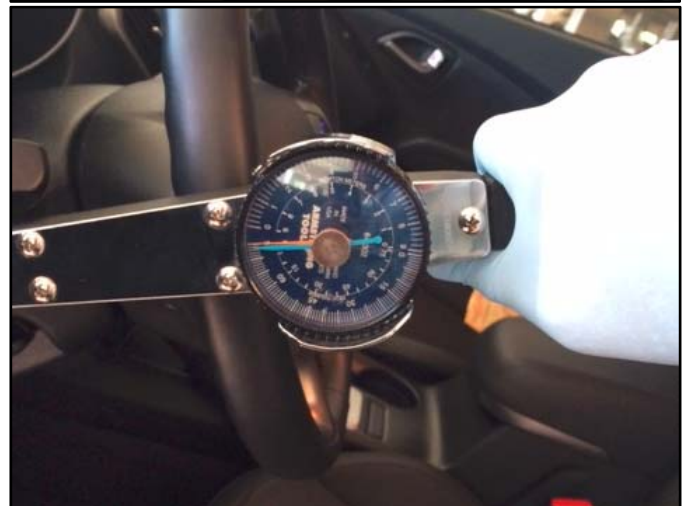
Description: This bulletin describes the service procedure to verify the torque of the two driver front airbag module assembly bolts.

1. Align the steering wheel to the center and ensure the ignition key is in the OFF position. (START/STOP button in the OFF position).
2. Verify the airbag module mounting bolt torque using a T40 torx and torque wrench. If necessary, tighten the bolts to the specification below.

Tightening torque
: 7.8 ~ 10.8 Nm (0.8 ~ 1.1 kgf.m,
5.8 ~ 8.0 lb-ft)
