Recall Bulletin

F/CMVSS NONCOMPLIANCE RECALL

SUBJECT: Passenger Airbag Partial Deployment

MODELS: 2015 Cadillac Escalade, Escalade ESV

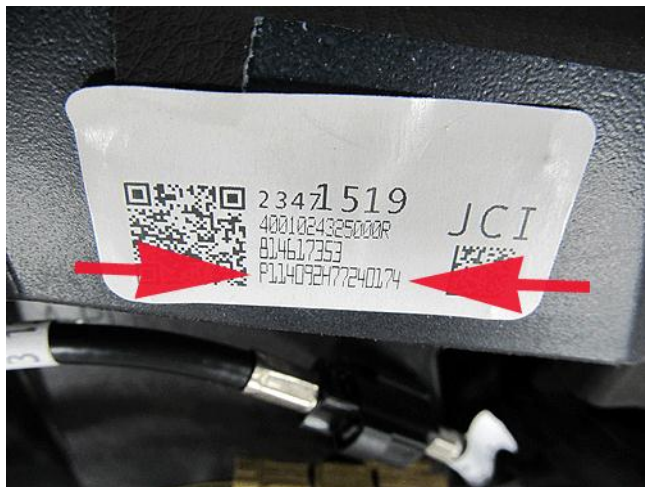
3909688

1. Locate the white paper tag on the instrument panel upper trim panel (there are two labels, it is the label toward the center of the vehicle).
2. Compare the last 9 numbers on the label to the Suspect Label Number Table below.
 - If the number does NOT appear on the list, the part is good and can be placed in inventory.
 - If the number IS on the list, DO NOT PLACE IN INVENTORY. Return the parts to GMCC&A using MR Code 7. If the part has been installed it would returned as a warranty return.

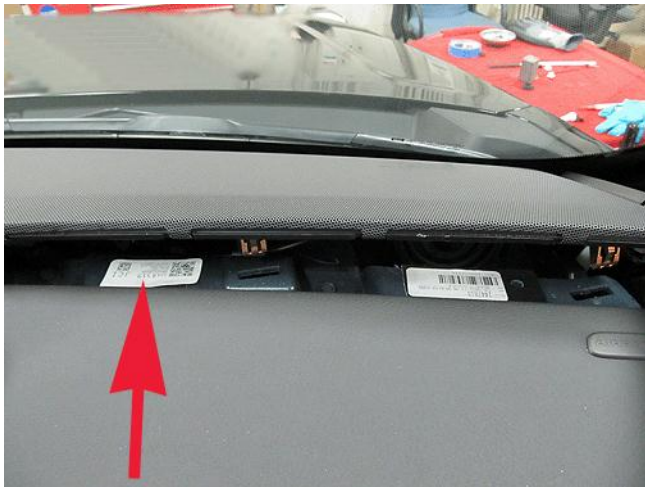
3909687

1. Remove the instrument panel extension. Refer to Instrument Panel Extension Replacement (Cadillac) in SI.

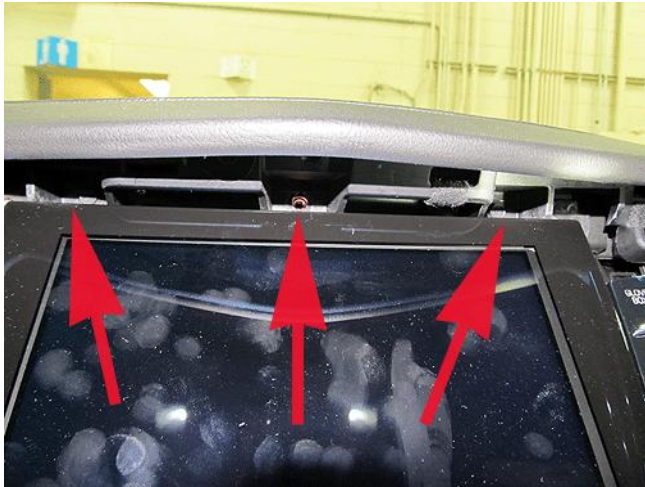
3909693

- When removing the left pillar trim, use care to not break the top clip mount on the trim.
- When removing the wood trim moldings, do not pry on the corners, the wood will chip.
- When removing the left and right console side trim, open the compartment lid and detach the trim from back to front.
- When removing the center trim plate, open the trim plate door to aid in removal.

- When removing the fasteners in the center of the upper left pad, there are three screws above the center screen. Ensure these are removed, if not, forcing the trim will break the mounts.
- Place the upper trim panel on a soft surface when removing and reinstalling the air bag module to prevent damage.

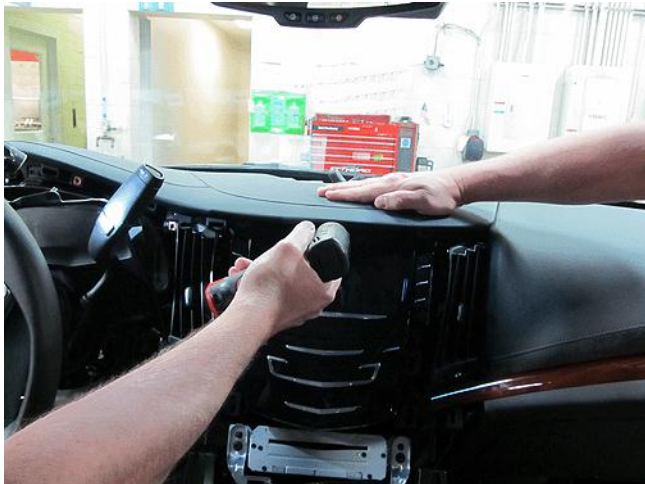
3909688

- When installing the air bag module on the new panel, ensure all of the tabs are fully engaged. This can be verified by an audible “click”. Gently pull on the installed assembly to verify full engagement.

- Apply hand pressure to the top of the trim panel when installing the fasteners in the center area.
- Ensure the air bag harness is connected when installing the right upper trim panel.
