Recall Bulletin

F/CMVSS NONCOMPLIANCE RECALL

SUBJECT: Passenger Airbag Partial Deployment

MODELS: 2015 Cadillac Escalade, Escalade ESV

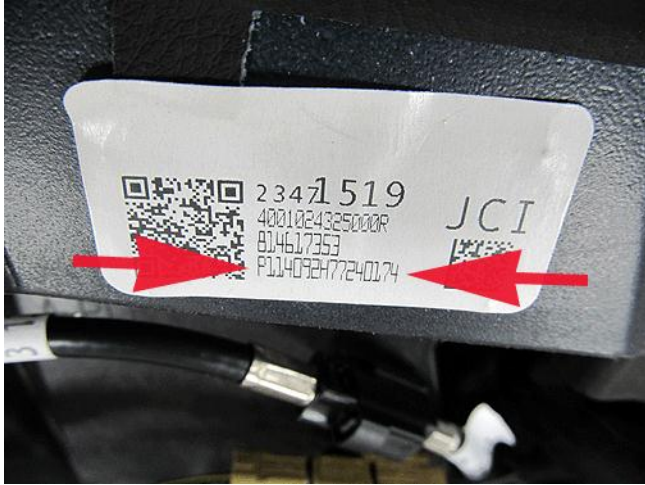
3909688

2. Locate the white paper tag on the instrument panel upper trim panel (there are two labels, it is the label toward the center of the vehicle).
3. Using a digital camera or the camera function on a cell phone, take a clear picture of the label.

4. Compare the last 9 numbers on the label to the Suspect Label Number Table below. The label will appear upside down in the photograph, rotate as required.
 - **If the number does NOT appear on the list**, no further action is required. Reinstall the instrument panel extension.
 - **If the number IS on the list**, return the part to GMCCA and proceed to the Replacement Procedure in this bulletin.
 -

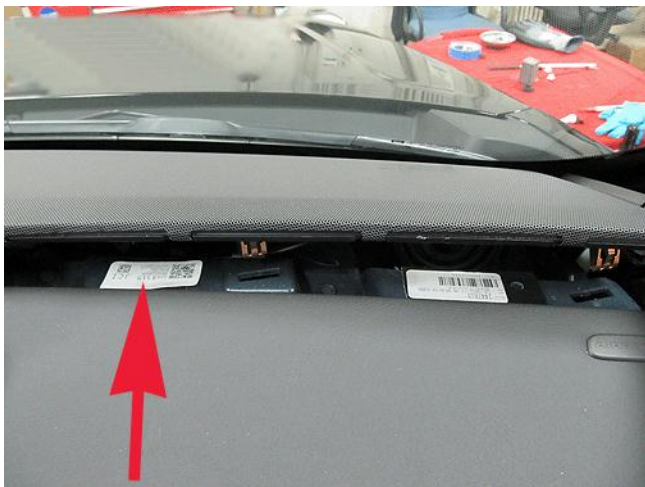
3909687

3. Remove the instrument panel extension. Refer to Instrument Panel Extension Replacement (Cadillac) in SI.

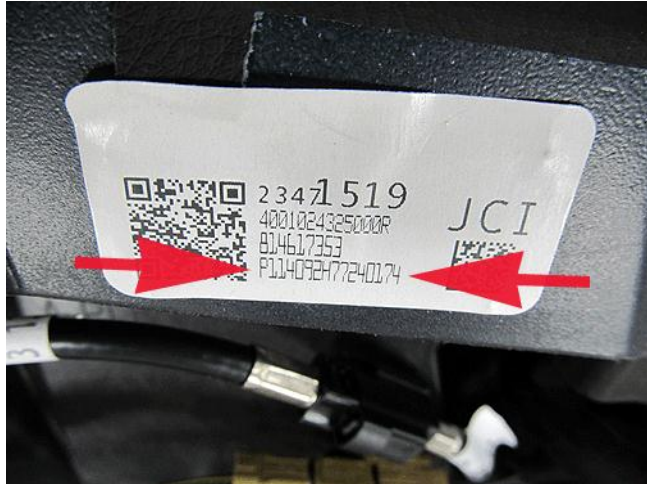
4. Locate the white paper tag on the instrument panel upper trim panel (there are two labels, it is the label toward the center of the vehicle).
5. Using a digital camera or the camera function on a cell phone, take a clear picture of the label.

6. Compare the last 9 numbers on the label to the Suspect Label Number Table below. The label will appear upside down in the photograph, rotate as required.
 - **If the number does NOT appear on the list**, no further action is required. Reinstall the instrument panel extension.
 - **If the number IS on the list**, proceed to the Replacement Procedure below.

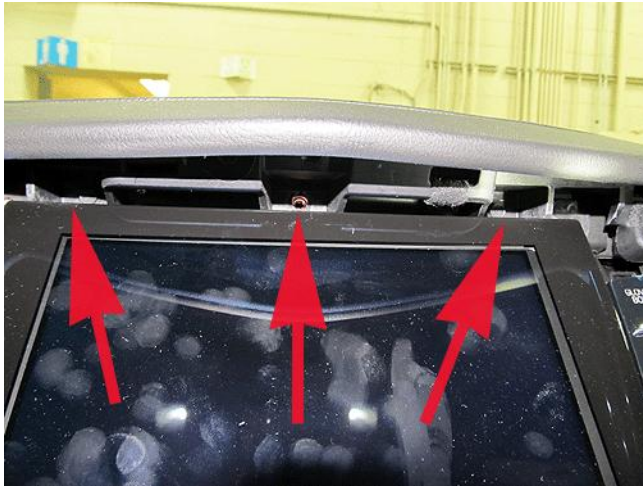
3909693

- When removing the left pillar trim, use care to not break the top clip mount on the trim.
- When removing the wood trim moldings, do not pry on the corners, the wood will chip.
- When removing the left and right console side trim, open the compartment lid and detach the trim from back to front.
- When removing the center trim plate, open the trim plate door to aid in removal.

- When removing the fasteners in the center of the upper left pad, there are three screws above the center screen. Ensure these are removed, if not, forcing the trim will break the mounts.
- Place the upper trim panel on a soft surface when removing and reinstalling the air bag module to prevent damage.

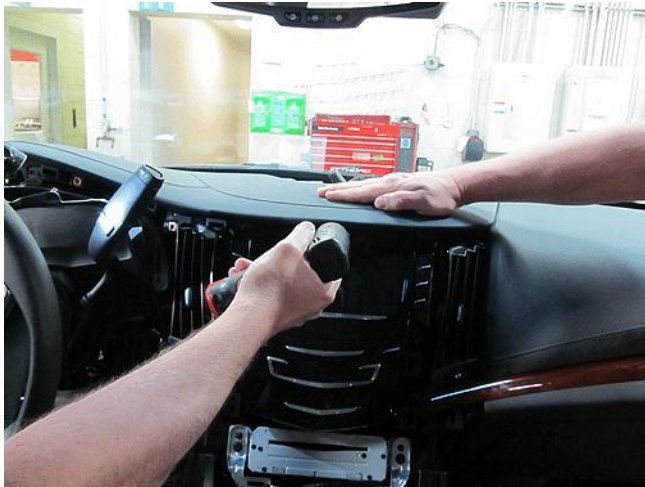
3909688

- When installing the air bag module on the new panel, ensure all of the tabs are fully engaged. This can be verified by an audible “click”. Gently pull on the installed assembly to verify full engagement.

- Apply hand pressure to the top of the trim panel when installing the fasteners in the center area.
- Ensure the air bag harness is connected when installing the right upper trim panel.
