# Recall Bulletin

## F/CMVSS NONCOMPLIANCE RECALL

**SUBJECT:** Passenger Airbag Partial Deployment

**MODELS:** 2015 Cadillac Escalade, Escalade ESV

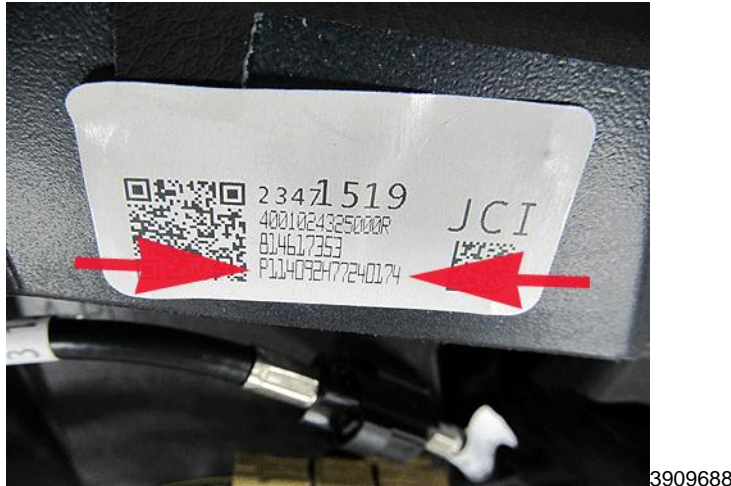
1. Locate the white paper tag on the instrument panel upper trim panel (there are two labels, it is the label toward the center of the vehicle).
2. Compare the last 9 numbers on the label to the Suspect Label Number Table on page 6.
  - If the number does NOT appear on the list, the part is good and can be placed in inventory.
  - If the number IS on the list, DO NOT PLACE IN INVENTORY. Return the parts to GMCC&A using MR Code 7. If the part has been installed it would returned as a warranty return.

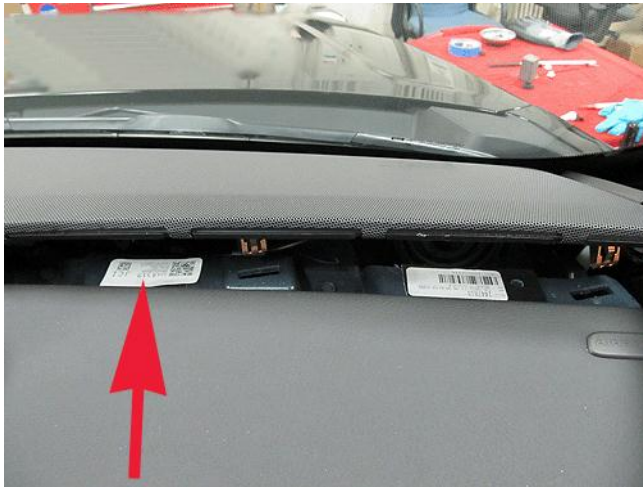
3909687

1. Remove the instrument panel extension. Refer to Instrument Panel Extension Replacement (Cadillac) in SI.

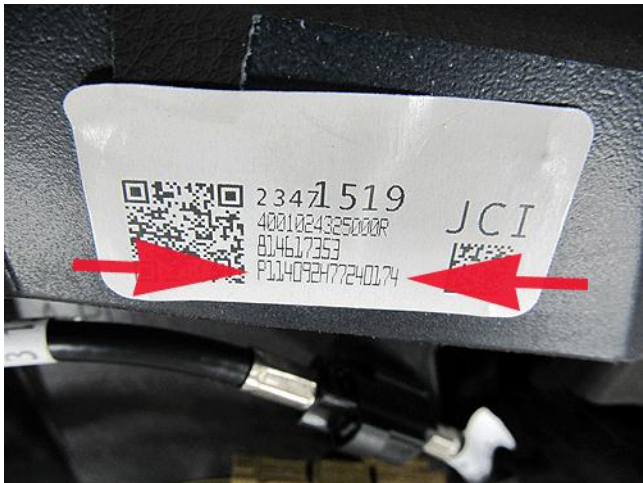
3909688

2. Locate the white paper tag on the instrument panel upper trim panel (there are two labels, it is the label toward the center of the vehicle).
3. Using a digital camera or the camera function on a cell phone, take a clear picture of the label.

4. Compare the last 9 numbers on the label to the Suspect Label Number Table below. The label will appear upside down in the photograph, rotate as required.
  - **If the number does NOT appear on the list**, no further action is required. Reinstall the instrument panel extension.
  - **If the number IS on the list**, return the part to GMCCA and proceed to the Replacement Procedure in this bulletin.

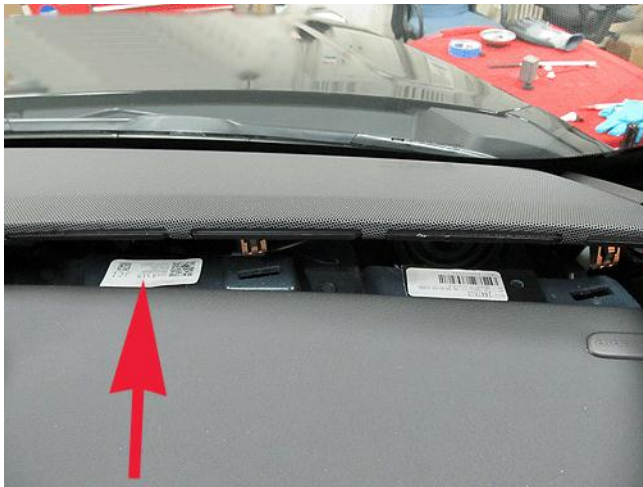
3909687

3. Remove the instrument panel extension. Refer to Instrument Panel Extension Replacement (Cadillac) in SI.

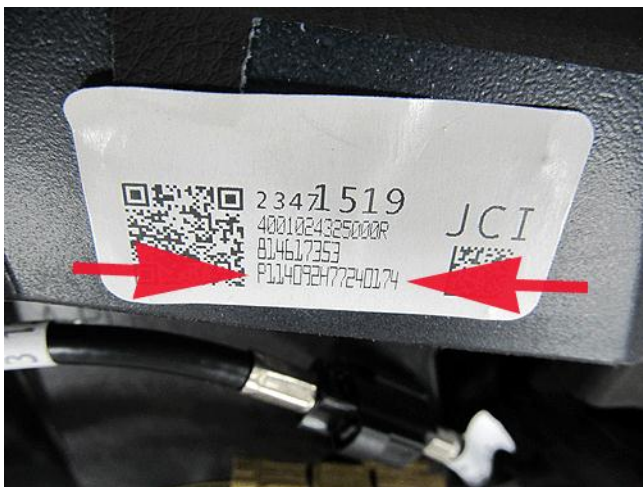
3909688

4. Locate the white paper tag on the instrument panel upper trim panel (there are two labels, it is the label toward the center of the vehicle).
5. Using a digital camera or the camera function on a cell phone, take a clear picture of the label.

6. Compare the last 9 numbers on the label to the Suspect Label Number Table below. The label will appear upside down in the photograph, rotate as required.
  - **If the number does NOT appear on the list**, no further action is required. Reinstall the instrument panel extension.
  - **If the number IS on the list**, proceed to the Replacement Procedure below.

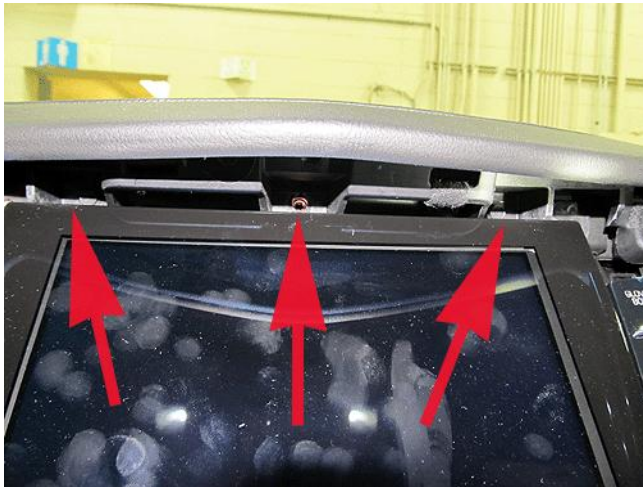
3909693

- When removing the left pillar trim, use care to not break the top clip mount on the trim.
- When removing the wood trim moldings, do not pry on the corners, the wood will chip.
- When removing the left and right console side trim, open the compartment lid and detach the trim from back to front.
- When removing the center trim plate, open the trim plate door to aid in removal.

Replace the right instrument panel upper trim panel. Refer to Instrument Panel Upper Trim Panel Replacement - Right Side (Cadillac) in SI.

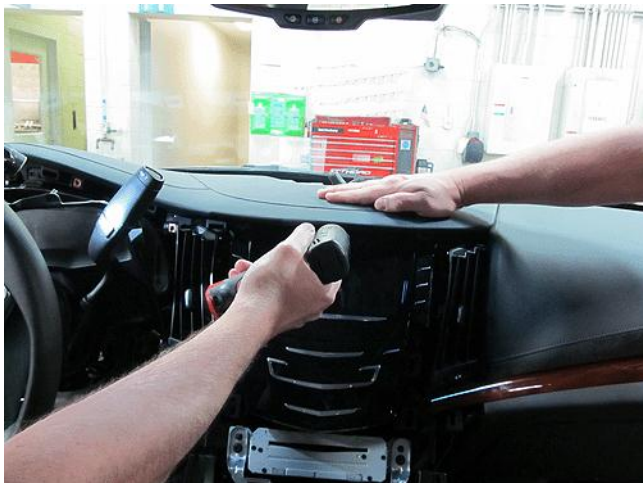
3909688

- When installing the air bag module on the new panel, ensure all of the tabs are fully engaged. This can be verified by an audible “click”. Gently pull on the installed assembly to verify full engagement.
