# Recall Bulletin

## F/CMVSS NONCOMPLIANCE RECALL

**SUBJECT:** Passenger Airbag Partial Deployment

**MODELS:** 2015 Cadillac Escalade, Escalade ESV

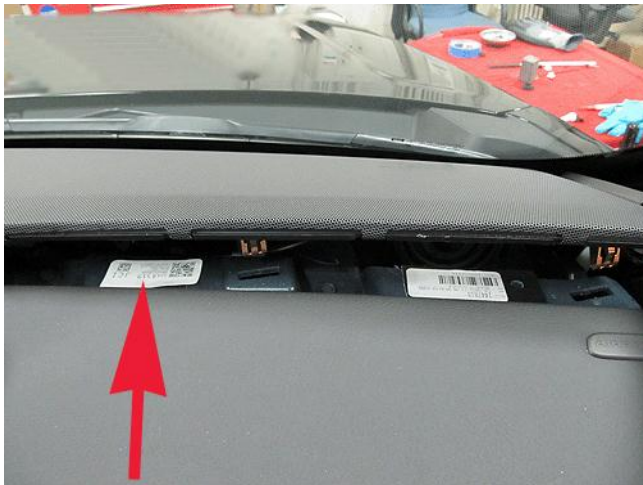
3909687

1. Remove the instrument panel extension. Refer to Instrument Panel Extension Replacement (Cadillac) in SI.

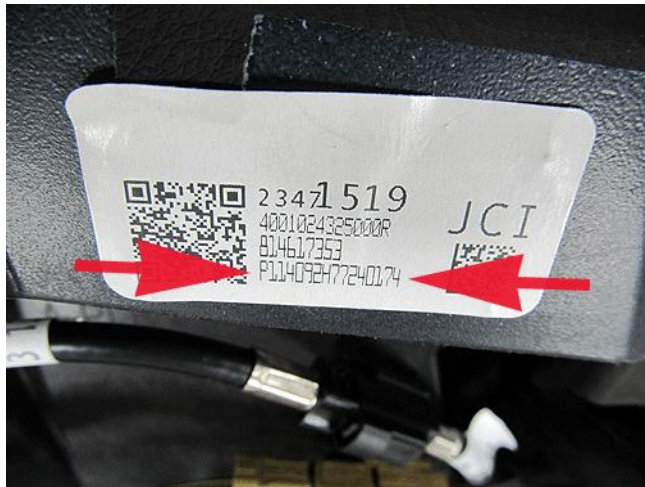
2. Locate the white paper tag on the instrument panel upper trim panel (there are two labels, it is the label toward the center of the vehicle).
3. Using a digital camera or the camera function on a cell phone, take a clear picture of the label.

4. Compare the last 9 numbers on the label to the Suspect Label Number Table below. The label will appear upside down in the photograph, rotate as required.
  - **If the number does NOT appear on the list**, no further action is required. Reinstall the instrument panel extension.
  - **If the number IS on the list**, proceed to the Replacement Procedure below.
