Automotive Technical Service Bulletin

October 24, 2014 Bulletin No. TS 15 10244

SUBJECT: Pigtail Installation for DRL Module and/or Signal Switch

MODEL(S): Forenza (RQ420)

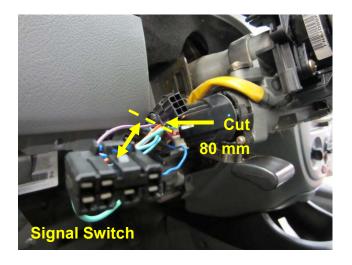
Make the cut to the Instrument Panel Harness in the following locations:

- a. DRL Module: 50mm from connector end.
- b. Signal Switch: 80mm from connector end.

1. Cut and complete the splice (steps 2 through 8) of a single wire. Repeat for each wire until all wires have been spliced. Once all wires have been spliced, go to Step 9.

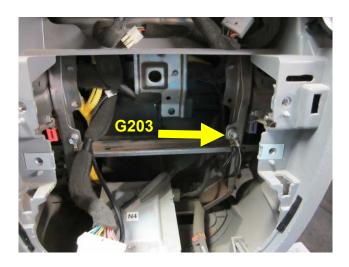
IMPORTANT: If the DRL Module, the DRL Module Wiring, or the DRL Connector show evidence of any heat related damage, in addition to the wiring repair please perform the following Ground G203 check.

3. Confirm tightness of G203.

Torque: 10N-m (89 lb-in)
