GM CUSTOMER CARE AND AFTERSALES  
DCS3177  
URGENT - DISTRIBUTE IMMEDIATELY

Subject: 14187A - Safety Recall  
Front Safety Belt Anchor  
Eligible Floor Plan Reimbursement Days Revised

Models: 2009-2014 Buick Enclave  
2009-2014 Chevrolet Traverse  
2009-2014 GMC Acadia  
2009-2010 Saturn Outlook

**SUBJECT:** Front Safety Belt Anchor

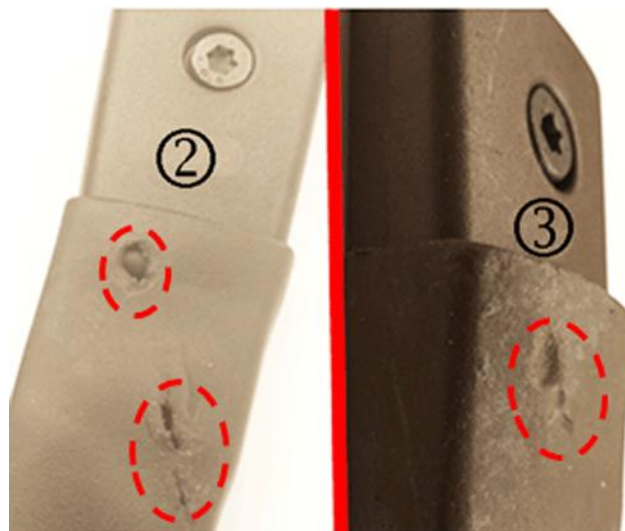
3910759

2. Inspect the seat belt anchor plate tensioner sleeve for any tears (1), holes (2) or wear (3).
  - If the driver **AND** passenger seat sleeves show no visible tears, holes or wear – Proceed to the *Rework Service Procedure*.
  - If either **ONE, OR BOTH**, of the driver and/or passenger seat sleeves show tears, holes or wear – Proceed to the *Rework Service Procedure* for the **UNDAMAGED** sleeve, then continue on to *Front Seat Belt Tensioner Replacement Procedure* for the **DAMAGED** sleeve(s).
