Recall Bulletin

PRODUCT SAFETY RECALL

SUBJECT: Front Safety Belt Anchor

MODELS: 2009-2014 Buick Enclave
2009-2014 Chevrolet Traverse
2009-2014 GMC Acadia
2009-2010 Saturn Outlook

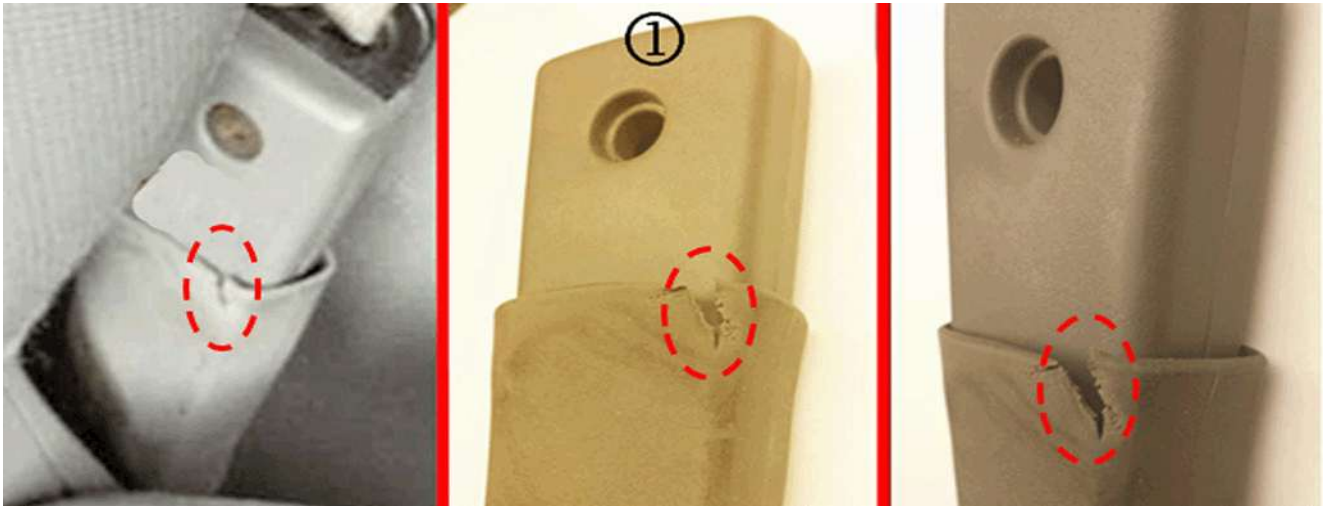
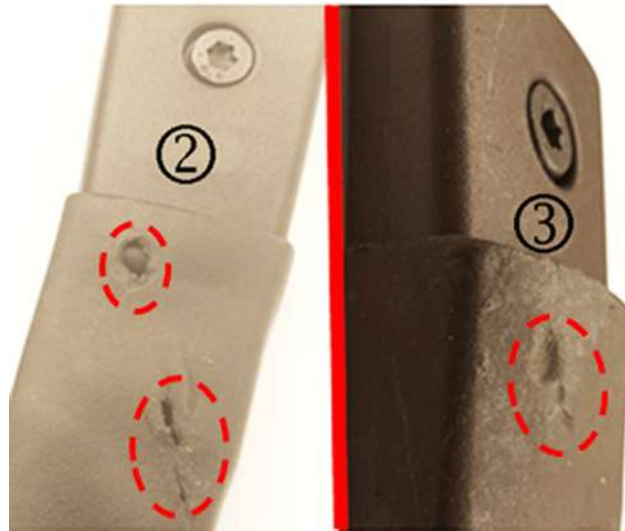
3910757

2. Inspect the seat belt anchor plate tensioner sleeve for any tears (1), holes (2) or wear (3).
 - If the driver **AND** passenger seat sleeves show no visible tears, holes or wear – Proceed to the *Rework Service Procedure*.
 - If either **ONE, OR BOTH**, of the driver and/or passenger seat sleeves show tears, holes or wear – Proceed to the *Rework Service Procedure* for the **UNDAMAGED** sleeve, then continue on to *Front Seat Belt Tensioner Replacement Procedure* for the **DAMAGED** sleeve(s).
