# SAFETY RECALL BULLETIN

SUBJECT:			No: <b>SR-14-004</b>
<b>2014 LANCER EVOLUTION AND LANCER RALLIART POWER STEERING PRESSURE HOSE ASSEMBLY – SAFETY RECALL CAMPAIGN</b>			DATE: <b>June, 2014</b>
			MODEL: <b>2014 Lancer Evolution and Lancer Ralliart</b>
CIRCULATE TO:	<input checked="" type="checkbox"/> GENERAL MANAGER	<input checked="" type="checkbox"/> PARTS MANAGER	<input checked="" type="checkbox"/> TECHNICIAN
<input checked="" type="checkbox"/> SERVICE ADVISOR	<input checked="" type="checkbox"/> SERVICE MANAGER	<input checked="" type="checkbox"/> WARRANTY PROCESSOR	<input checked="" type="checkbox"/> SALES MANAGER

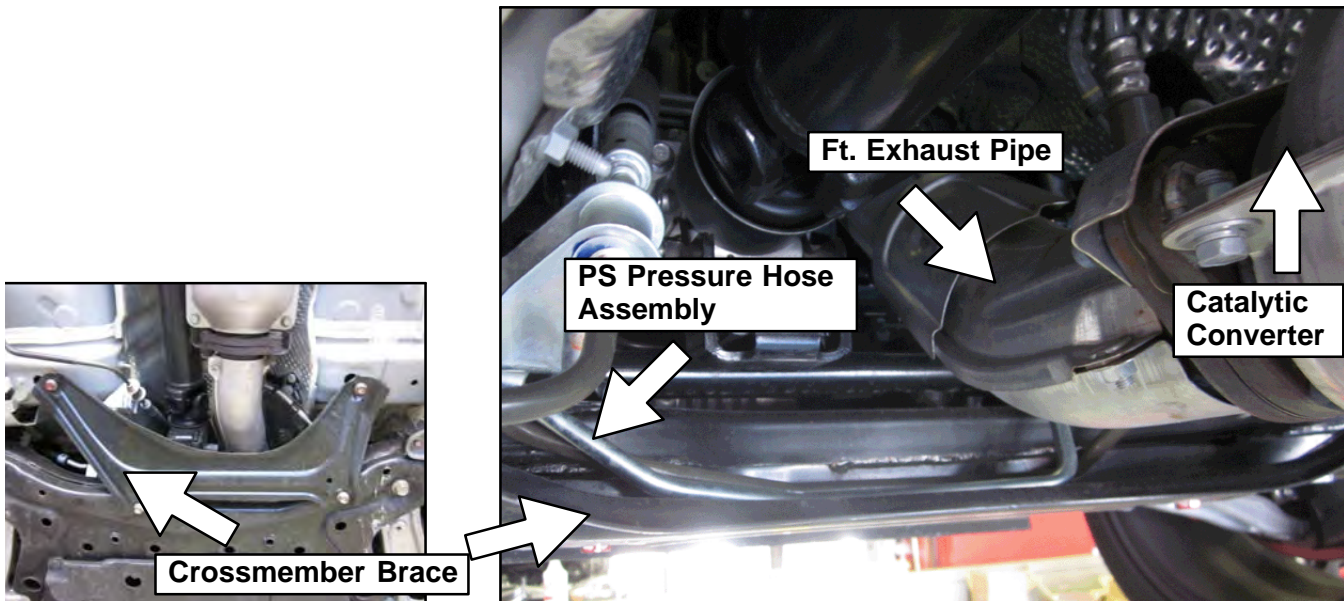
The power steering pressure hose assembly may have been installed with insufficient clearance to the crossmember brace during production, possibly causing the power steering pressure hose assembly to rust from abrasive contact between the two components. In the worst case scenario, a pin hole could develop and allow for power steering fluid leakage, resulting in increased steering effort and potential for a fire in the presence of an ignition source.

1. Place the vehicle on a lift. Set the parking brake and turn the ignition switch to "LOCK" (off) position. If vehicle is TC-SST equipped, ensure selector is in "P" (park) position.
2. Raise the vehicle. From underneath, locate the power steering pressure hose assembly and the crossmember brace (where the front exhaust pipe connects to the catalytic converter).

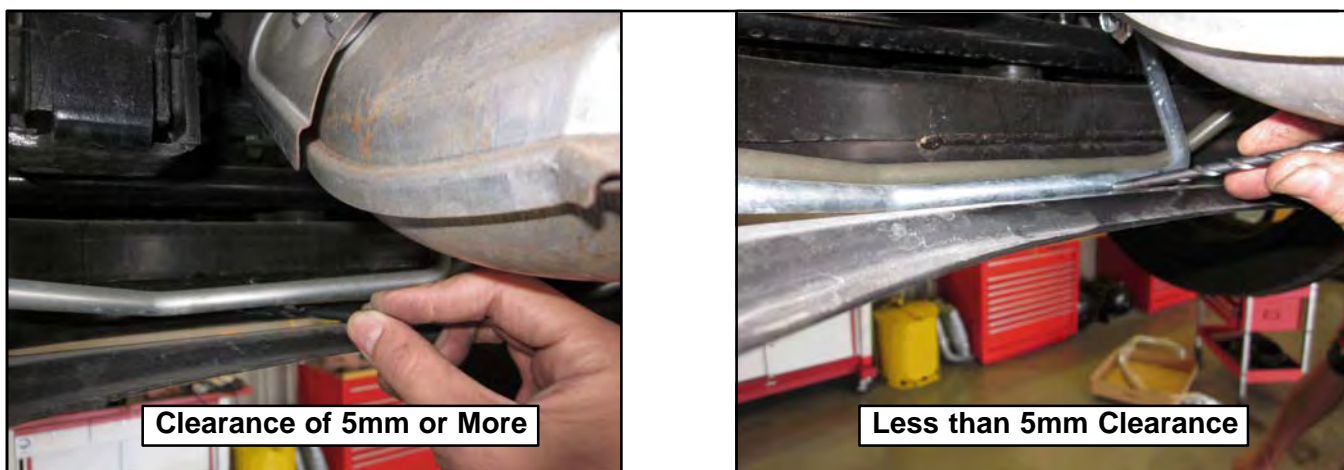
3. Using a taper gauge, thickness gauge, or 5mm drill bit, measure the clearance between the power steering pressure hose assembly and the crossmember brace.

- a. If the clearance between the two components is 5mm (0.2 in) or more, **replacement is not necessary**. Complete the campaign claim and enter campaign labor operation **C1404W01**.
- b. If the clearance between the two components is less than 5mm (0.2 in), proceed to the **Replacement Procedure** below.
