July 23, 2014

SUBJECT: DEMONSTRATION / DELIVERY HOLD - Safety Recall 14S08 - Supplement #1
Certain 2010-2014 Model Year Taurus and 2013-2014 Model Year Police Interceptor
Sedan Vehicles Operated in Corrosion States
License Plate Lamp Assembly Replacement

CERTAIN 2010-2014 MODEL YEAR TAURUS AND 2013-2014 MODEL YEAR POLICE INTERCEPTOR SEDAN VEHICLES OPERATED IN CORROSION STATES — LICENSE PLATE LAMP ASSEMBLY REPLACEMENT

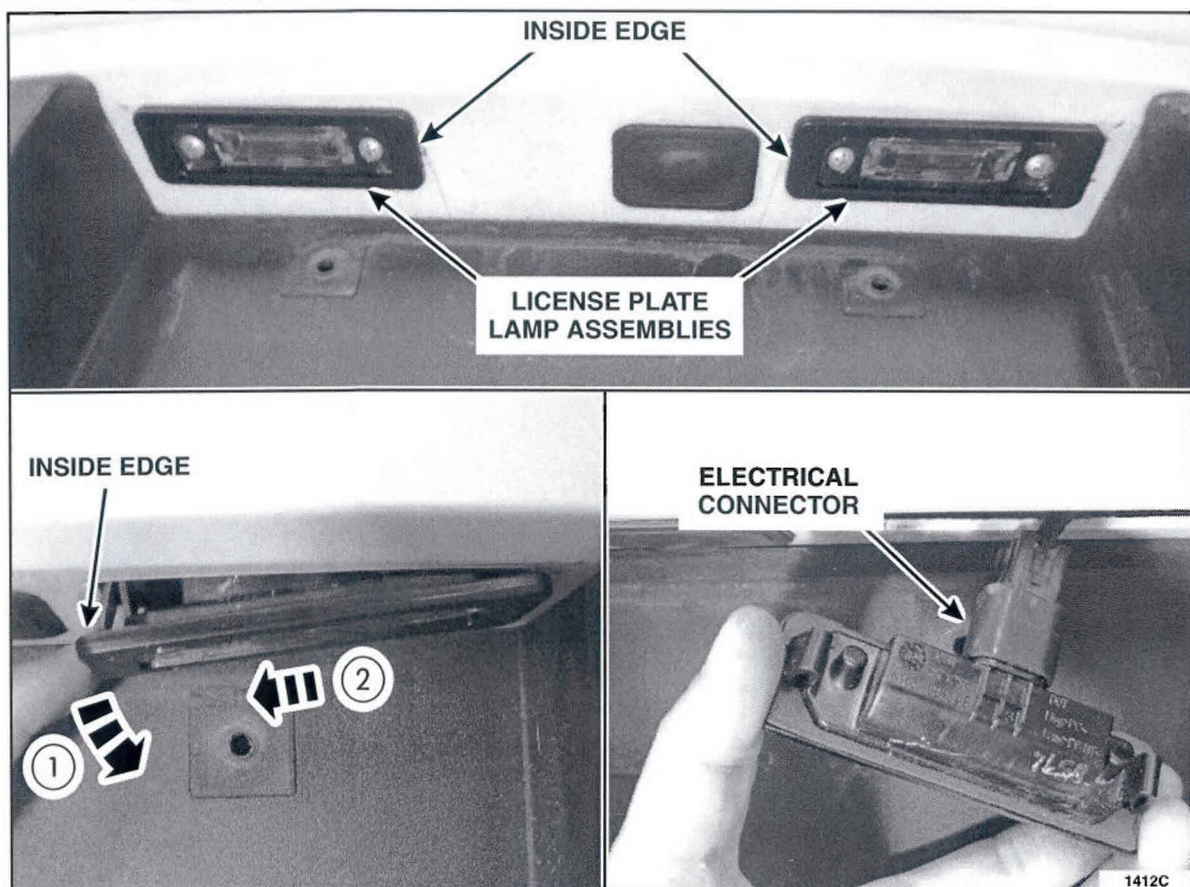
FIGURE 1

In some of the affected vehicles that are operated in high-corrosion environments associated with road salt use, moisture in the license plate lamp assemblies can lead to corrosion. The corrosion can bridge the positive and negative terminal plates creating a short circuit in the license plate lamp assemblies that causes high current draw, excessive heat and potentially a fire.

1. Remove and discard the RH and LH license plate lamp assemblies. See Figure 1.
 - a. Pull downward on inside edge of the RH and LH license plate lamp assemblies to release the inside edge clip.
 - b. Disconnect the electrical connector. Remove and discard the RH and LH license plate lamp assemblies.

3. Install the *new* RH and LH license plate lamp assemblies. See Figure 1.
- a. Connect the electrical connectors to the *new* RH and LH license plate lamp assemblies.
 - b. Install the *new* RH and LH license plate lamp assemblies into the bumper cover.
