Recall Bulletin

PRODUCT SAFETY RECALL

SUBJECT: Transmission Turbine Shaft Fracture

MODELS: 2012 Chevrolet Sonic
With 6 Speed Automatic Transmission (Model 6T30 - RPO MH9)
And 1.8L Engine (RPO LUW)

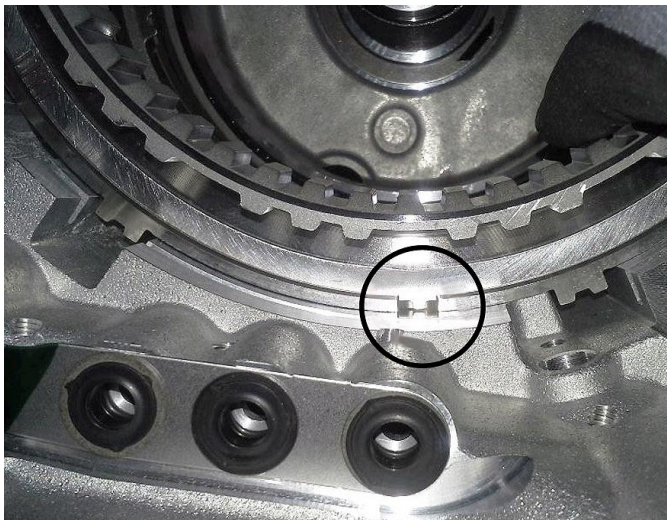
3961479

Proper Alignment of the (543) Low and Reverse Clutch Assembly (Zoomed In Below)

Installation procedures in SI. Also note the photos below that show proper alignment of the (543) Low and Reverse Clutch Assembly to prevent incorrect installation and transmission damage. It is also recommended that GM technicians log on to <https://www.centerlearning.com/> and view a related training video that is found at the 40 minute mark of 10214.07D July 2014 Emerging Issues Seminar by following this path: *Resources>> Video on Demand>> Enter 10214.07D in the “Search Videos” Field >> Click on the Magnifying Glass Icon to search for the video.* For Canada technicians, this video can be viewed on the GM Centre of Learning (LMS) web site, which can be accessed via the Single Sign-on process through Global Connect. Click on the “Resources” menu option, and then select “Video on Demand,” “GM Pro – Centre of Learning” and “Service Technical.” The video will be in the list displayed on the page.

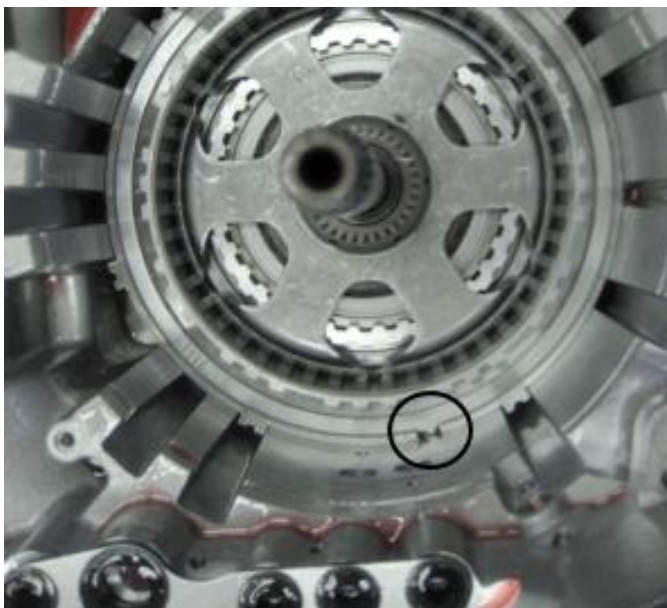
3965414

Proper Alignment of the (543) Low and Reverse Clutch Assembly (Zoomed Out Below)
