Recall Bulletin

PRODUCT SAFETY RECALL

SUBJECT: Transmission Turbine Shaft Fracture

MODELS: 2012 Chevrolet Sonic
With 6 Speed Automatic Transmission (Model 6T30 - RPO MH9)
And 1.8L Engine (RPO LUW)

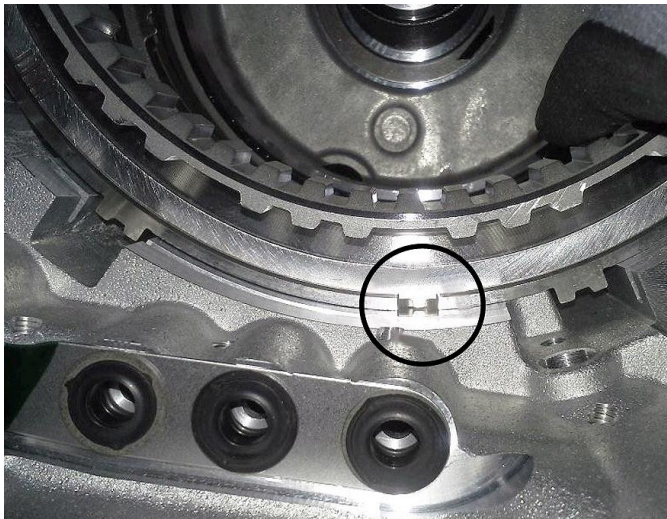
3961479

Proper Alignment of the (543) Low and Reverse Clutch Assembly (Zoomed In Below)

Reverse Clutch Assembly and Low and Reverse Clutch Plate Installation and Low and Reverse and 1-2-3-4 Clutch Housing, and 1-2-3-4 Clutch Plate Installation procedures in SI. Also note the photos below that show proper alignment of the (543) Low and Reverse Clutch Assembly to prevent incorrect installation and transmission damage. It is also recommended that GM technicians log on to <https://www.centerlearning.com/> and view a related training video that is found at the 40 minute mark of 10214.07D July 2014 Emerging Issues Seminar by following this path: *Resources>> Video on Demand>> Enter 10214.07D in the "Search Videos" Field >> Click on the Magnifying Glass Icon to search for the video.* For Canada technicians, this video can be viewed on the GM Centre of Learning (LMS) web site, which can be accessed via the Single Sign-on process through Global Connect. Click on the "Resources" menu option, and then select "Video on Demand," "GM Pro – Centre of Learning" and "Service Technical." The video will be in the list displayed on the page.

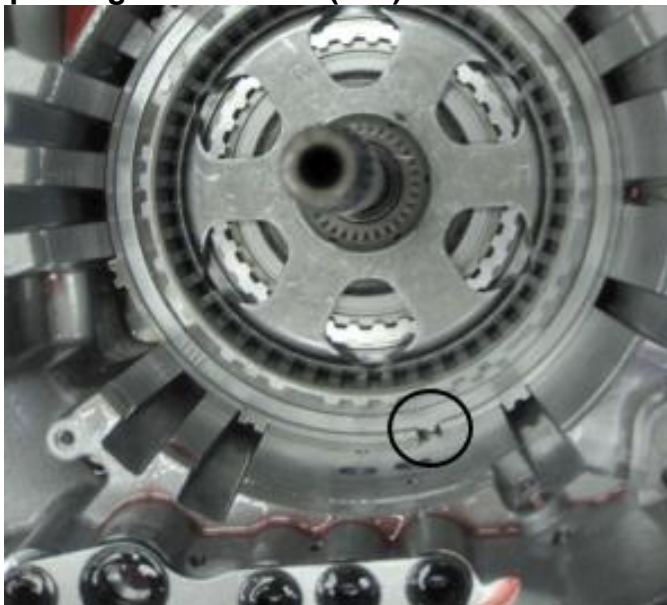
3965414

Proper Alignment of the (543) Low and Reverse Clutch Assembly (Zoomed Out Below)
