PRODUCT SAFETY RECALL

SUBJECT: Driver's Seat Belt Replacement

MODELS: 2004-2011 Saab 9-3 Convertible

SAAB	Recall Bulletin	Campaign ID:	14222/15027	
		Date:	July 2015	
		Issue No:	Ι

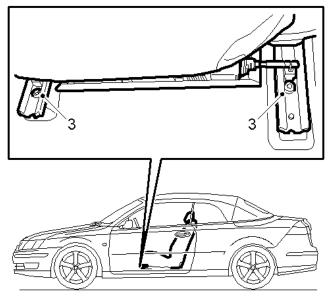
- 3. Remove the front screws (3) which secure the seat's rails.
- 4. Move the seat to its forward position, and remove the rear screws holding the seat rails.
