Recall Bulletin

PRODUCT SAFETY RECALL

SUBJECT: Transmission Shift Cable

MODELS: 2013-2014 Cadillac ATS
2014 Cadillac CTS
Equipped with Automatic Transmission (RPO MYA or MGG)

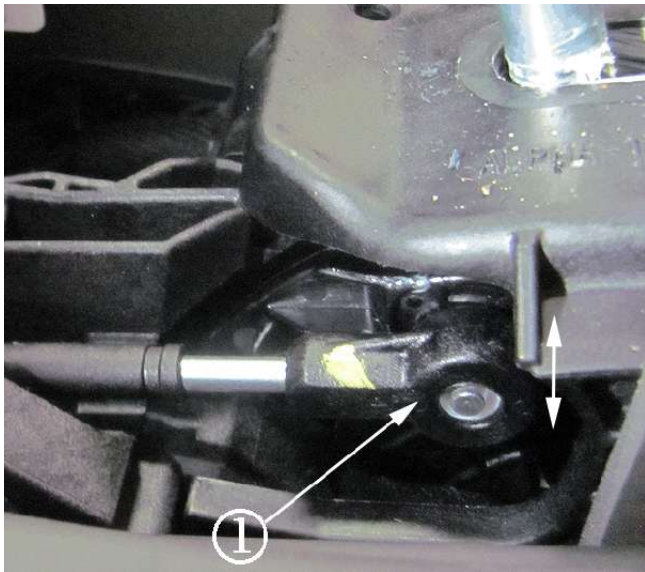
3940460

3.1 Ensure the transmission range selector lever cable terminal rod end (1) is connected to the shift lever pin correctly.

- Push and pull on the terminal rod end (1) to determine if the terminal rod end is connected to the shift lever pin. Push and pull direction is indicated in the photograph with a two way arrow.
- If the terminal rod end (1) is NOT connected to the shift lever pin, push the terminal rod end onto the shift lever pin. An audible click is present when the terminal rod end is installed onto the shift lever pin correctly.

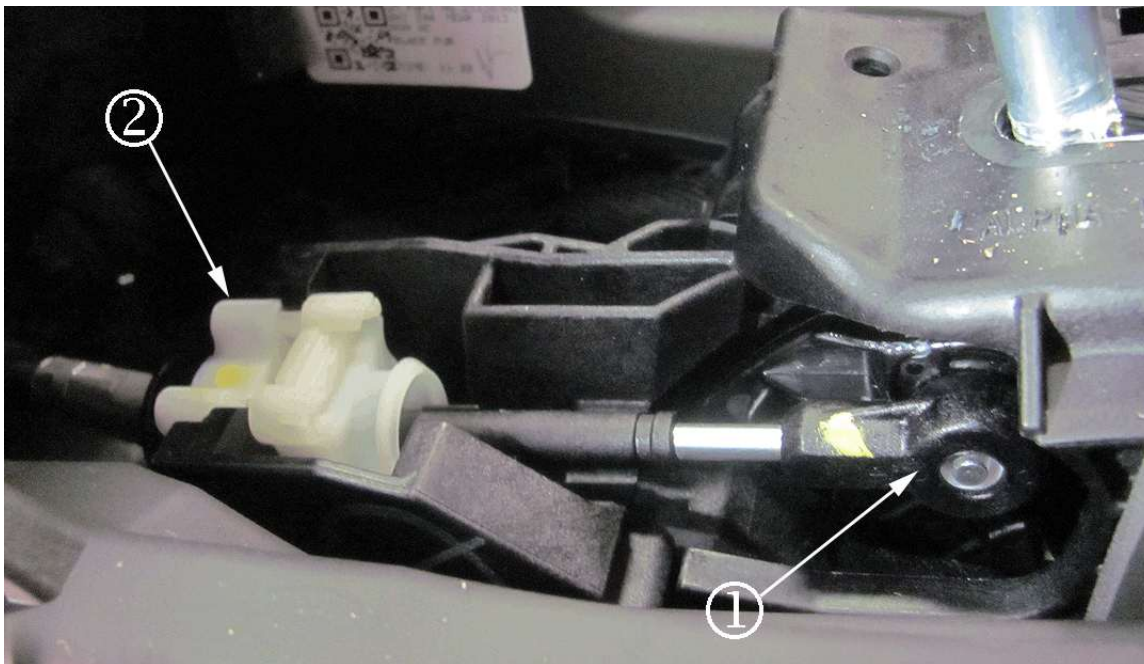
3940456

Note: Inspect the range selector lever cable at the terminal rod end (1) and bracket end fitting (2). Review steps 3.1-3.2.

3.2 Ensure the transmission range selector lever cable bracket end fitting (2) is seated into the bracket housing correctly.

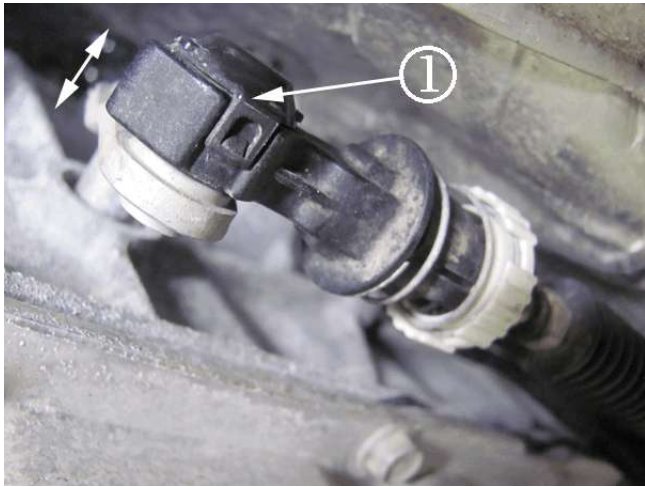
3940474

5.1 Ensure the transmission range selector lever cable terminal rod end (1) is connected to the shift lever pin correctly.

- Push and pull on the terminal rod end (1) to determine if the terminal rod end connected to the shift lever pin. Push and pull direction is indicated in the photograph with a two way arrow.
- If the terminal rod end (1) is NOT connected to the shift lever pin, push the terminal rod end onto the shift lever pin. An audible click is present when the terminal rod end (1) is installed onto the shift lever pin correctly.

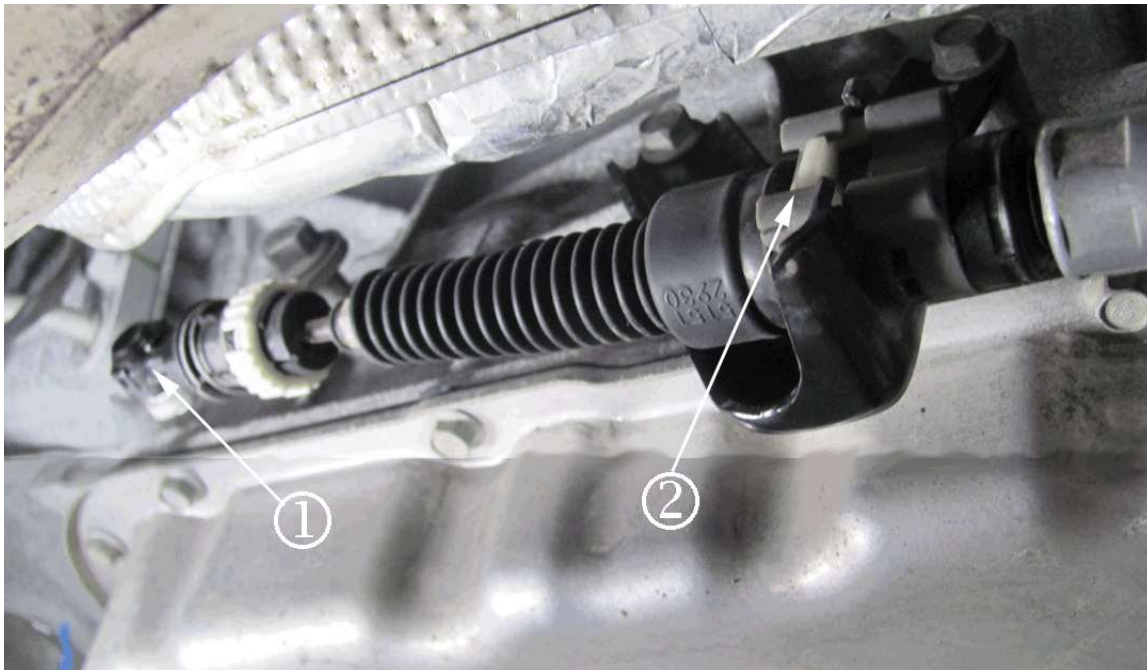
3940468

Note: Inspect the range selector lever cable at the terminal rod end (1) and bracket end fitting (2). Review steps 5.1-5.2.

5.2 Ensure the transmission range selector lever cable bracket end fitting is seated into the bracket housing correctly.
