# Recall Bulletin

## PRODUCT SAFETY RECALL

**SUBJECT:** Ignition Key

**MODELS:** 2010-2014 Chevrolet Camaro

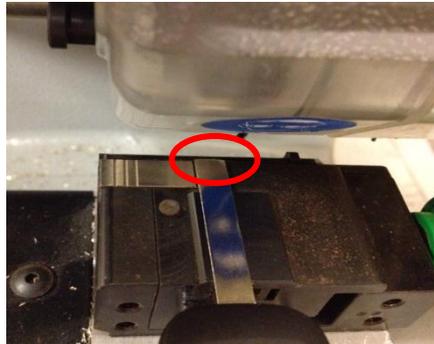
3947698

**Note:** The key blank should fit into the Jaw as shown in the picture. Make sure there is no gap in the area circled in the picture. Remove the guard if necessary.

- a. Select “key search”
- b. Choose “car, model” selection
- c. Enter make, model & hit enter
- d. Select “cut by decode”
- e. Insert the original key into Jaw “C” and change cutter if necessary
