# Recall Bulletin

## PRODUCT SAFETY RECALL

**SUBJECT:** Ignition Key

**MODELS:** 2010-2014 Chevrolet Camaro

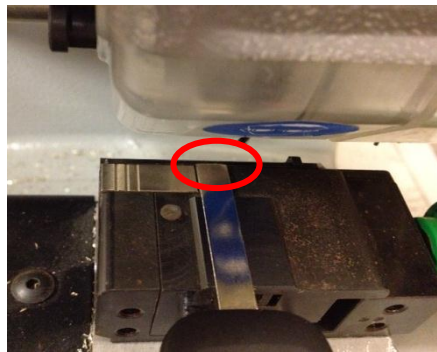
3947698

**NOTE:** The key blank should fit into the Jaw as shown in the picture. Make sure there is no gap in the area circled in the picture. Remove the guard if necessary.
