SUBJECT: Safety Recall Campaign "XC";
Daytime Running Light (DRL) Module Overheating

MODEL(S): Verona (RP625)

YEAR: 2004~2006

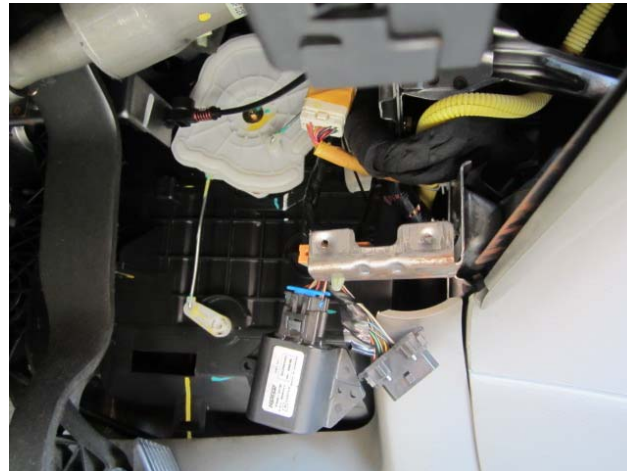
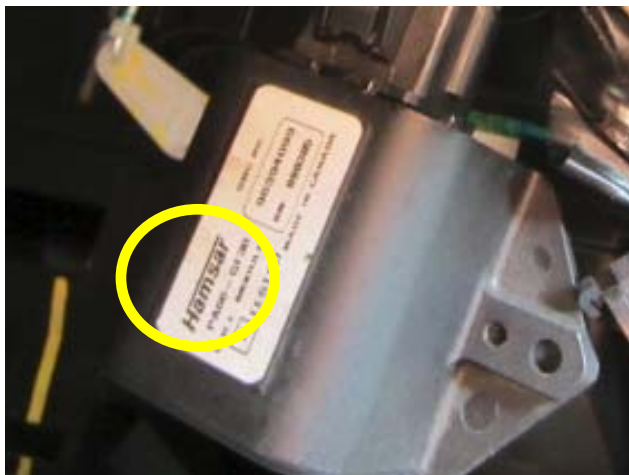
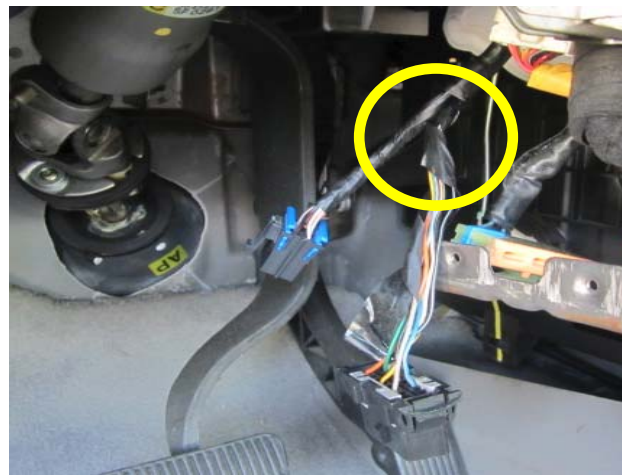
The DRL Module is located behind the knee bolster and right of the steering column, near the center console area. The DRL Module can be identified by its manufacture name "Hamsar" on the label. It also shares the same harness bundle with the DLC connector.

1. Record the radio presets then turn the ignition switch to the LOCK position and remove the key.
2. Disconnect the battery negative (-) cable and wait at least 90 seconds before proceeding.
3. Remove the instrument panel Lower Cover and Knee Bolster. Then remove the screws holding the DRL module in place and disconnect it from its electrical connector.
