SAFETY RECALL BULLETIN

SUBJECT:			No: SR-14-005
OUTLANDER AWD REPLACEMENT TRANSFER ASSEMBLY – SAFETY RECALL CAMPAIGN			DATE: July, 2014
			MODEL: 2007 & 2009 Outlander
CIRCULATE TO:	<input checked="" type="checkbox"/> GENERAL MANAGER	<input checked="" type="checkbox"/> PARTS MANAGER	<input checked="" type="checkbox"/> TECHNICIAN
<input checked="" type="checkbox"/> SERVICE ADVISOR	<input checked="" type="checkbox"/> SERVICE MANAGER	<input checked="" type="checkbox"/> WARRANTY PROCESSOR	<input checked="" type="checkbox"/> SALES MANAGER

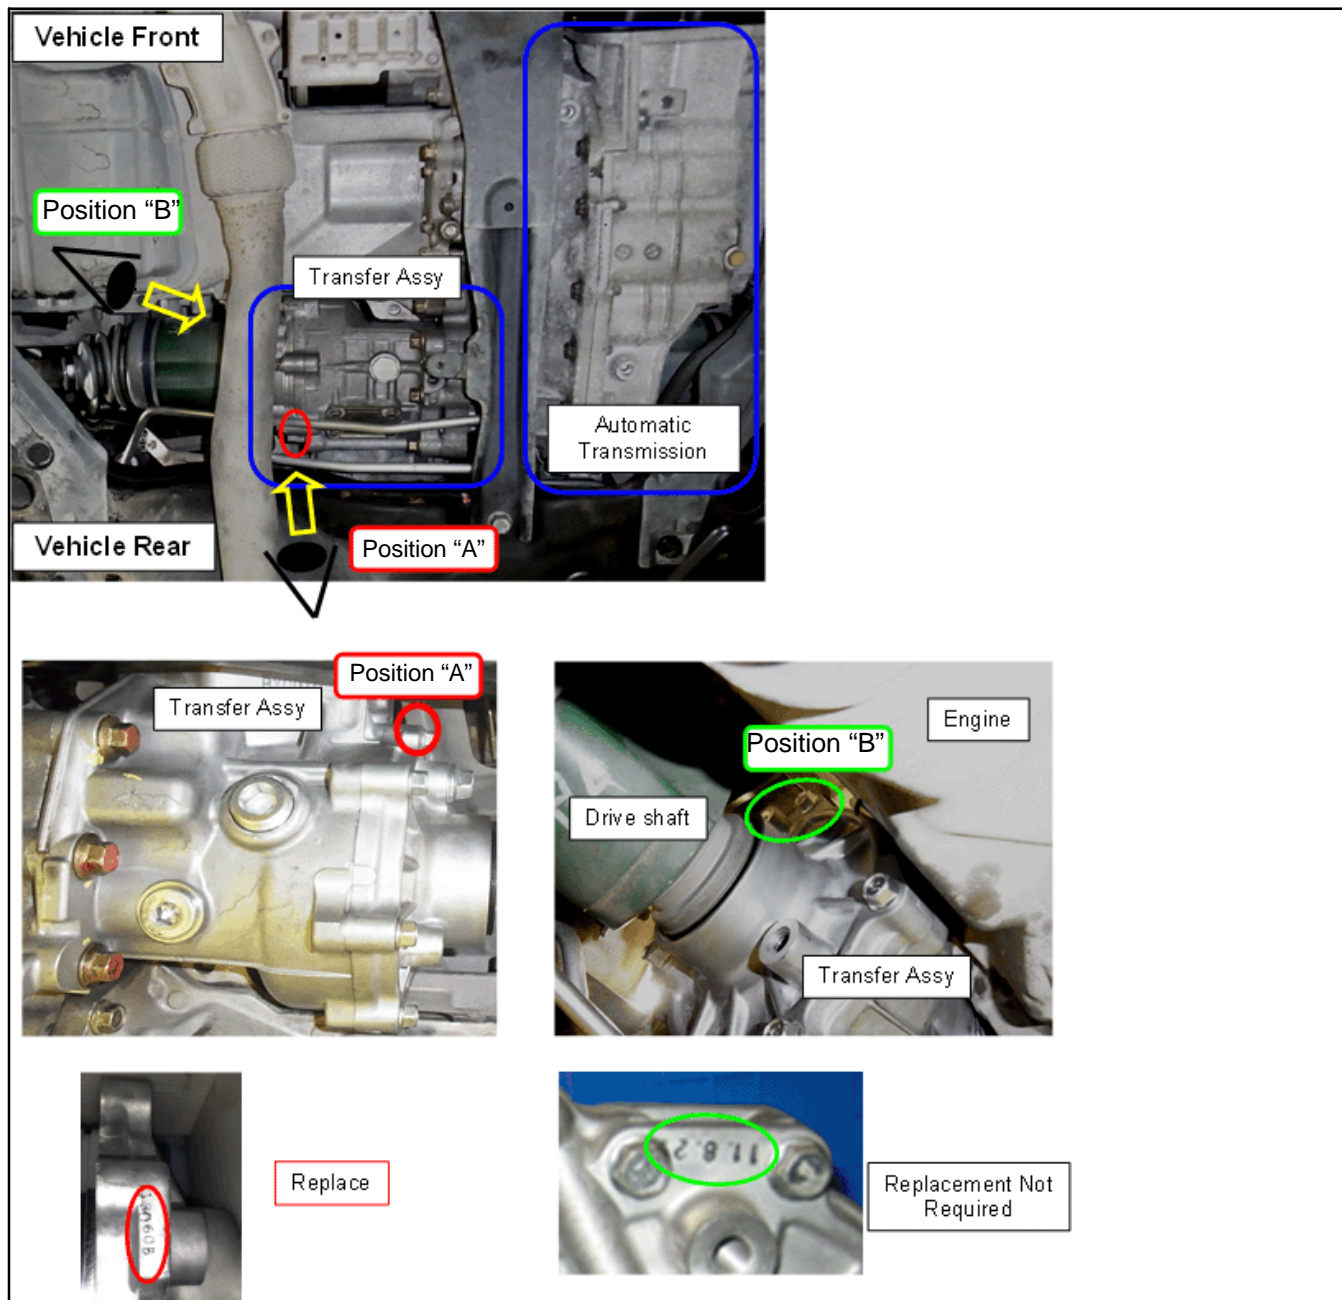
1. Place the vehicle on a lift. Stop the engine, shift the selector to "P" (Park) position, and engage the parking brake
2. Raise the vehicle. Locate the transfer assembly's production date stamp.

- a. If the production date stamp is in Position "A", **transfer assembly replacement is required**. Proceed to the **Replacement Procedure** section.
- b. If the production date stamp is in Position "B", **transfer assembly replacement is not required**. Complete the campaign claim and enter campaign labor operation **C1407T01**.

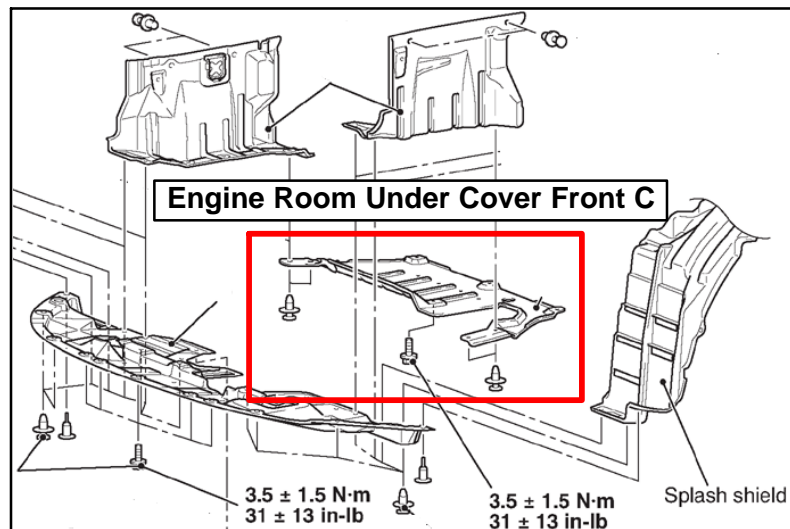
1. Remove the right front wheel.
2. Remove engine room under cover front C.

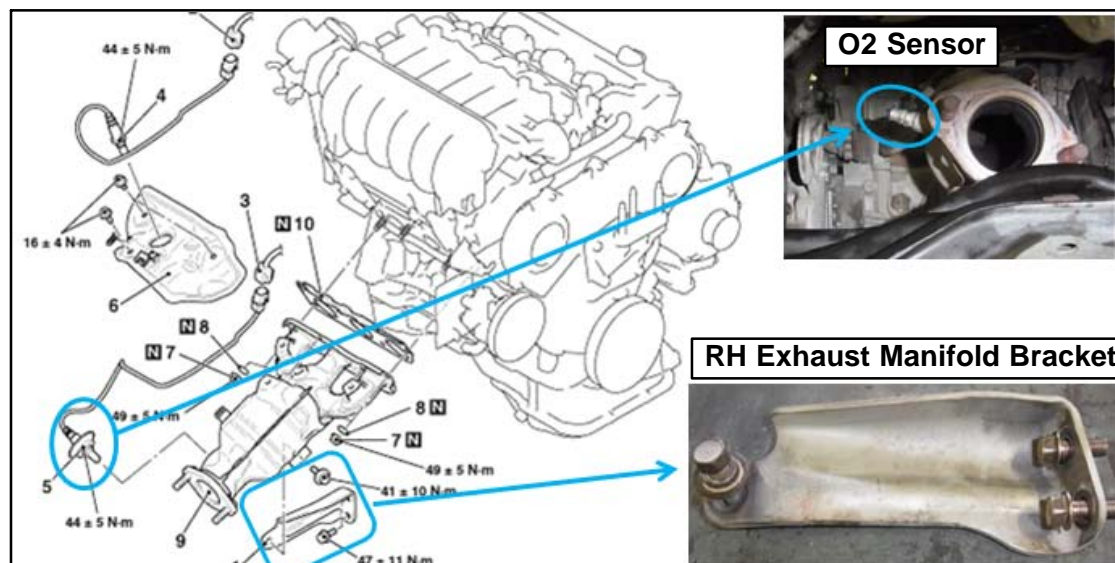
4. Drain the transfer assembly oil. Please refer to the applicable service manual, Group 23C – Automatic Transaxle, On-Vehicle Service > Transfer Oil Replacement.
5. Remove the front exhaust pipe. Please refer to the applicable service manual, Group 15 – Intake and Exhaust, Exhaust Pipe and Main Muffler > Removal and Installation (3.0L Engine).
6. Remove the right exhaust manifold bracket and O2 sensor.

NOTE: Use rust penetrant lubricant during O2 sensor removal to prevent damage.

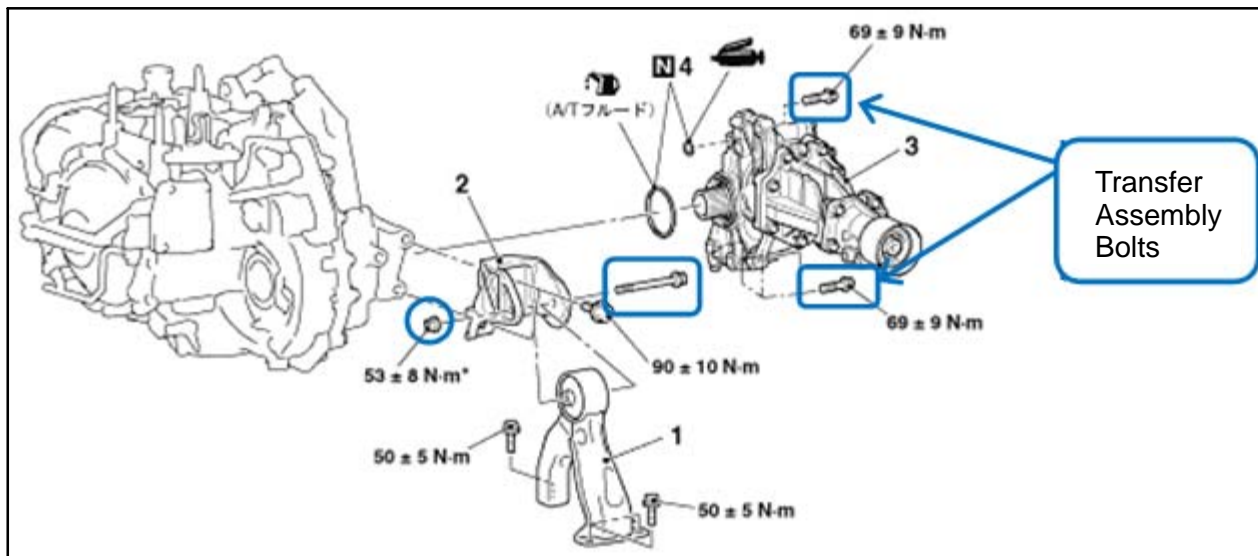
8. Remove the right hand front driveshaft assembly. Please refer to the applicable service manual, Group 26 – Front Axle, Driveshaft Assembly > Removal and Installation.
9. Remove the front roll stopper and centermember. Please refer to the applicable service manual, Group 32 – Power Plant Mount, Engine Roll Stopper and Centermember > Removal and Installation.
10. Remove the power steering hoses. Please refer to the applicable service manual, Group 37 – Power Steering, Power Steering Hoses > Removal and Installation.
11. Remove the transfer assembly. Please refer to the applicable service manual, Group 23C – Automatic Transaxle, Transfer Assembly (AWD) > Removal and Installation.

NOTE: Loosen the indicated transfer assembly bolts before removing the rear roll stopper.

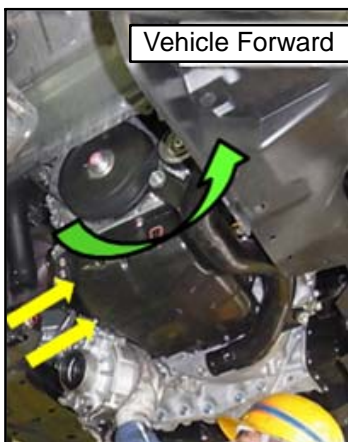
NOTE: Move the engine and transmission assembly forward to create space for transfer assembly removal. Do not use a tool such as a bar to move the engine and transmission. Be careful not to push the engine into the radiator assembly.

- a. To create space for transfer assembly removal, roll the engine by pushing the oil pan towards the direction indicated by the yellow arrows.

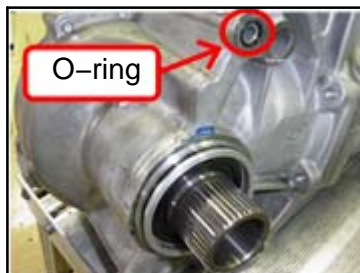
12. Install the new transfer assembly P/N 3200A158. Please refer to the applicable service manual, Group 23C – Automatic Transaxle, Transfer Assembly (AWD) > Removal and Installation.

NOTE: Install O-ring P/N MD743612 to the new transfer assembly.

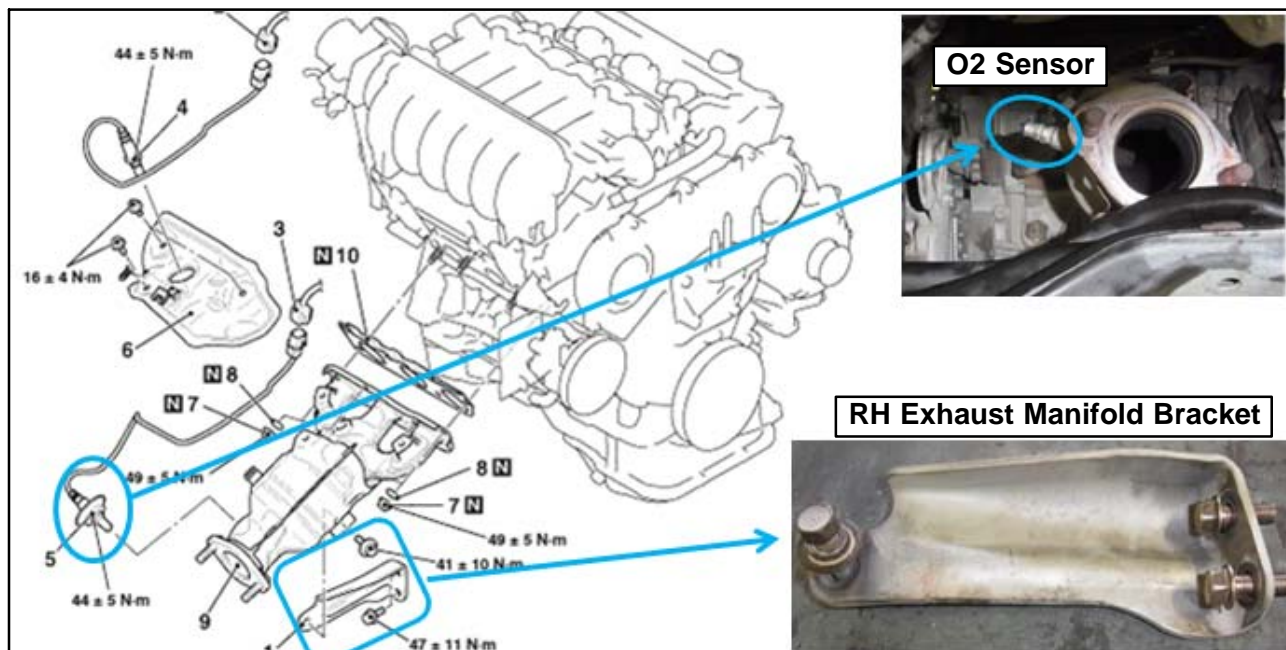
14. Install the front roll stopper and centermember. Please refer to the applicable service manual, Group 32 – Power Plant Mount, Engine Roll Stopper and Centermember > Removal and Installation.
15. Install the propeller shaft. Please refer to the applicable service manual, Group 25 – Propeller Shaft, Propeller Shaft > Removal and Installation.
16. Install the right exhaust manifold bracket and O2 sensor. Torque specification for right exhaust manifold bracket is 35 ± 8 ft-lb (47 ± 11 N-m). Torque specification for O2 sensor is 33 ± 3 ft-lb (44 ± 5 N-m).

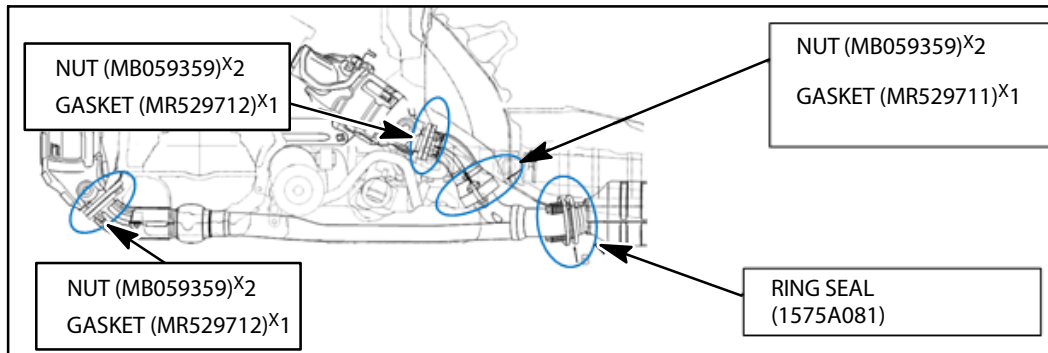
17. Install the front exhaust pipe. Please refer to the applicable service manual, Group 15 – Intake and Exhaust, Exhaust Pipe and Main Muffler > Removal and Installation (3.0L Engine).

NOTE: Install (6) new nuts P/N MB059359, (1) new gasket P/N MR529711, (2) new gaskets P/N MR529712, and (1) new seal ring P/N 1575A082.

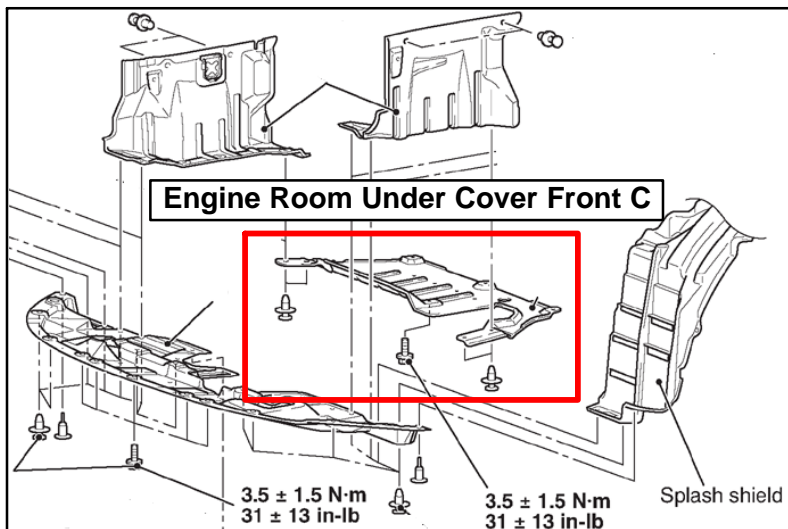
21. Install the engine room under cover front C.
