Recall Bulletin

SUBJECT: Driver Front Airbag Inflator Failure

MODELS: 2013-2014 Chevrolet Cruze

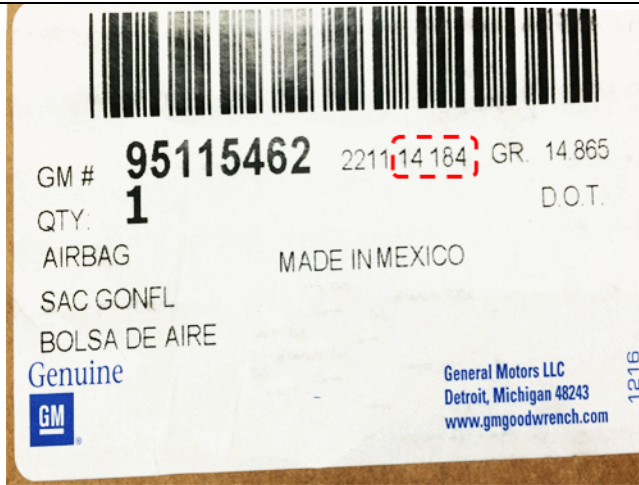
3988952

2. **Before installation**, inspect the new replacement steering wheel airbag module **box**. A Julian date (shown circled in the example above) will be present on the label of the box the module was shipped in.

The date breakpoint of affected parts is JUNE 30, 2014. Parts purchased and received on, or prior to, June 30, 2014 are discrepant and should be returned. Parts received after June 30, 2014 are good.

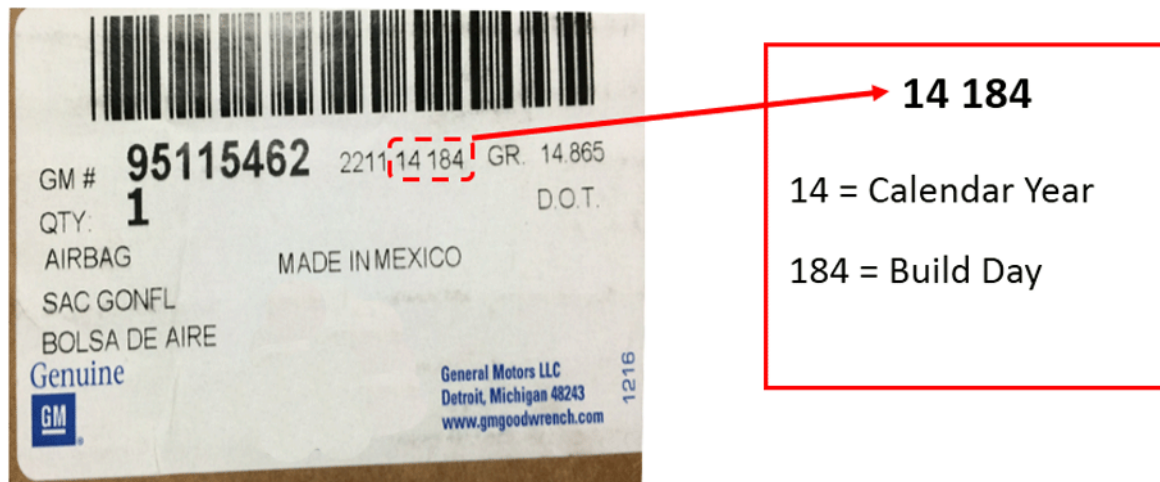
3988953

IMPORTANT: The **AFFECTED** date codes for the above example would be: **14 181 and prior.**

Example: The example above is showing the label of one of the two available service parts. The label on the other part would be similar. The date on the label in this example is Calendar Year 14, Build Day 184 (**NOT AFFECTED**)

- If the Calendar Year is 14 and the build date is on, or prior to, **Build Day 181** the part is discrepant and should be returned.
 - If the build date falls after date **Build Day 181**, continue on to step #4.
4. Install the new steering wheel airbag module. Refer to *Steering Wheel Airbag Replacement* in SI.
- NOTE: The removed steering wheel airbag module MUST be defaced on the airbag cover (customer facing side) with a paint pen or permanent marker.**
- WARNING: The removed steering wheel airbag modules that are the subject of this recall MUST NOT be deployed. It is possible that the inflator could rupture propelling pieces of the metal inflator under force sufficient to cause injury.**
5. DO NOT deploy the removed steering wheel airbag module. The removed steering wheel airbag module is to be returned to the supplier. See *Airbag Return Instructions* below.

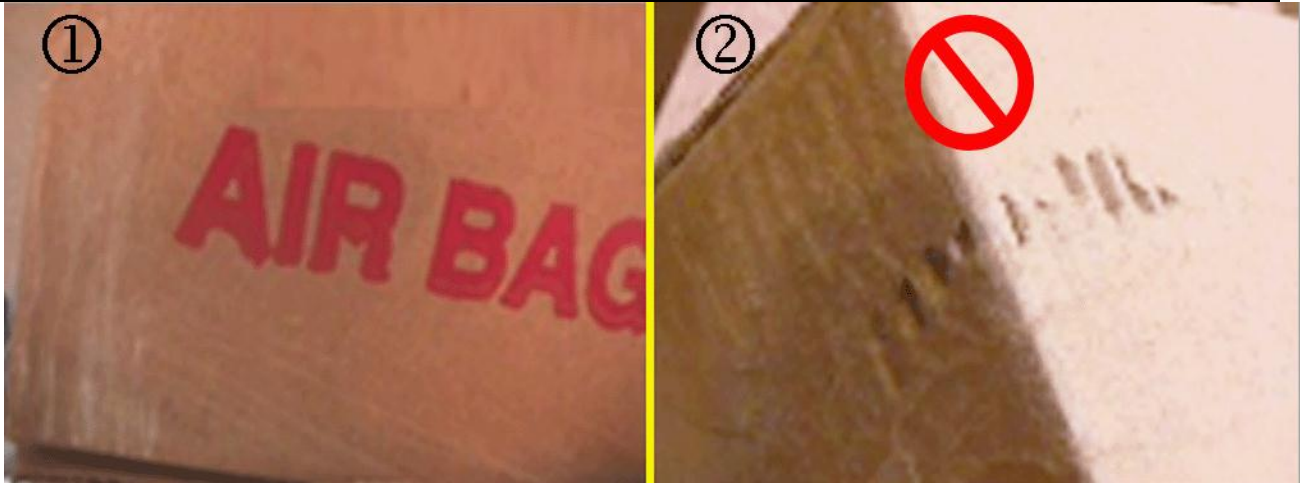
3961561

- **Abrasions:** Abrasions result from sliding the package against a rough surface (e.g. concrete floors). Major abrasions (2) are NOT acceptable. Note the flutes are visible.

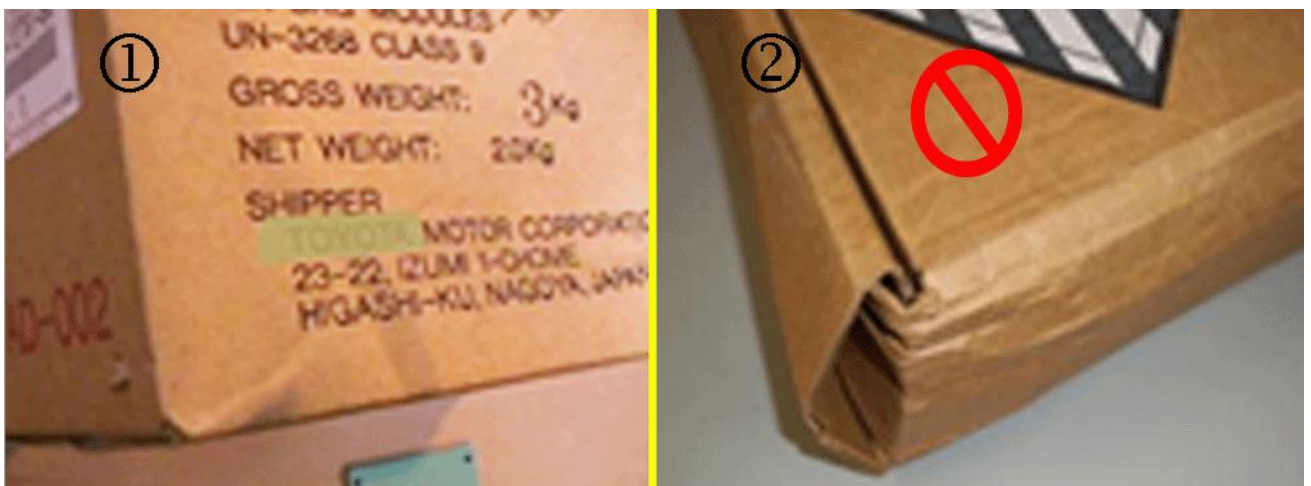
3961563

- **Compressions:** Compressions result from superimposed weights (e.g. stacked too high) or from dropping the packages. Small dimples (1) are acceptable.

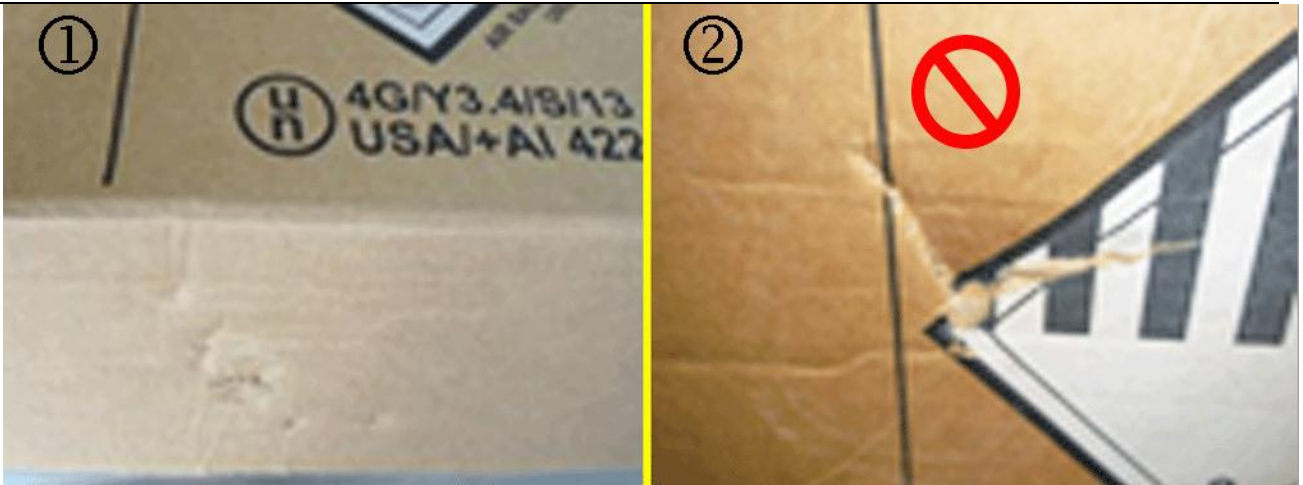
3961564

- **Dents:** Minor dents (1) occur through normal handling and picking (e.g. pulling from bin locations) and are acceptable. Major dents (2) result from impacts with others objects (e.g. pallet impacts).

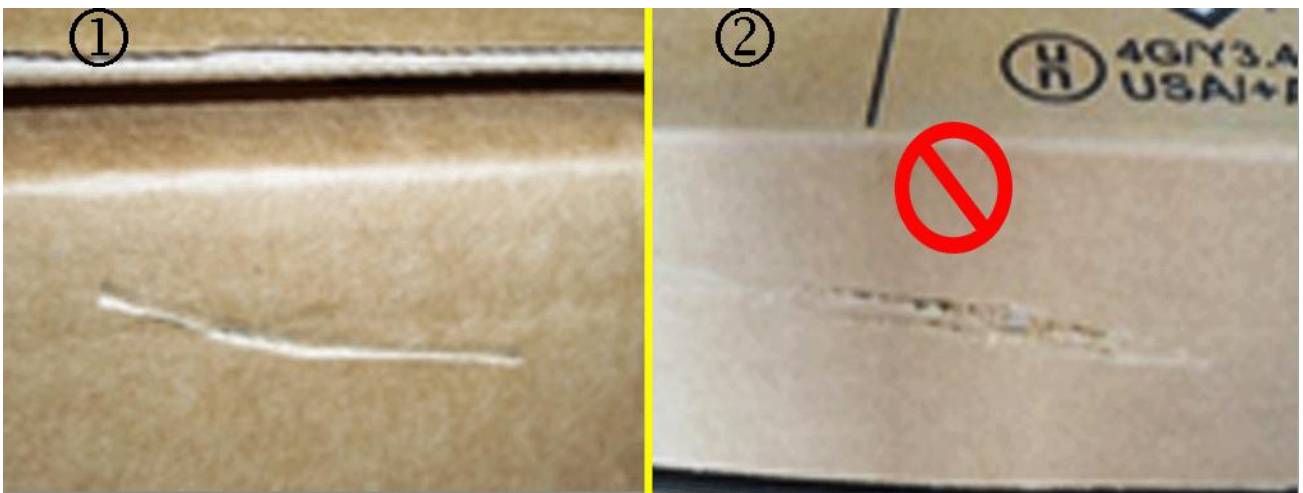
3961565

- **Incisions:** Minor incisions (1) are acceptable. Major incisions (2) (e.g. pallet box cut open with utility knife) are NOT acceptable.

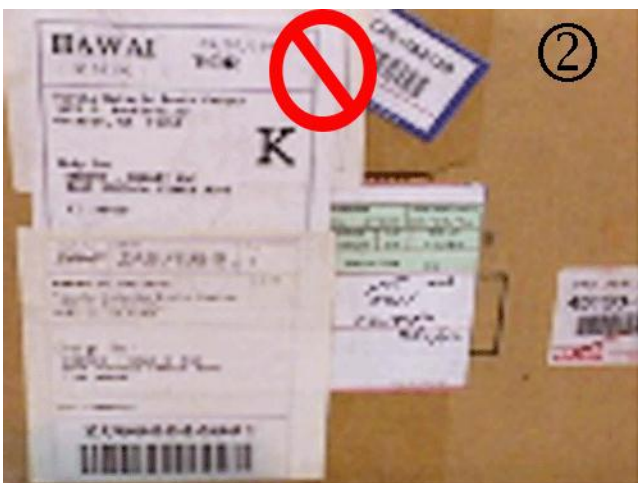
3961566

- **Labeling:** Packages with excessive labeling are NOT acceptable, particularly if the labels obscure other required marks and labels.

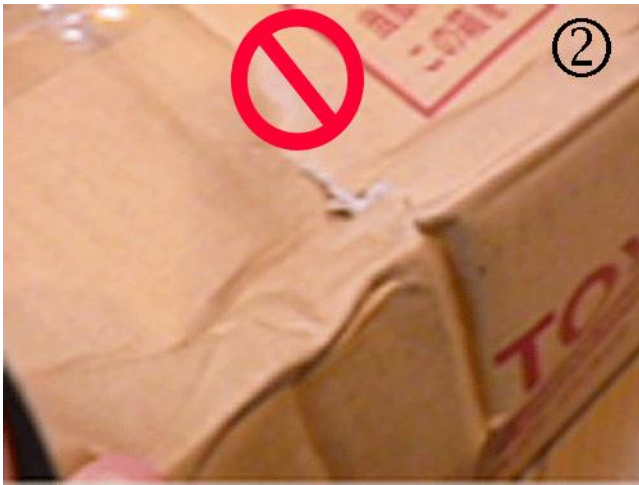
3961567

- **Other Damages:** Multiple damages, such as those shown above, may affect the integrity of the packages, and are NOT acceptable. Others that are not as severe may be acceptable. If questionable, repackage the material.

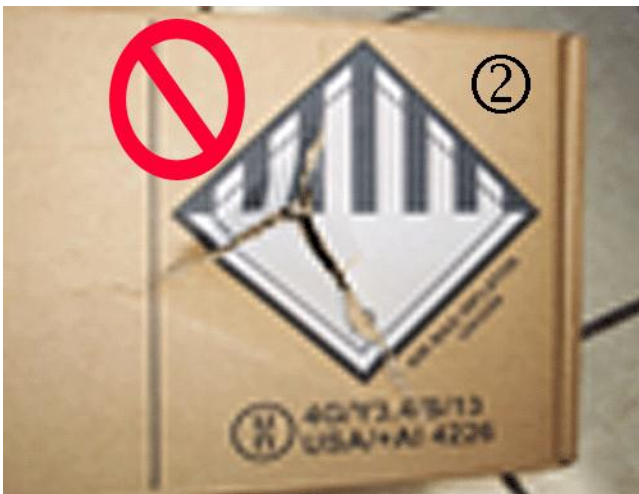
3961568

- **Punctures:** Any punctures, even minor ones, are NOT acceptable.

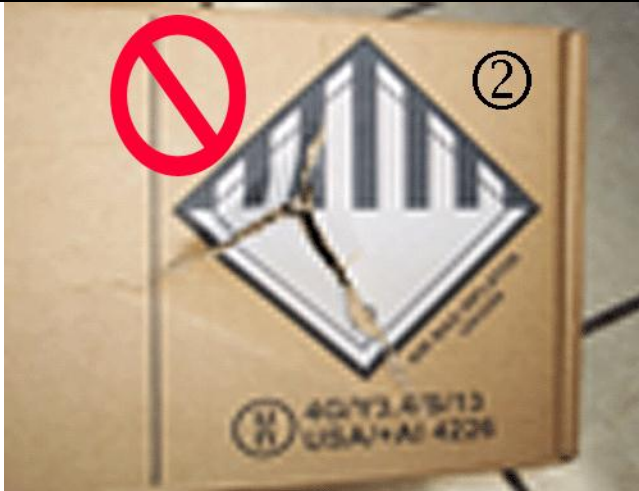
3961568

- **Tears:** Minor tears will not generally affect the structural integrity of the packaging and are considered to be normal "wear and tear", however, large tears or rips are NOT acceptable.

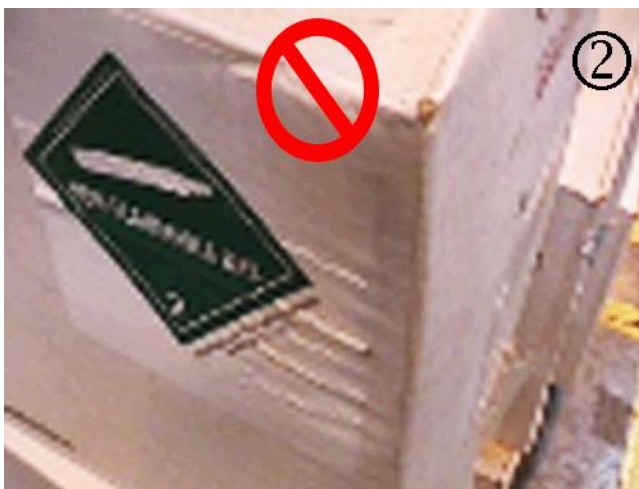
3961569

- **Water Damages:** Water Damages, such as the example shown above, are NOT acceptable. Water damages will affect the structural integrity of the packaging. These packages should be repacked in appropriate specification packages.
1. **DO NOT DEPLOY THE AIRBAG.** Ensure that the box the replacement airbag arrived in is not damaged and place the steering wheel airbag in the box. Also, make sure to include a copy of the repair order in the box.
