Dealer Service Instructions for:

Safety Recall P36 / NHTSA 14V-391

Sun Visor Wiring

2011 – 2014 (WD) Dodge Durango

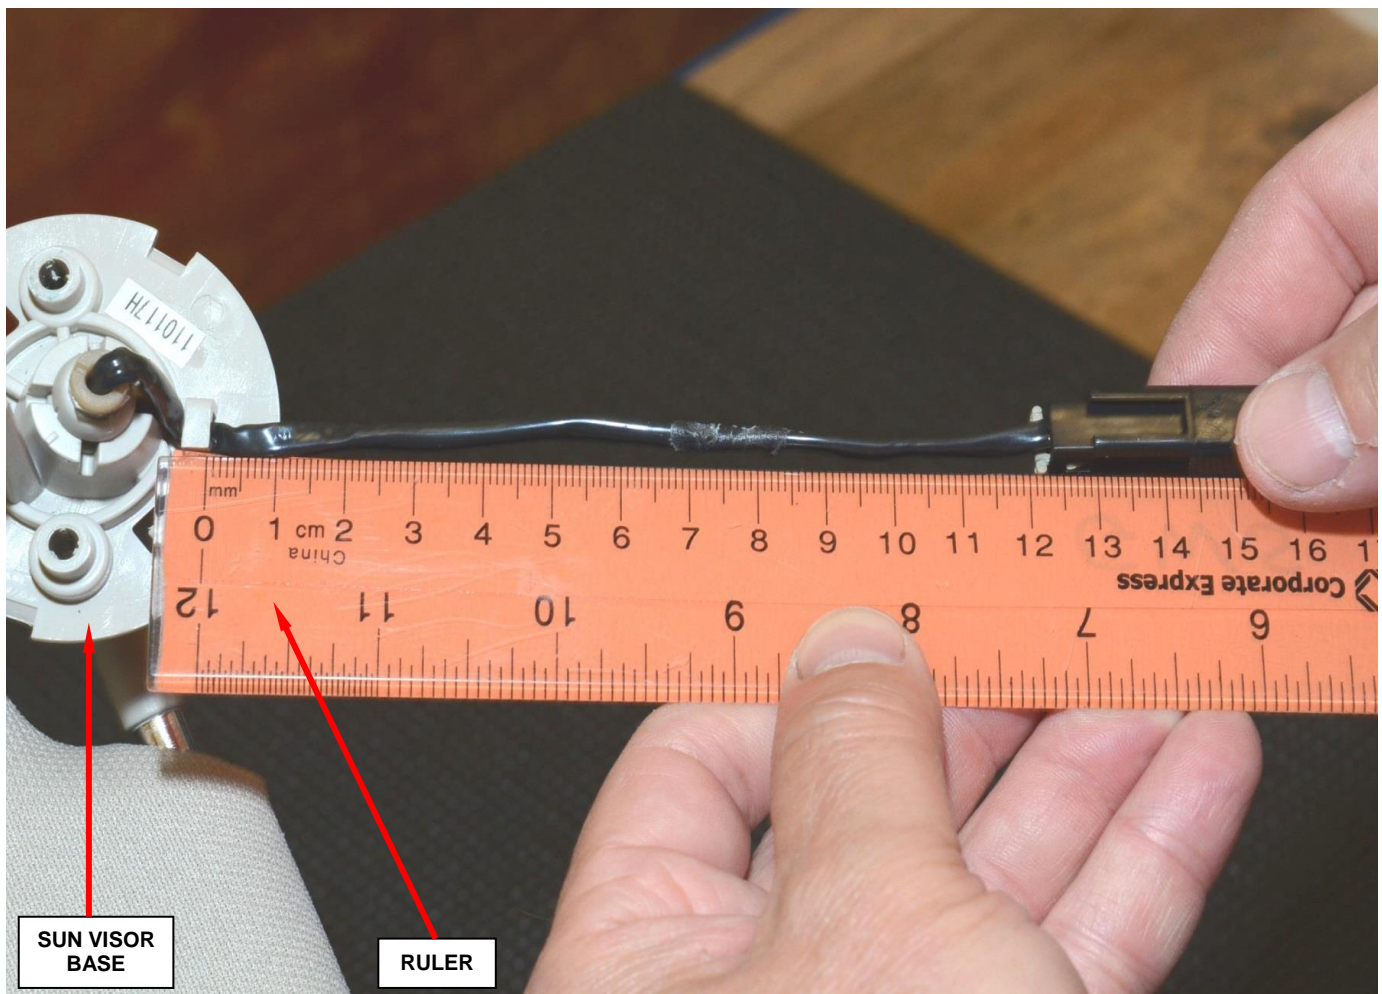
**Figure 26 – Measure Wire Length**

NOTE: The majority of the vehicles built before September 01, 2012 will have a 4 ³/₄ inch (120 mm) long sun visor wire. The majority of the vehicles built after September 01, 2012 will have a 2 ³/₄ inch (70 mm) long sun visor wire.

52. Remove and discard the original right and left side sun visor wire guides.
53. Measure the length of the sun visor wire to determine the correct wire routing (Figure 26).

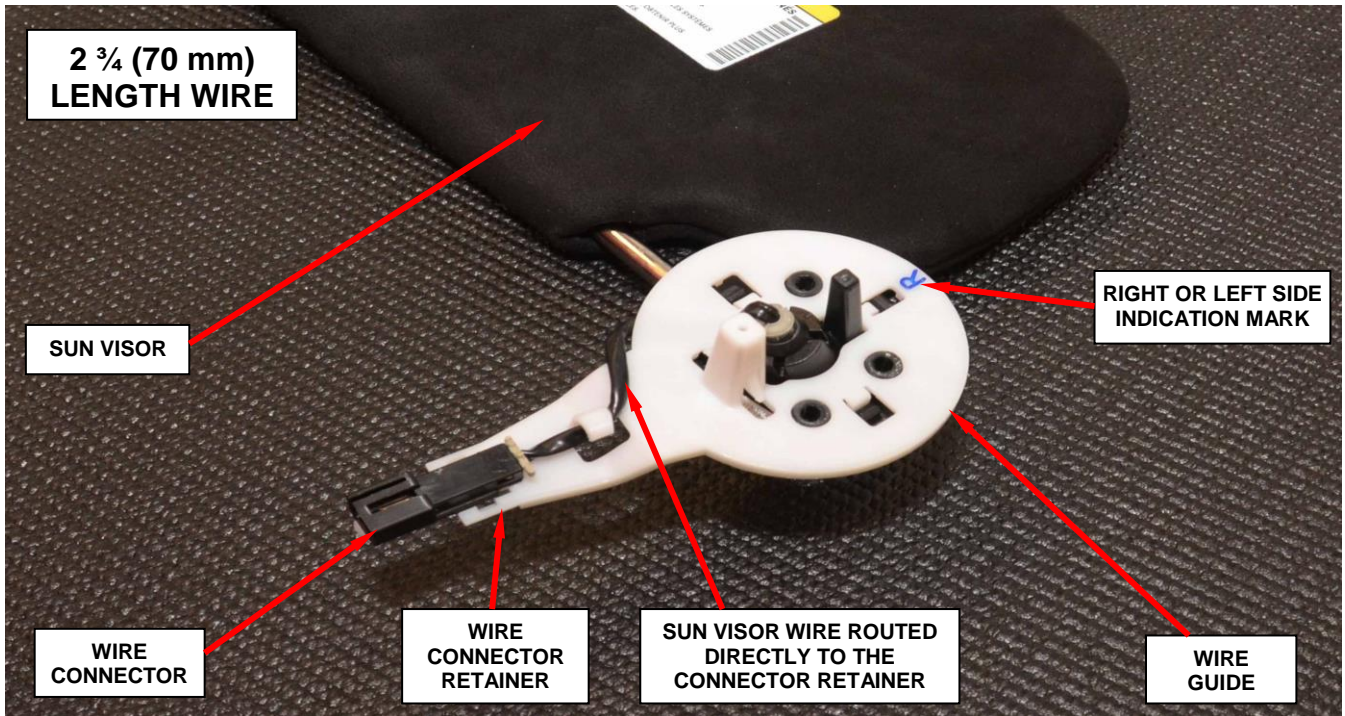
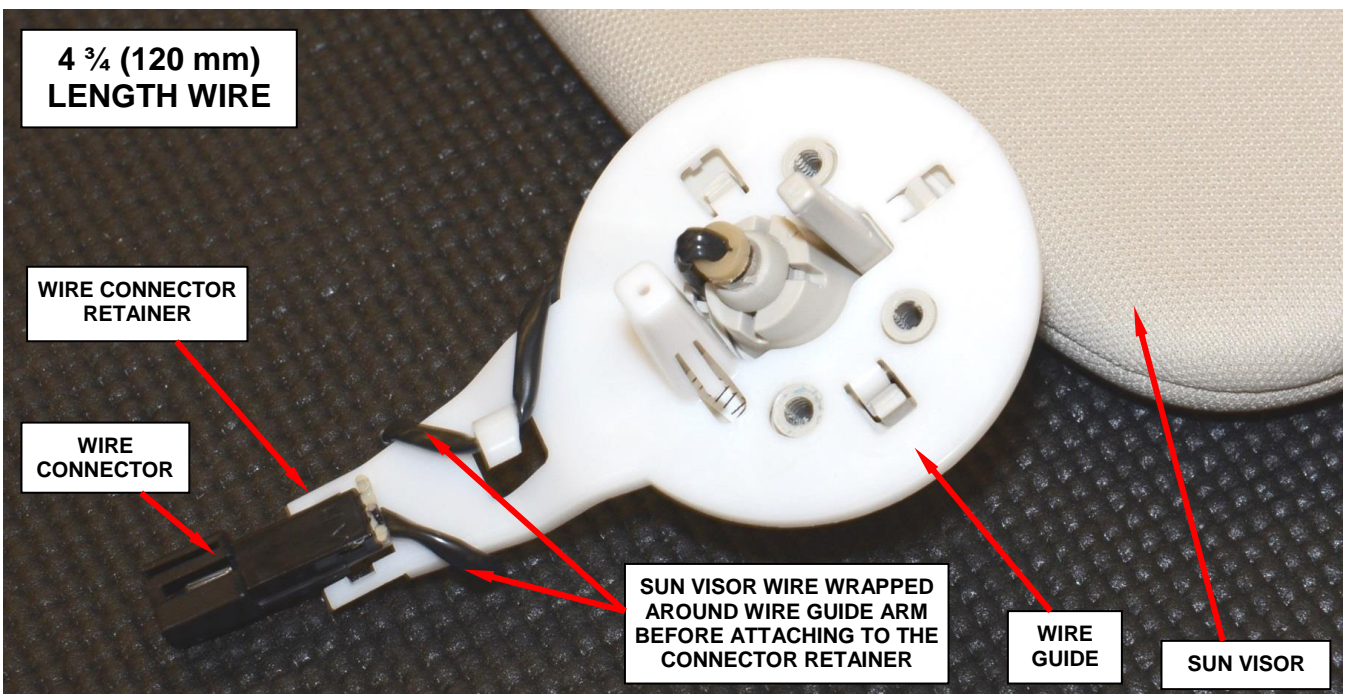
Figure 28 - Sun Visor Wire Routing (2 3/4 Inch / 70 mm Length Wire)
(Parts removed from vehicle for photographic purposes only)

Figure 29 – Sun Visor Wire Routing (4 3/4 Inch / 120 mm Length Wire)
(Parts removed from vehicle for photographic purposes only)

56. Route the wire as shown in Figure 28 or 29 depending on the length of the sun visor wire. Then connect the sun visor wire harness electrical connector to the wire guide connector retainer.
