# **Safety Recall P36 / NHTSA 14V-391**

## **Sun Visor Wiring**

2011 – 2014 (WD) Dodge Durango

(WK) Jeep® Grand Cherokee

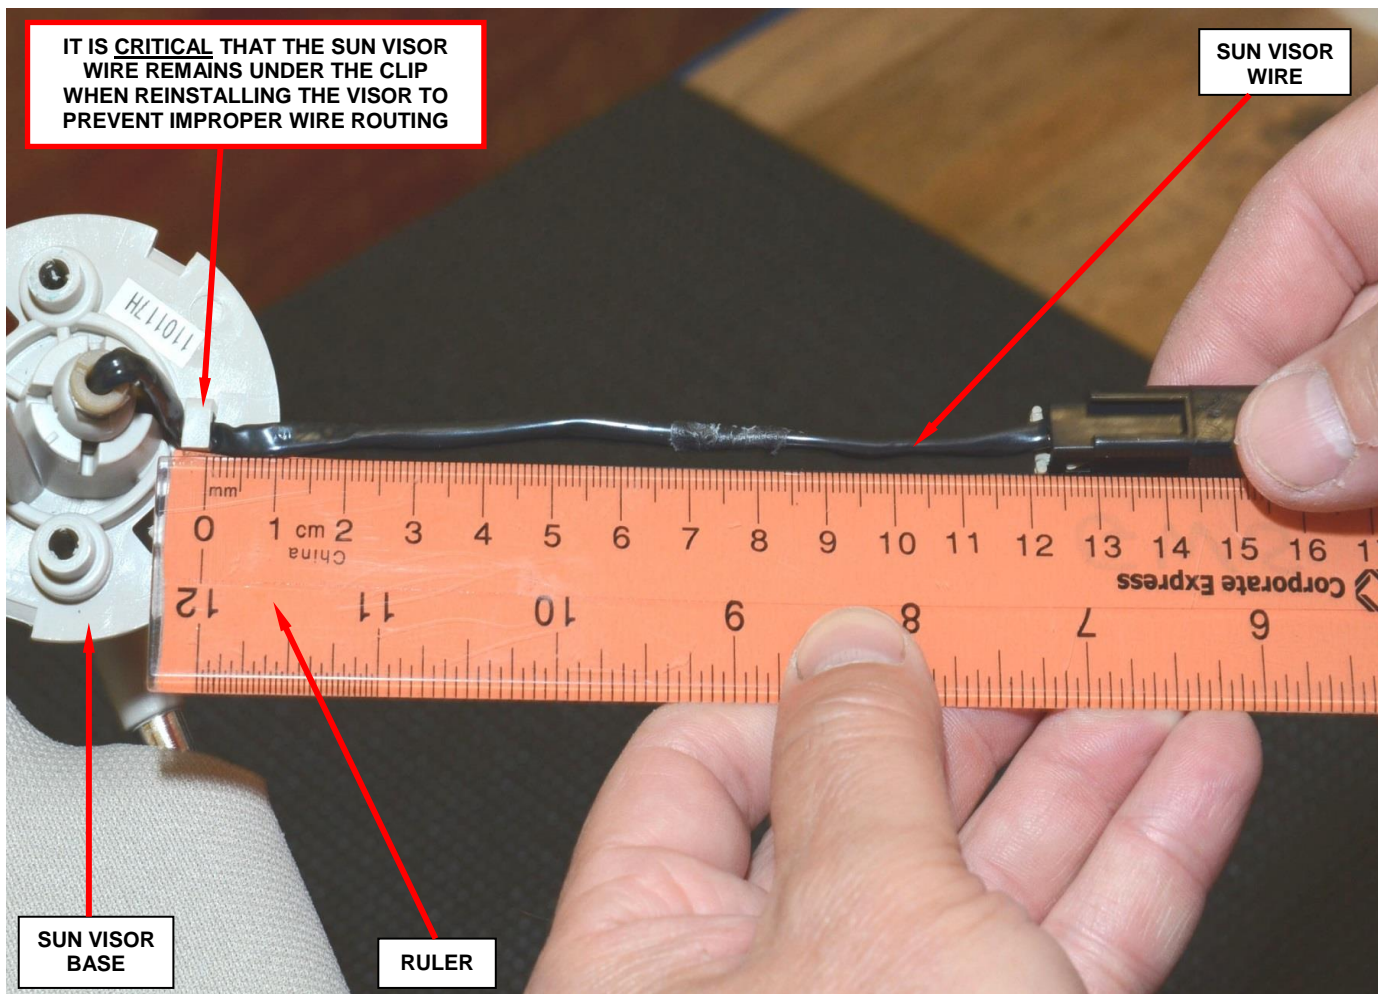
**Figure 20 – Measure Wire Length**

**NOTE:** The majority of the vehicles built before September 01, 2012 will have a 4 <sup>3</sup>/<sub>4</sub> inch (120 mm) long sun visor wire. The majority of the vehicles built after September 01, 2012 will have a 2 <sup>3</sup>/<sub>4</sub> inch (70 mm) long sun visor wire.

36. Remove and discard the original right and left side sun visor wire guides.
37. Measure the length of the sun visor wire to determine the correct wire routing (Figure 20).

**CAUTION:** It is critical that the sun visor wire remains under the clip shown in Figure 20 when reinstalling the visor to prevent improper wire routing.
