# Recall Bulletin

## PRODUCT SAFETY RECALL

**SUBJECT:** Unintended Ignition Key Rotation

**MODELS:** 2011-2014 Cadillac CTS (VIN D and Built After December 12, 2010)  
Equipped with Traditional Key Ignition

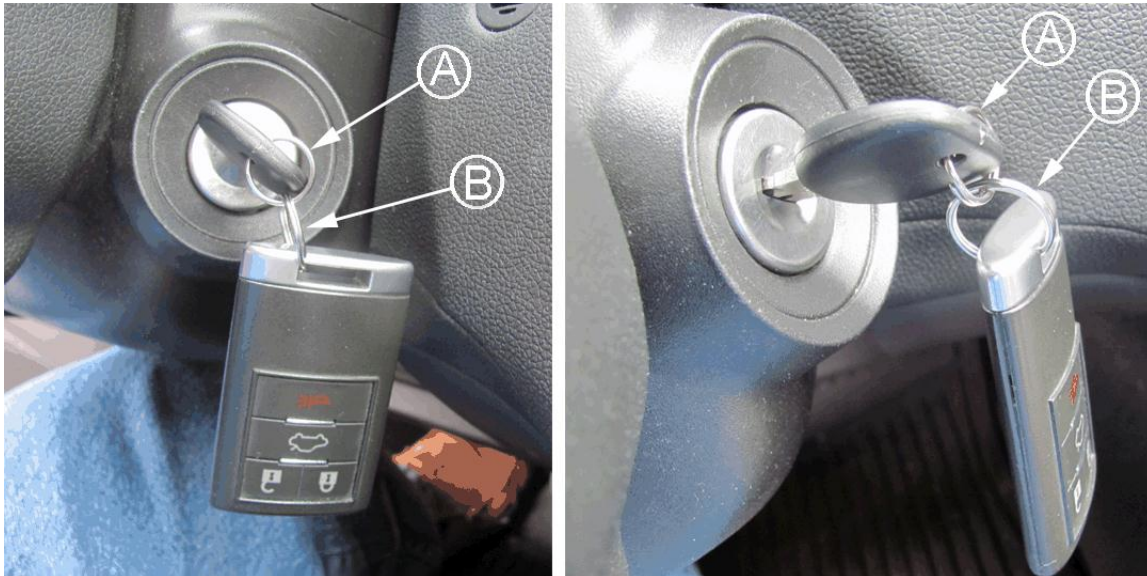
3966144

General Motors has decided that a defect which relates to motor vehicle safety exists in certain 2011-2014 model year Cadillac CTS vehicles. If the key ring is carrying added weight and the vehicle goes off road or experiences some other jarring event, or if the driver unintentionally bumps the key ring or items attached to the key ring with their knee, the key may unintentionally move away from the "run" position. If this occurs, engine power, power steering and power braking may be affected, increasing the risk of a crash. The timing of the key movement out of the "run" position, relative to the activation of the sensing algorithm of the crash event, may result in the airbags not deploying, increasing the potential for occupant injury in certain kinds of crashes.

1. Remove the ignition key and FOB from the original key ring(s).
2. Discard the original key ring(s).
3. Install one 16 mm key ring (A) on the ignition key.
4. Install one 18 mm key ring (B) onto the key FOB.

5. Attach the 16 mm key (A) ring to the 18 mm (B) key ring. Refer to the photograph to view the correct key ring assembly.
