TECHNICAL BULLETIN
P046NAS4
13 NOV 2014

Safety Recall: Supplementary Restraint System (SRS) Warning Lamp Illuminated

LR2 (LF)

Range Rover Evoque (LV)

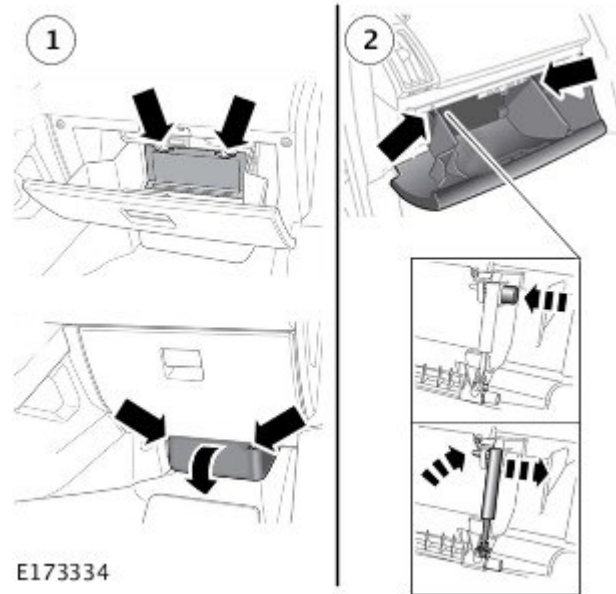
Once the software download parts confirmation screen is presented, remove the OCSCM fuse (fuse number 60; fuse rating 5A).

- The fuse box is located in the passenger compartment:
 - '1' - Range Rover Evoque
 - '2' - LR2
- Press the on-screen green ✓ (tick) to continue.
- Install the previously removed OCSCM fuse when SDD displays a blue scroll bar in the center of the screen.
 - This should be within 10 seconds of pressing the green ✓ (tick) on the software download confirmation screen.
 - If the download is completed successfully, continue to the next step.
 - If the download fails again, please contact your local Technical HelpLine for assistance.
