Recall Bulletin

PRODUCT SAFETY RECALL

SUBJECT: Steering Assembly Bolt Not Properly Torqued

MODELS: 2014 Buick Regal
2014 Cadillac XTS
2014 Chevrolet Camaro, Impala

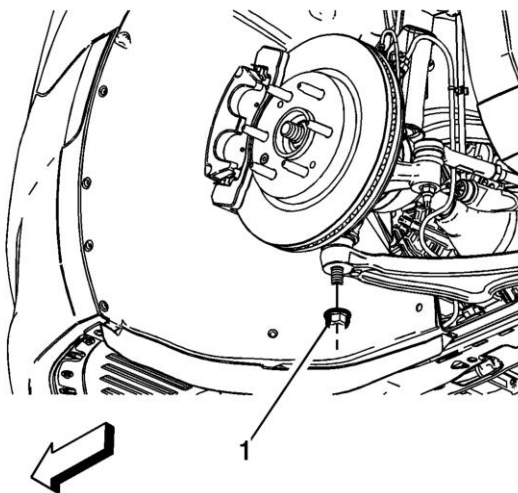
2904794

2. Locate the steering knuckle nut (1). This nut connects the lower control arm and ball joint. Refer to photograph.

3. Inspect the steering knuckle nut (1) using a calibrated torque wrench. Move the nut not more than 5 degrees and note the static torque reading. Verify the steering knuckle nut is tightened to a minimum of 130 Nm (96 lb-ft).
 - If the nut is tightened to a minimum 130 Nm (96 lb-ft), proceed to step 4. No further action is required.
 - If the nut is NOT tightened to a minimum of 130 Nm (96 lb-ft), tighten the nut to 145 Nm (107 lb-ft). Proceed to step 4 after tightening the nut.
4. Lower the vehicle. Refer to *Lifting and Jacking the Vehicle* in SI.
