# Recall Bulletin

## PRODUCT SAFETY RECALL

**SUBJECT:** Steering Assembly Bolt Not Properly Torqued

**MODELS:** 2014 Buick Regal  
2014 Cadillac XTS  
2014 Chevrolet Camaro, Impala

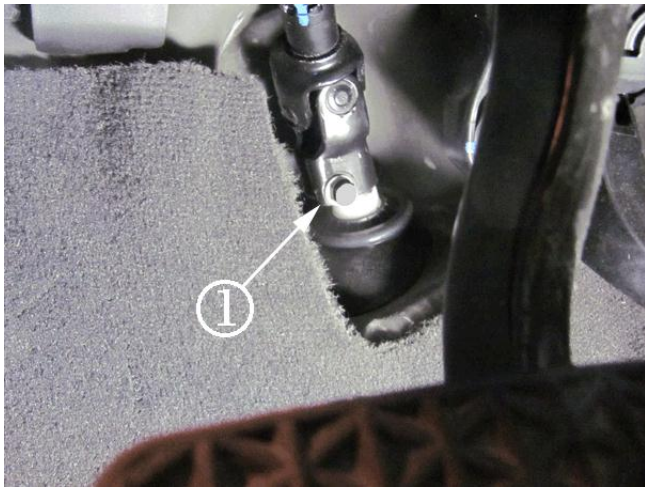
3949699

### **I-Shaft Bolt Inspection – All Chevrolet Impala, Buick Regal and Cadillac XTS Vehicles**

2. Locate the intermediate steering shaft lower bolt (1).
3. Verify the intermediate steering shaft lower bolt (1) is tightened to a minimum of 26 Nm (19 lb-ft).
  - If the bolt is tightened to 26 Nm (19 lb-ft), no further action is required.
  - If the bolt is NOT tightened to a minimum of 26 Nm (19 lb-ft), tighten the bolt to 34 Nm (25 lb-ft).

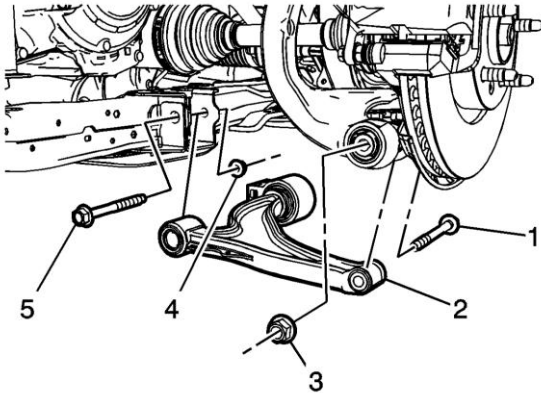
2381096

**Cadillac XTS Left Side Steering Knuckle Nut Inspection GNB Suspension: VIN 2G61M5S37E9158011**

2. Locate the steering knuckle nut (3). This nut connects the lower control arm and ball joint. Refer to photograph.
3. Inspect the steering knuckle nut (3) using a calibrated torque wrench. Move the nut not more than 5 degrees and note the static torque reading. Verify the steering knuckle nut is tightened to a minimum of 120 Nm (89 lb-ft).
  - If the nut is tightened to a minimum 120 Nm (89 lb-ft), proceed to step 4. No further action is required.
  - If the nut is NOT tightened to a minimum of 120 Nm (89 lb-ft), tighten the bolt to 115 Nm (85 lb ft) + 120 degrees. Proceed to *Cadillac XTS Left Side Tie Rod Nut Inspection: VIN 2G61M5S37E9158011* in this bulletin, after tightening the nut.

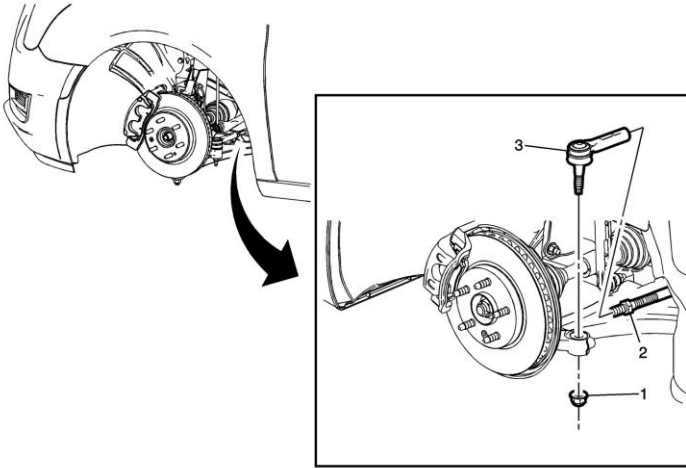
2784020

### Cadillac XTS Left Side Tie Rod Nut Inspection: VIN 2G61M5S37E9158011

2. Locate the tie rod nut (1).
3. Inspect the tie rod nut (1) using a calibrated torque wrench. Move the nut not more than 5 degrees and note the static torque reading. Verify the tie rod nut is tightened to a minimum of 36 Nm (27 lb-ft).
  - If the nut is tightened to a minimum 36 Nm (27 lb-ft), proceed to steps 5 and 6. No further action is required.
  - If the nut is NOT tightened to a minimum of 36 Nm (27 lb-ft), tighten the bolt to 35 Nm (26 lb -ft) + 30 degrees. Proceed to *Cadillac XTS Front Wheel Hub Nut: VIN 2G61M5S37E9158011* in this bulletin after tightening the nut.

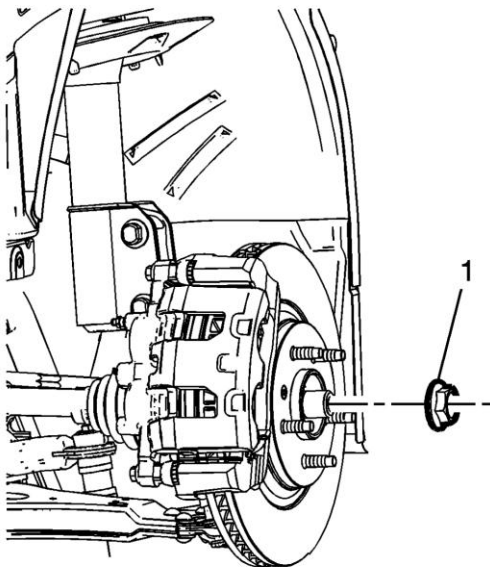
2607977

### Cadillac XTS Front Wheel Hub Nut: VIN 2G61M5S37E9158011

1. Locate the front wheel hub nut (1).

2. Inspect the front wheel hub nut (1) using a calibrated torque wrench. Move the nut not more than 5 degrees and note the static torque reading. Verify the front wheel hub nut is tightened to a minimum of 225 Nm (166 lb-ft).
  - If the nut is tightened to a minimum 225 Nm (166 lb-ft), proceed to steps 5 and 6. No further action is required.
  - If the nut is NOT tightened to a minimum of 225 Nm (166 lb-ft), tighten the bolt to 225 Nm (166 lb-ft). Proceed to steps 5 and 6 after tightening the nut.
3. Install the front tire and wheel assembly. Refer to *Tire and Wheel Removal and Installation* in SI.
4. Lower the vehicle. Refer to *Lifting and Jacking the Vehicle* in SI.
