Technical Service Bulletin

GROUP	NUMBER
CAMPAIGN	14-01-044
DATE	MODEL(S)
NOVEMBER 2014	VERACRUZ (EN)

CYLINDER HEAD COVER OIL LEAK REPAIR (RECALL CAMPAIGN 121)

Applicable Vehicles: Veracruz (EN) vehicles built from January 13, 2006 to July 24, 2012

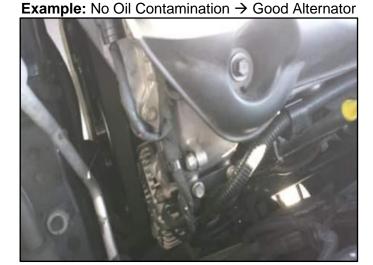
Inspect for oil contamination of Alternator

Visually inspect the alternator for presence of any level of oil contamination due to oil leakage that may have occurred down from the rocker cover.

The example shown has a high level of oil contamination on the alternator, but ANY level of oil contamination found outside or inside the alternator requires replacement of the alternator.

Example: Oil Contamination → Replace Alternator

If ANY level of oil contamination is found inside or on the exterior of the alternator, then the alternator must be replaced using the service procedure outlined in the following pages.
