# RECALL CAMPAIGN BULLETIN

NTB14-085

## VOLUNTARY SAFETY RECALL CAMPAIGN 2014 FRONTIER CREW CAB REAR SEATBELT ANCHOR WELD NUT

**APPLIED VEHICLES:** 2014 Frontier Crew Cab (D40)

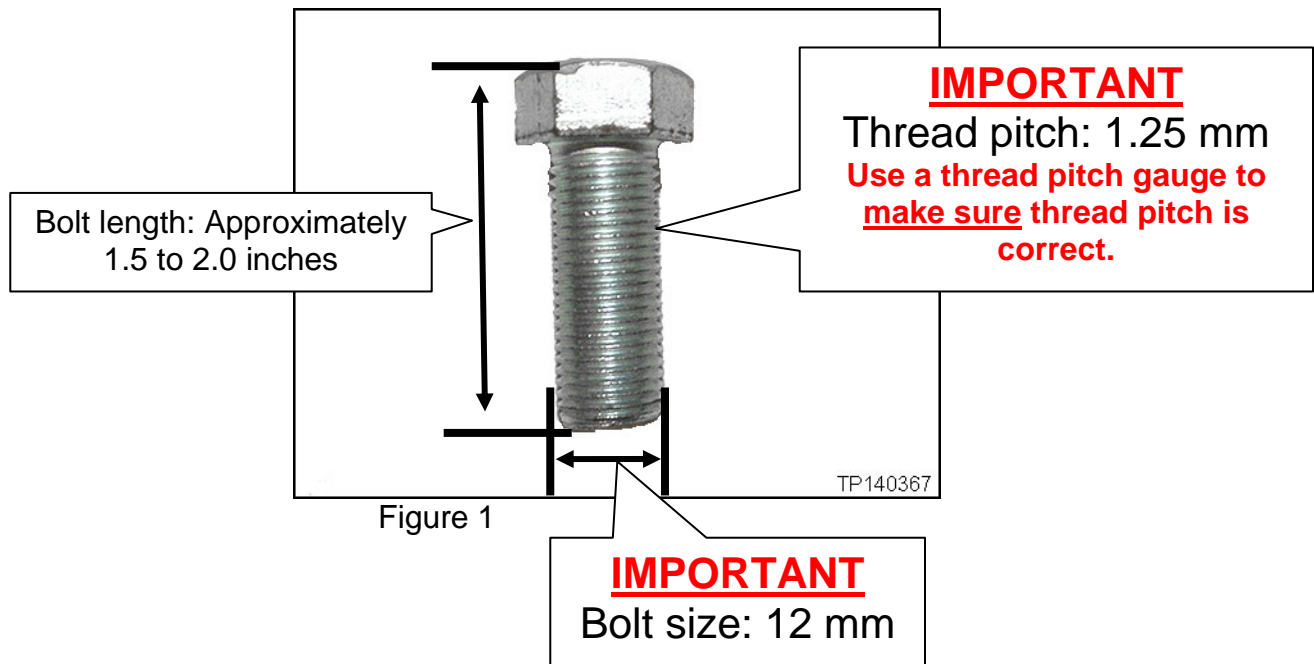
Obtain an inspection bolt, from a local source, as shown in Figure 1.

- The Service Procedure in this bulletin will determine if an over-sized weld nut was incorrectly installed for the 2<sup>nd</sup> row seat (rear seat) seatbelt lower anchor located in the left and right side rear pillars (C-pillars).
- **An over-sized bolt of the exact size and thread pitch, as shown above, is required to perform the inspection.**

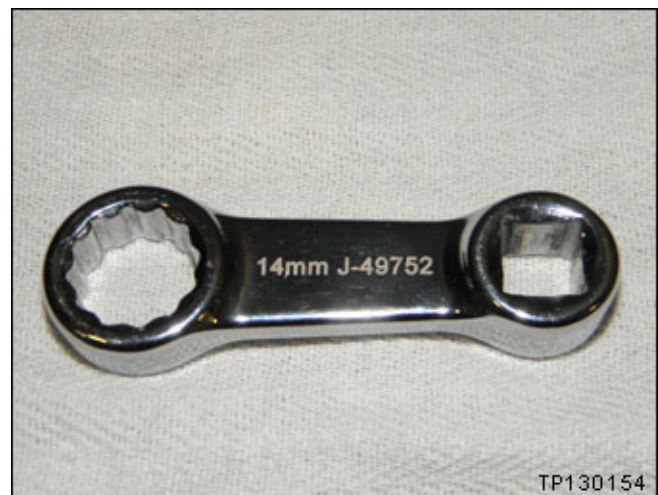
Figure 2

- 14 mm Torque Adaptor J-49752 is a dealer "essential tool".
- Each dealer was previously shipped one J-49752.
- Additional tools can be ordered from TECH-MATE at 1-800-662-2001.

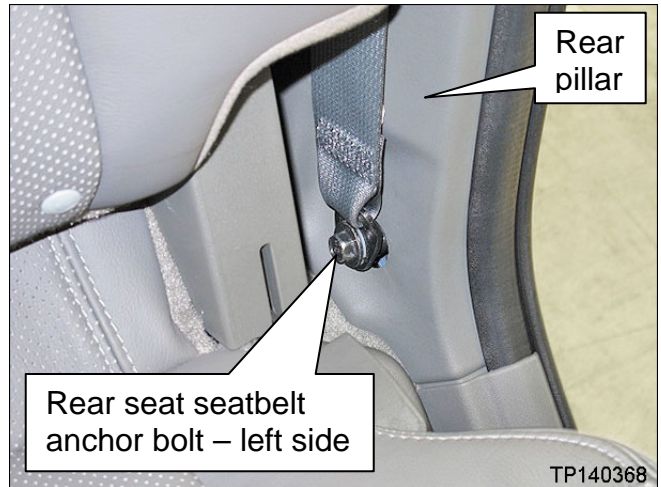
Figure 3

1. Locate and remove the two rear seat seatbelt anchor bolts located in the rear pillars (see Figure 3).
  - The left side (driver side) is shown.
  - Both sides will need to be removed for this inspection.
  - The right side (passenger side) is a mirror image.

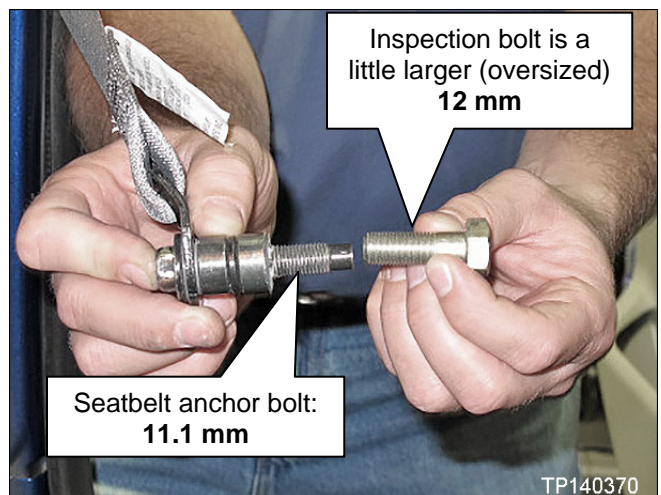
Figure 4

2. Confirm the inspection bolt is slightly larger than the seatbelt anchor bolt.

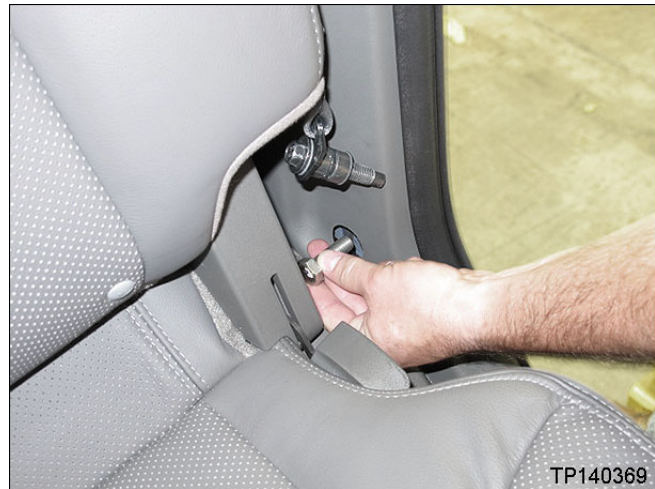
Figure 5

3. Insert the inspection bolt into the seatbelt lower anchor bolt hole.
4. **By hand only** – attempt to thread the inspection bolt into the weld nut.
  - Make at least three attempts to thread the bolt into the nut.
  - The left side (driver side) is shown.
  - **Make sure to perform this inspection on both sides (the passenger side and the driver side).**

- If the inspection bolt **DOES NOT** thread into either side seatbelt lower anchor weld nut after three attempts:
  - a. Re-install the original anchor bolts.
  - b. Torque the anchor bolts to 49 N-m (5.0 kg-m, **36 ft-lb**)\* using the 14 mm torque adaptor (J-49752).

- If the inspection bolt **DOES** thread into either side seatbelt lower anchor weld nut:
  - a. Hold the vehicle.
    - If the vehicle has been sold (customer owned) provide a rental car for the customer.
  - b. Send an email to [nnafqasupport@nissan-usa.com](mailto:nnafqasupport@nissan-usa.com)  
 Email subject line: PC309 Needs Repair  
 Include in the email:
    - Dealer name address and dealer code
    - Contact person's name and phone number
    - VIN
    - Number of NG inspection results (one side or both sides).
