SIB 65 17 14

RECALL CAMPAIGN 14V-428: REPLACE PASSENGER'S FRONT AIR BAG MODULE:

This Service Information bulletin (Revision 7) supersedes SI B65 17 14 dated **December 2022**.

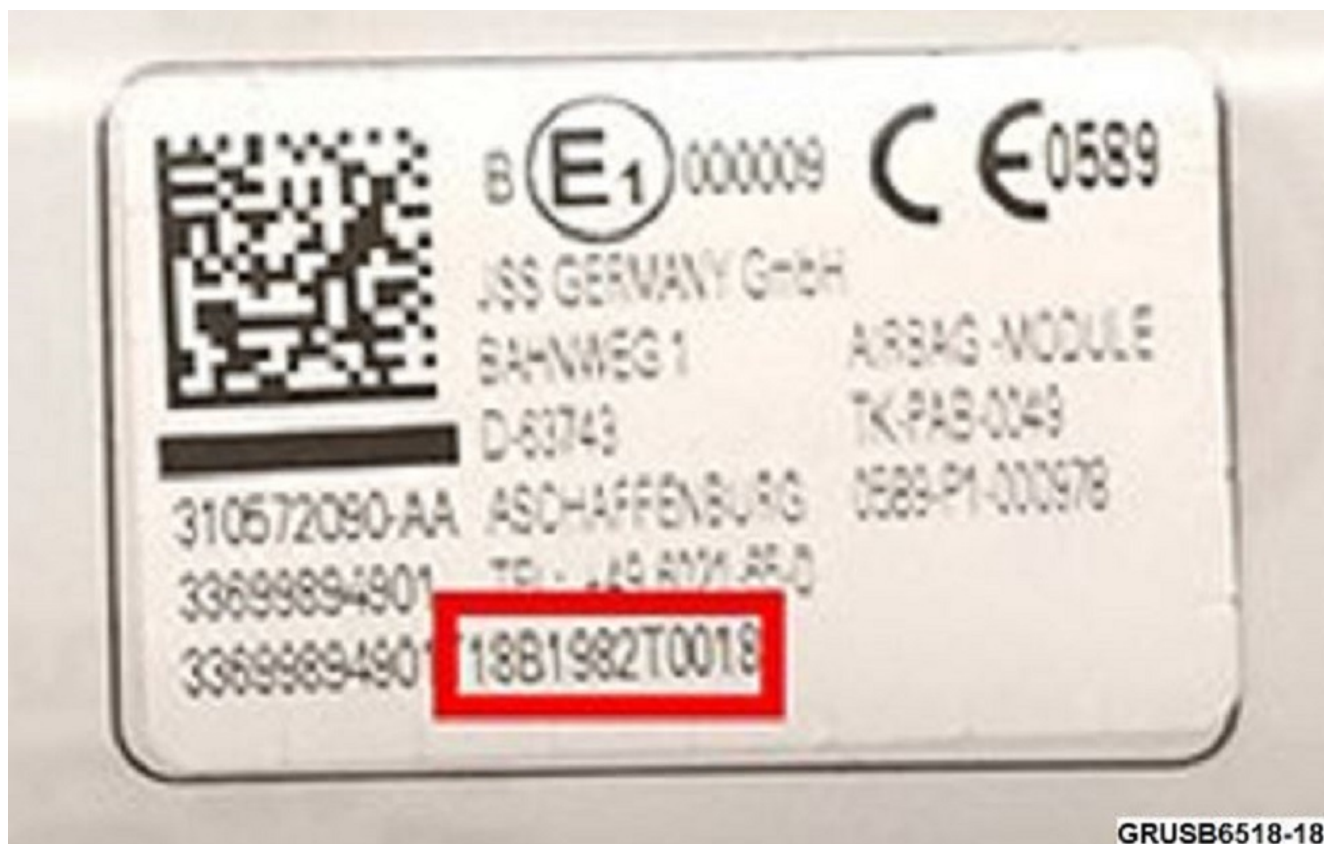
Please make sure to document the serial number (circled) before installation.

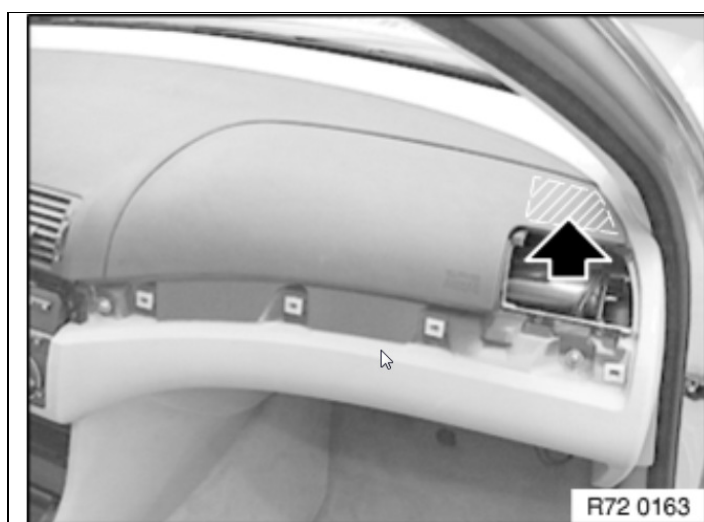
- Position of the retaining clip of the front passenger's airbag cover

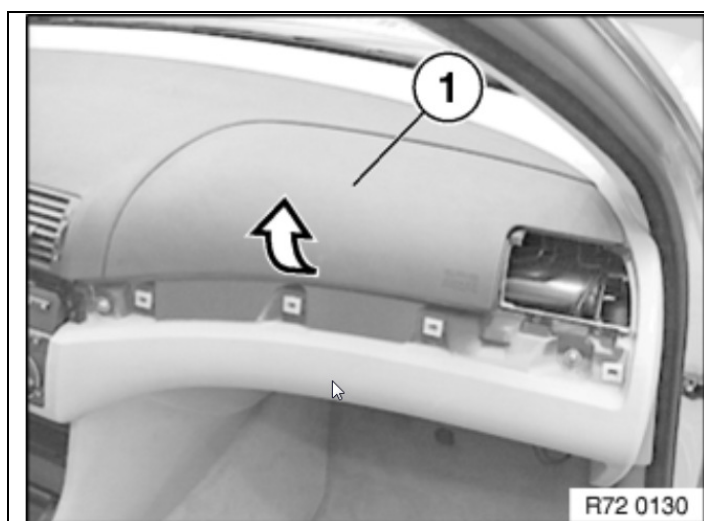
The retaining clip remains in the dashboard when removing the cover.

- Lever out the front passenger's airbag cover (1).

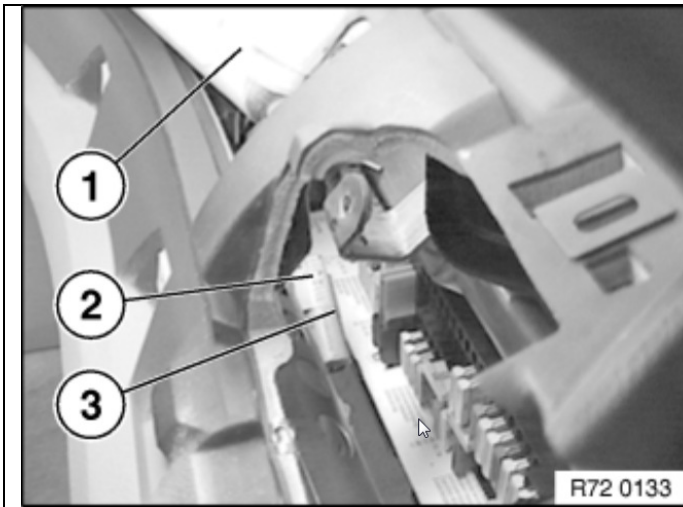
Do not tension the cable when removing the front passenger's airbag module (1)!

- Open the lock by pressing on the tab (2).
- Disconnect the plug connection (3).
- Remove the front passenger's airbag module (1).
