RECALL CAMPAIGN 14V-428: REPLACE PASSENGER'S FRONT AIR BAG MODULE:

This Service Information bulletin supersedes SI B65 17 14 **dated November 2018**

MODEL

Model Year from 2000 to 2006

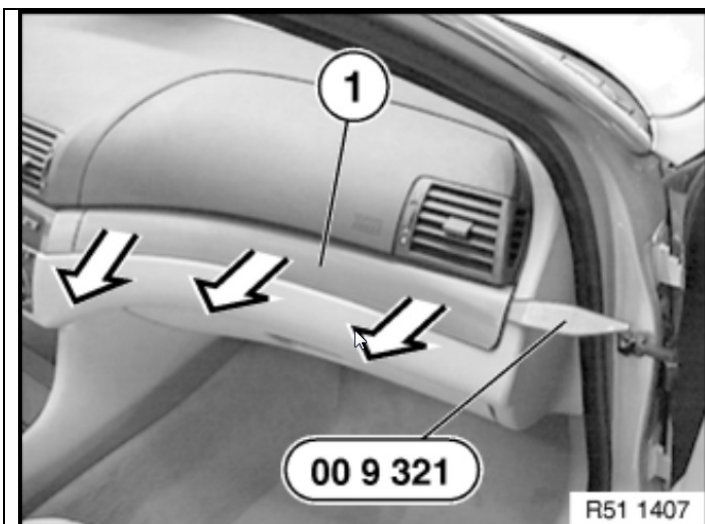
- Insert special tool 00 9 321 at the side and with the second special tool 00 9 321 next to the retaining pin.
- Unclip the decorative strip (1).

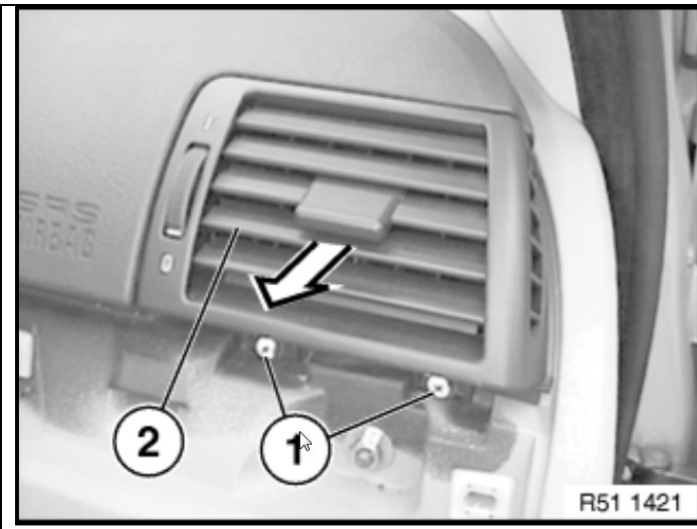
- Loosen the screws (1).
- Withdraw the fresh air grill (2) in the direction of the arrow.

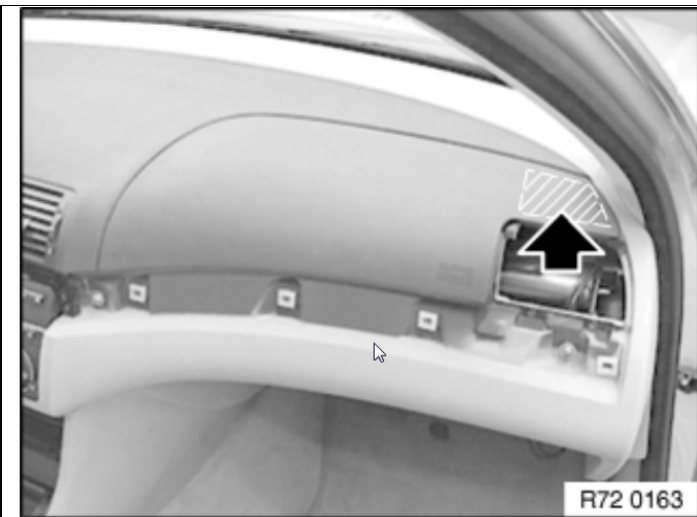
- Position of the retaining clip of the front passenger's airbag cover

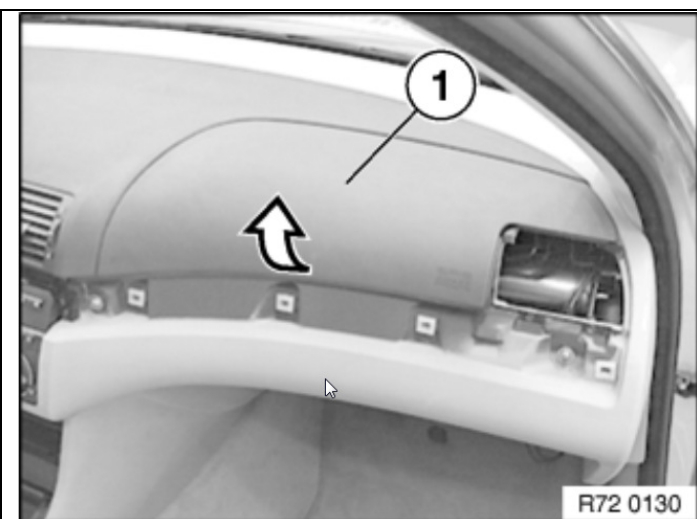
- Lever out the front passenger's airbag cover (1).

The retaining clip remains in the dashboard when removing the cover.

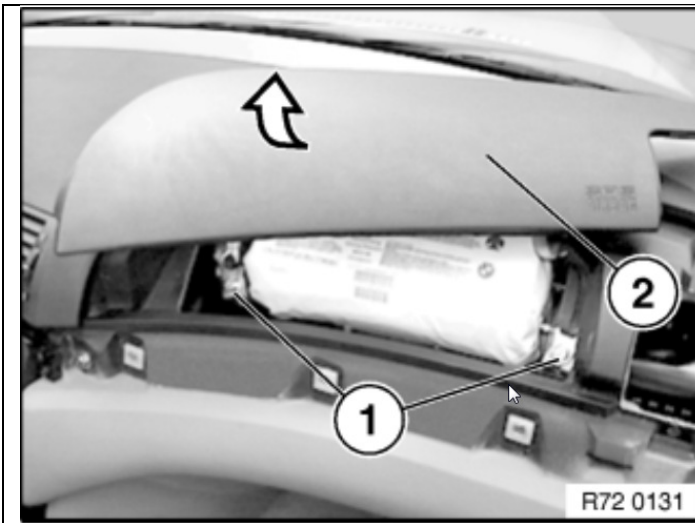
- Undo the screws (1) and place the front passenger's airbag cover (2) on top.

- Tightening torque for the retaining straps for the cover, passenger's airbag module on the instrument panel carrier: 9 Nm

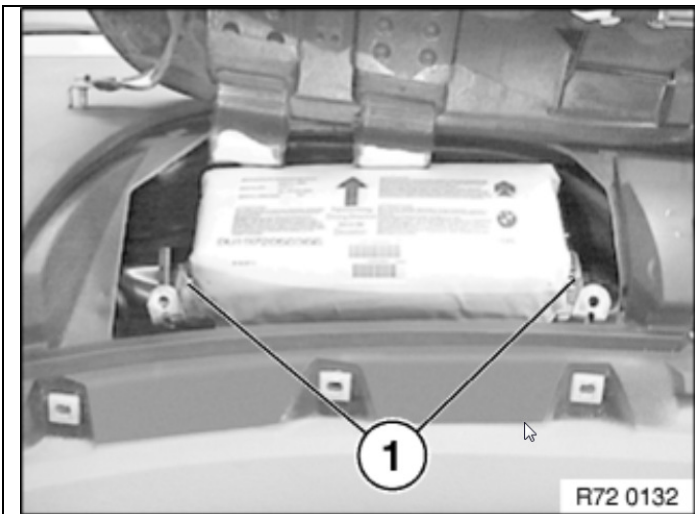
- Undo the screws (1) at the front passenger's airbag module.

- Tightening torque for the passenger's airbag module on the instrument panel carrier: M8 nut, 22 Nm

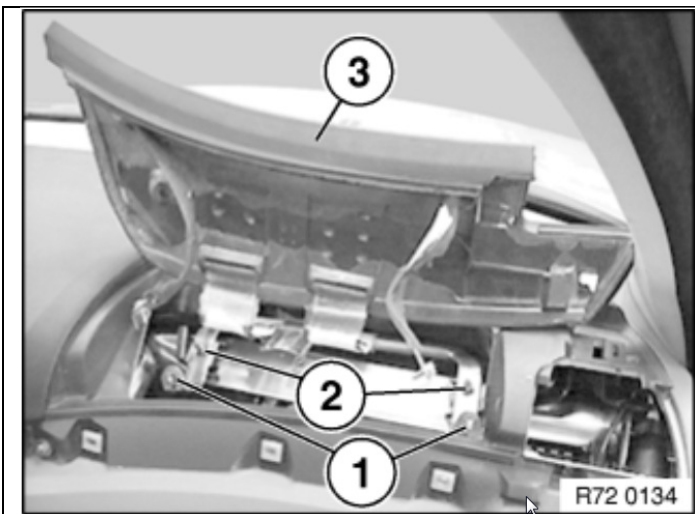
- Pull off the retaining tube (1) from the stud bolt (2) and completely remove the cover (3).
- Remove and replace the passenger's side airbag module.

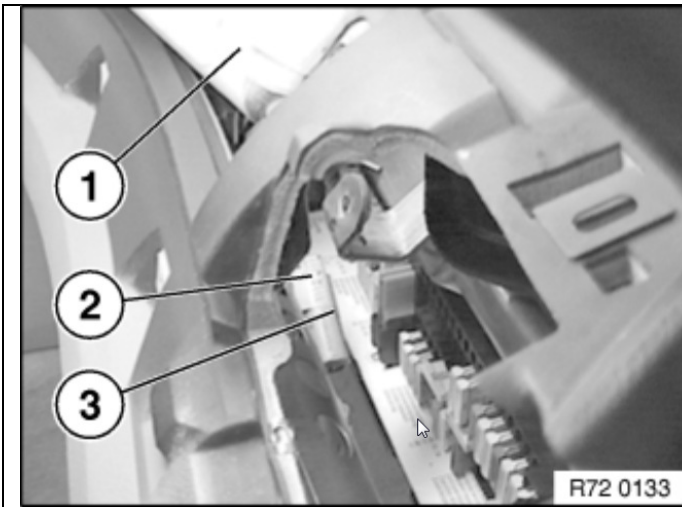
Do not tension the cable when removing the front passenger's airbag module (1)!

- Open the lock by pressing on the tab (2).
- Disconnect the plug connection (3).
- Remove the front passenger's airbag module (1).

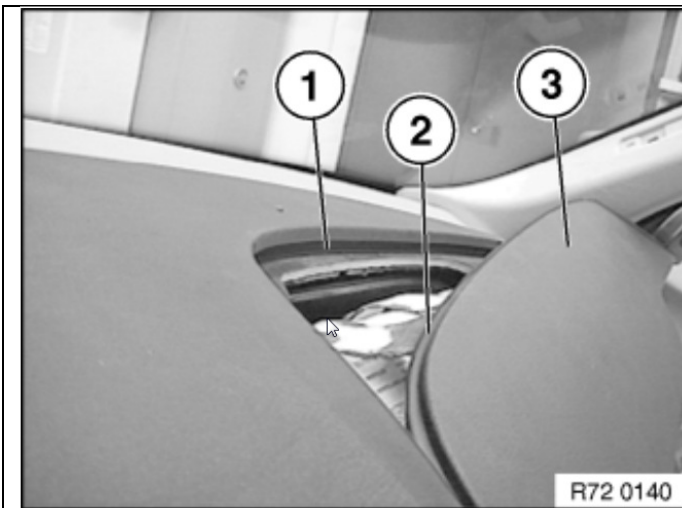
The front passenger's airbag cover (3) must engage into the all-round groove (1) of the dashboard with the lug (2).

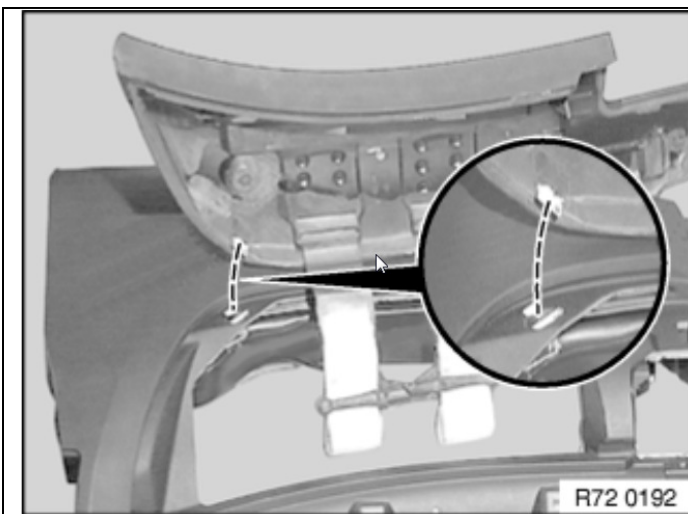
The additional retaining lug at the front passenger's airbag cover must engage in the retaining clip of the dashboard trim panel.
