SIB 65 17 14

2019-10-25

## RECALL CAMPAIGN 14V-428: REPLACE PASSENGER'S FRONT AIR BAG MODULE:

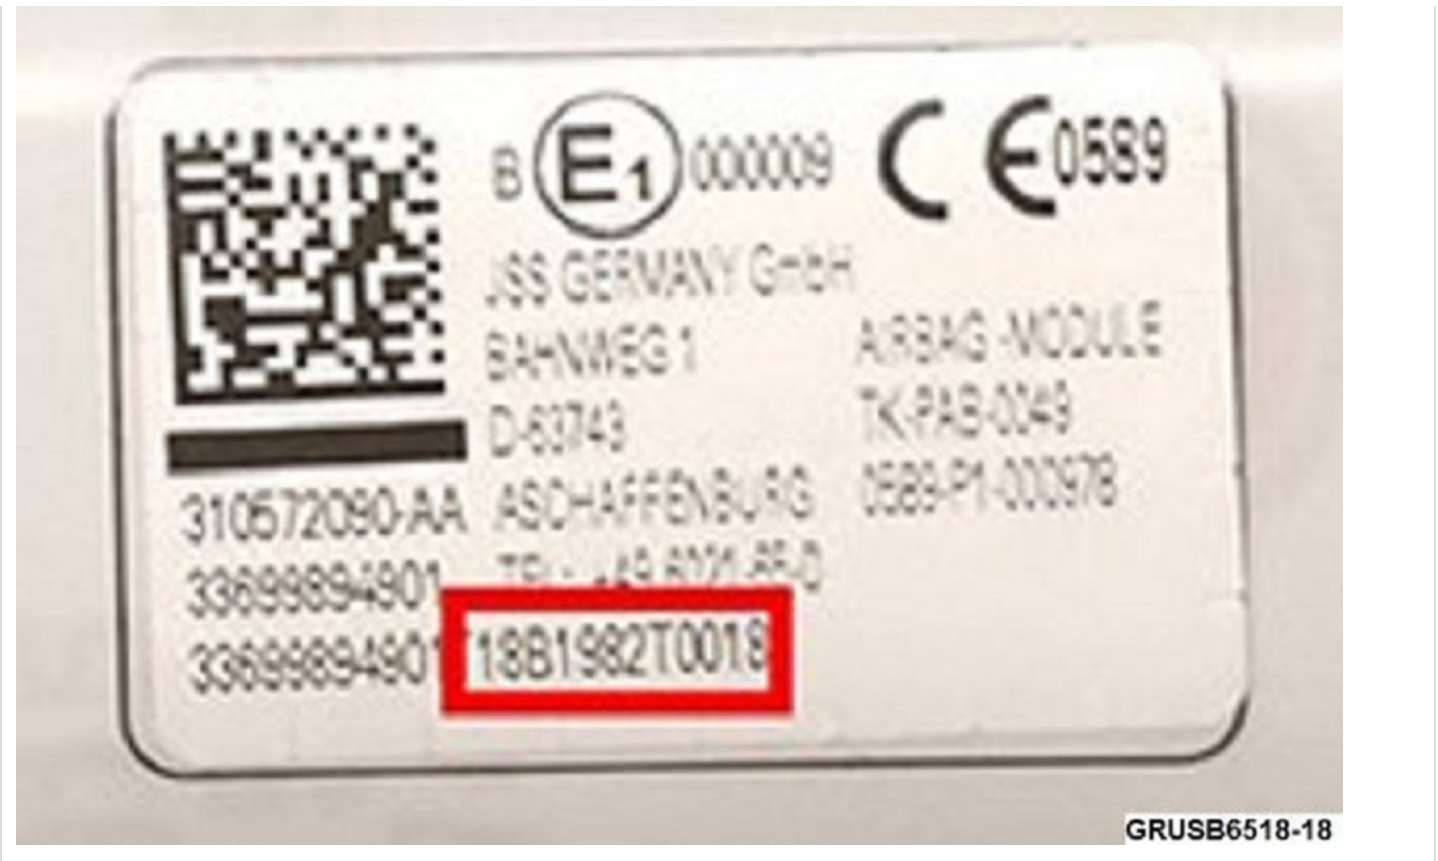
**Please make sure to document the serial number (circled) before installation.**

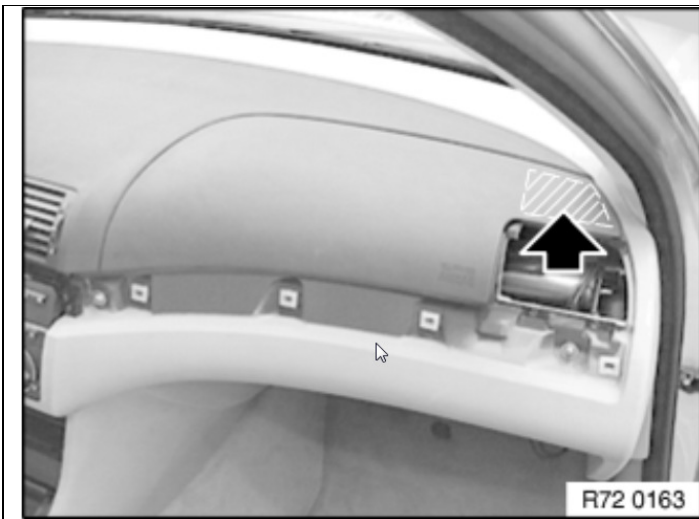
- Position of the retaining clip of the front passenger's airbag cover
